# a living river

CHARTING WETLAND CONDITIONS OF THE LOWER SANTA CRUZ RIVER

2015 Water Year

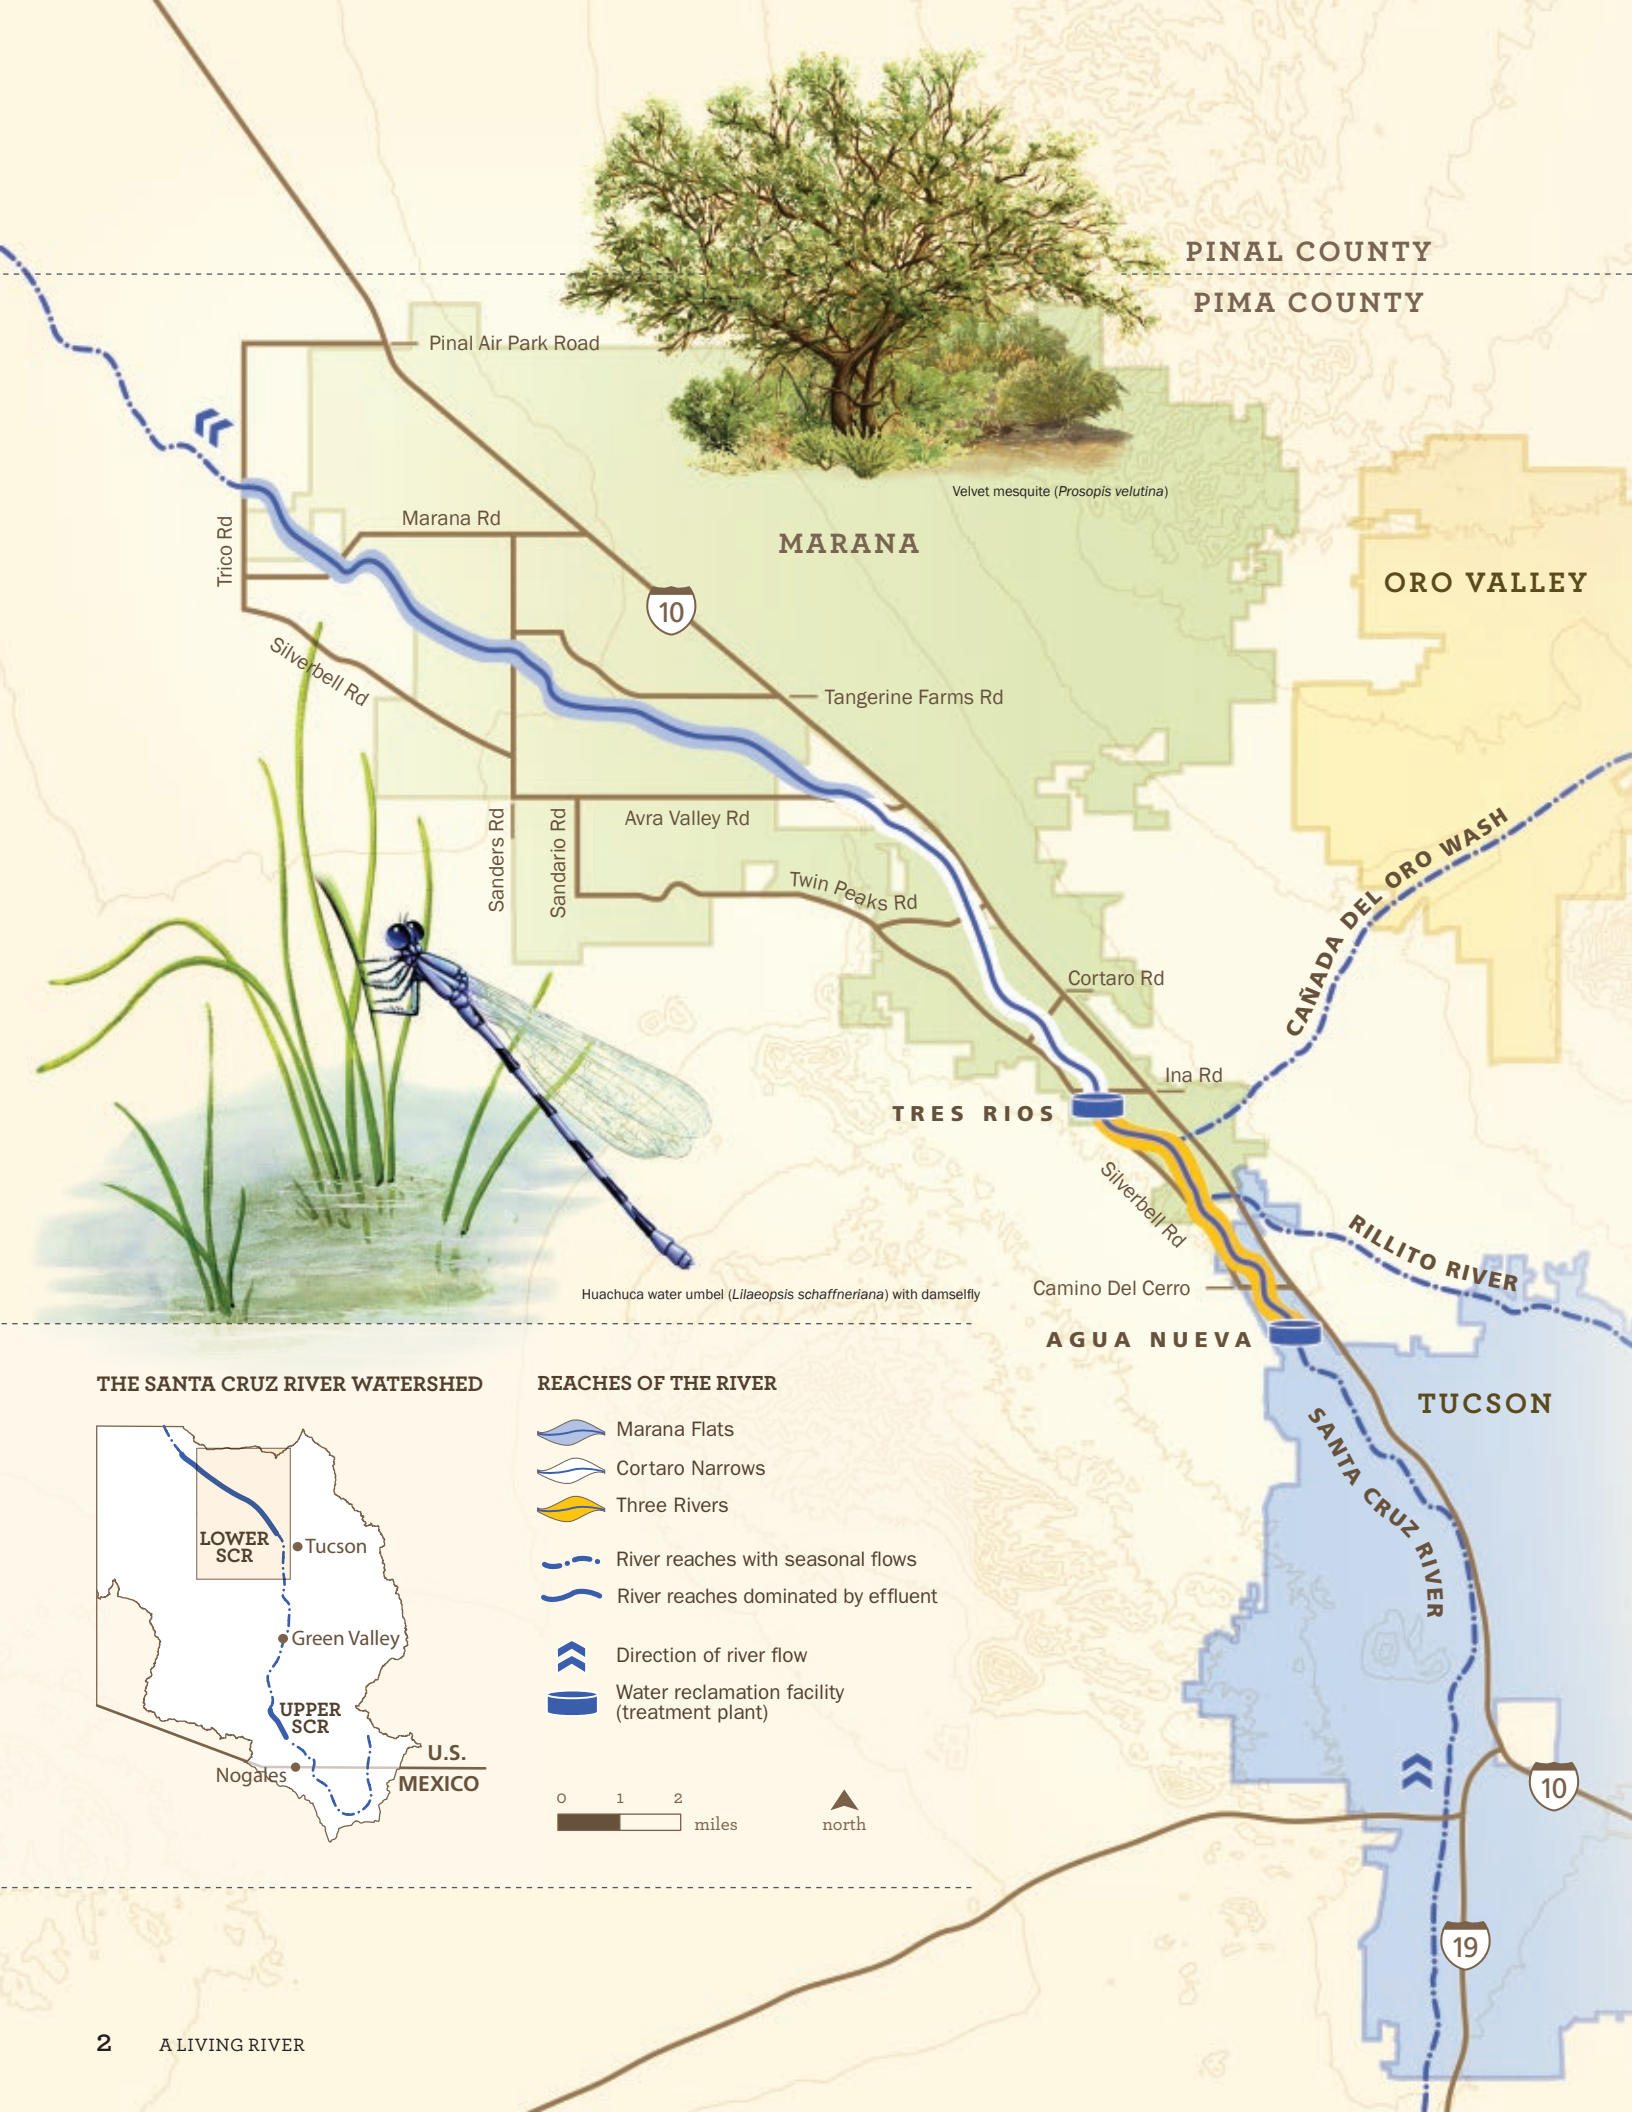
THE SANTA CRUZ RIVER WATERSHED

REACHES OF THE RIVER

- Marana Flats
- Cortaro Narrows
- Three Rivers
- River reaches with seasonal flows
- River reaches dominated by effluent
- Direction of river flow
- Water reclamation facility (treatment plant)

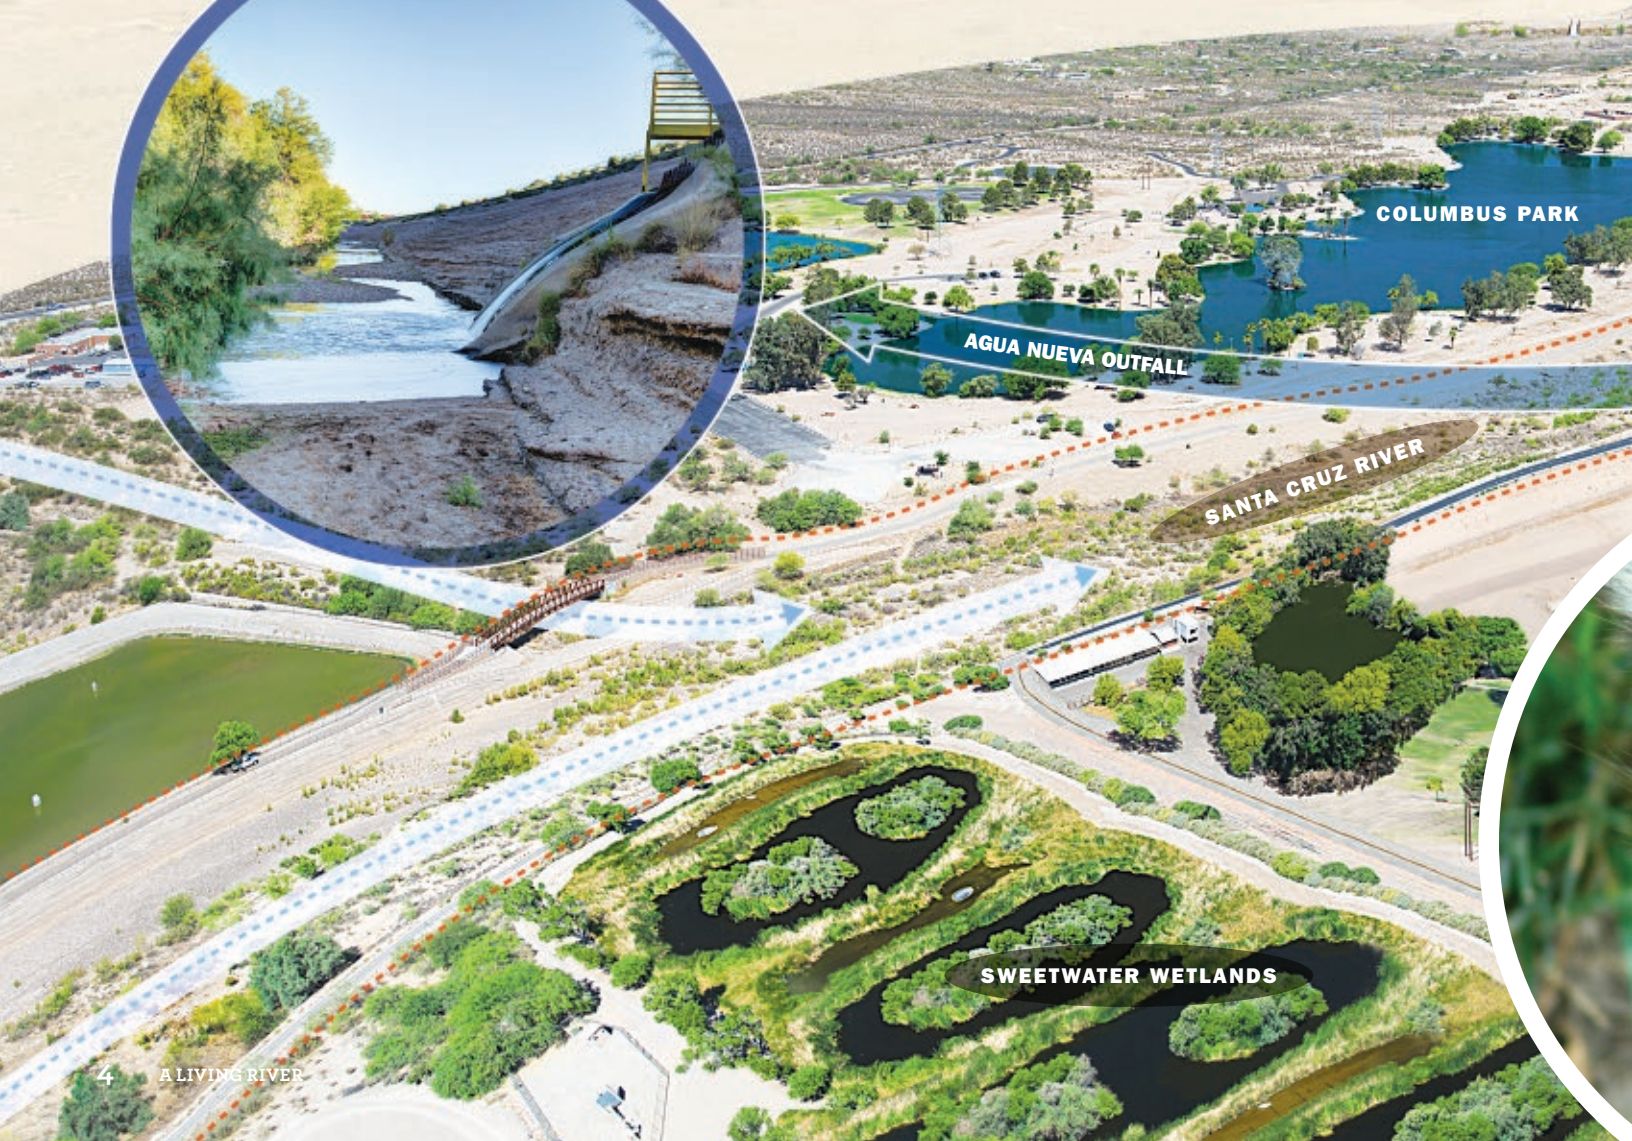
# The Ribbon of Green

Sections of the Santa Cruz that are dependent entirely on stormwater tend to have vegetation that is adapted to drier conditions. Add effluent to the river and suddenly we see a vivid ribbon of green snaking its way downstream (notice the green start near the Agua Nueva outfall). This green ribbon includes native

willows and other wetland plants that need more water. Though these ribbons of green represent a small fraction of the landscape in the desert Southwest, they provide vital habitat for wildlife in the region. They also create a vibrant, cooling corridor for people to enjoy as they visit river parks and travel The Loop recreational path.

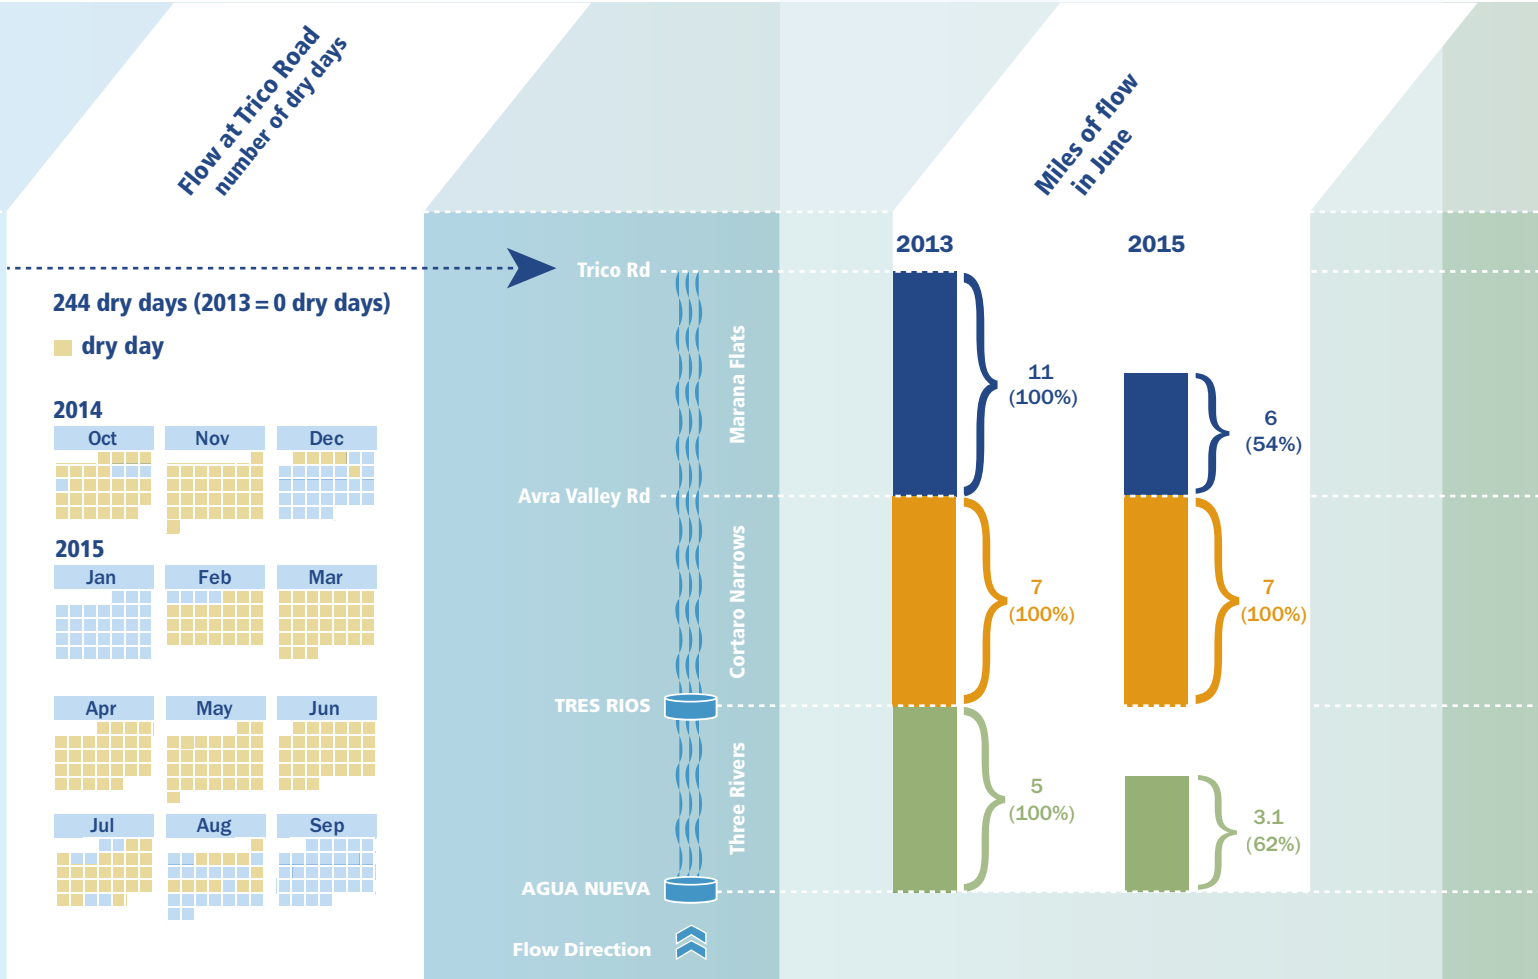
Flow extent decreased considerably in 2015. When measured as miles of flow in June, prior to the start of the monsoons, only Cortaro Narrows maintained flow through the entire reach. When looking at daily flow at Trico Road, the end of the study area, there were 244 days when the river was dry and did not flow. In 2013 the river flowed every day past Trico Road. Overall, decreased flow extent is likely due to increased infiltration (see water budget page 8). Reductions in effluent released from Agua Nueva also contributed to changes observed in the Three Rivers reach. Some wastewater was redirected to Tres Rios and thus released further downstream, and more effluent was used to supply recharge basins near Agua Nueva. Learn more about changes in flow extent and view data from 2013–2015 at [www.tiny.cc/lr15](http://www.tiny.cc/lr15).

Data source: Pima County Regional Flood Control District and U.S. Geological Survey

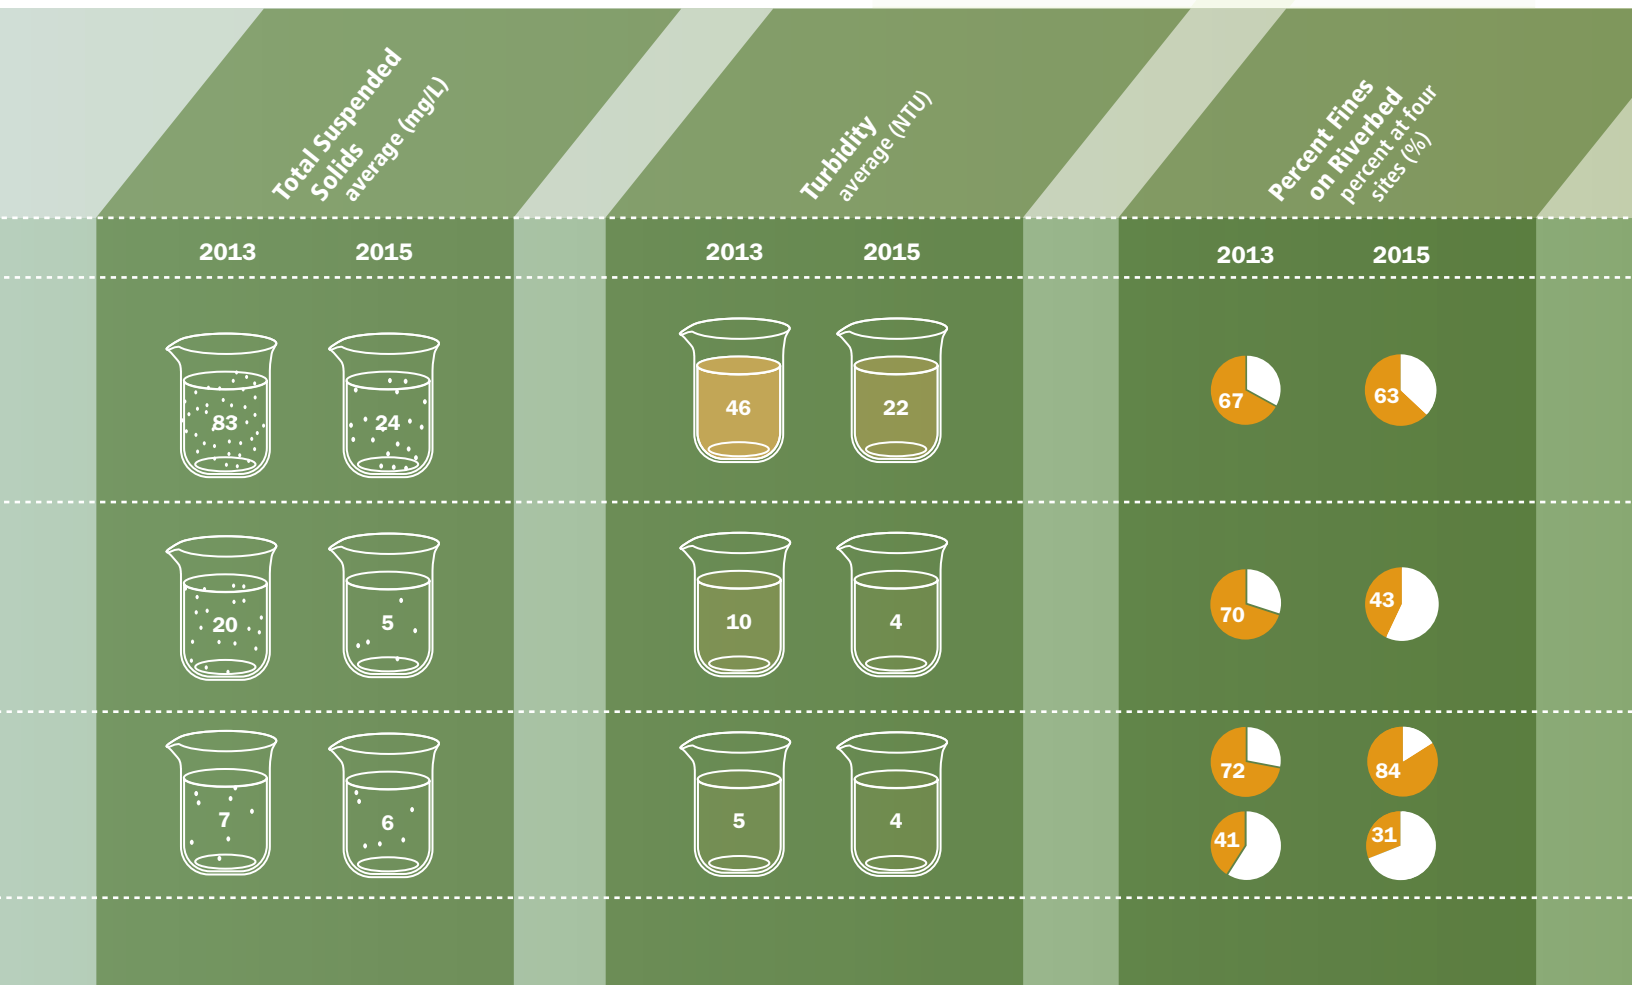
Water clarity was measured throughout the year at several locations when the river was not flooding (murky conditions are normal during storm flows). Suspended solids in the water declined in 2015. Turbidity evaluates the ease of seeing through the water, with high scores representing cloudier water. Average turbidity was lower in 2015, indicating improved water clarity. The percent fines that settle out of the water onto the riverbed was reduced at two sites in the spring of 2015, suggesting improved conditions for aquatic life on the riverbed. Similar, or increased, levels of fine materials are found in areas experiencing reduced flows. Slow flows allow particles to easily settle onto the riverbed. Learn more about changes in water clarity and view data from 2013–2015 at [www.tiny.cc/lr15](http://www.tiny.cc/lr15).

Data source: Pima County Regional Wastewater Reclamation Department, Harris Environmental Group, Inc.

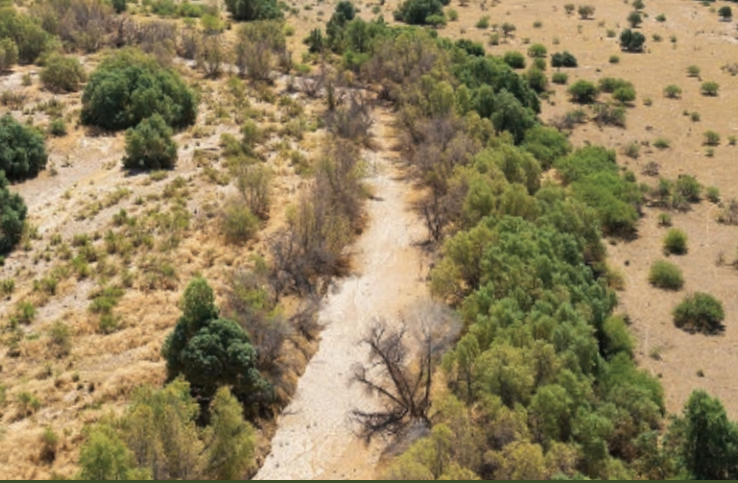
The areas with increasingly dry conditions had a decrease in willows, and vegetation may be shifting to upland plants

In the spring of 2015, measurements of riparian vegetation were taken at seven sites along the river and at one site in a dry area of the river upstream of Agua Nueva. The release of effluent supports wetland species and mature trees that are most abundant downstream of the reclamation facilities. The changes in vegetation observed since 2013 were at the downstream ends of Three Rivers and Marana Flats, where increasingly dry conditions exist because of reductions in flow extent. While there were still wetland plants in these

areas, the plant community may be shifting to plants that grow well in drier, low-nitrogen environments like those found upstream of the Agua Nueva outfall. Decreased flow resulted in reduced cover of mature riparian trees in these areas. Riparian tree cover indicates presence of sufficient soil moisture and is measured as the area covered by tree stems in square meters per hectare (M²/HA). Cover of live Goodding willow notably decreased between 2013 and 2015, while cover of dead Goodding willow increased. This native species has shallow roots and is more sensitive to reductions in soil moisture. The willow decline suggests a shift to more deep-rooted trees and upland plants in drying areas. Learn more about riparian vegetation and view data from 2013–2015 at [www.tiny.cc/lr15](http://www.tiny.cc/lr15).

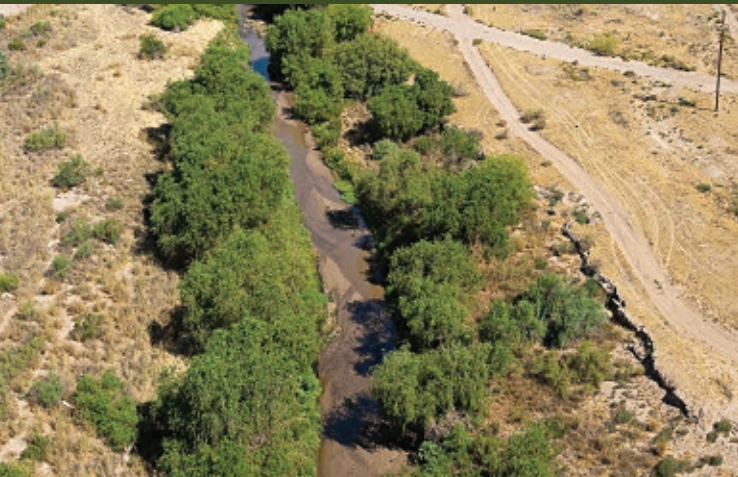
Downstream of Agua Nueva and Tres Rios had wetland plants and those growing well with high nitrogen

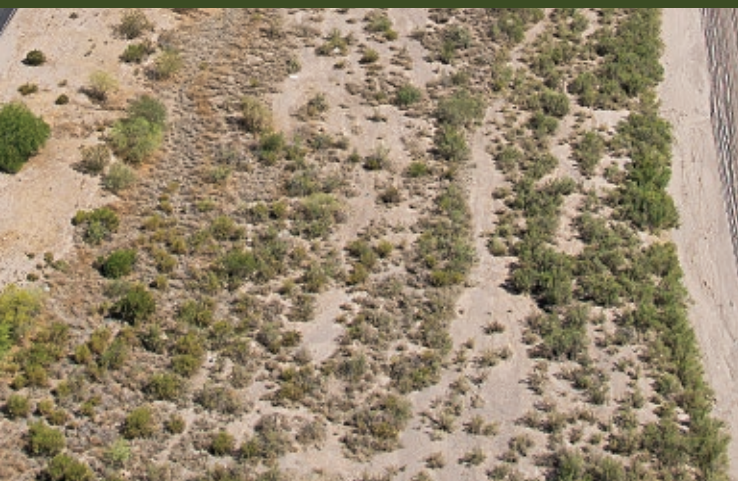
The dry area upstream of Agua Nueva had upland plants and those growing well with low nitrogen

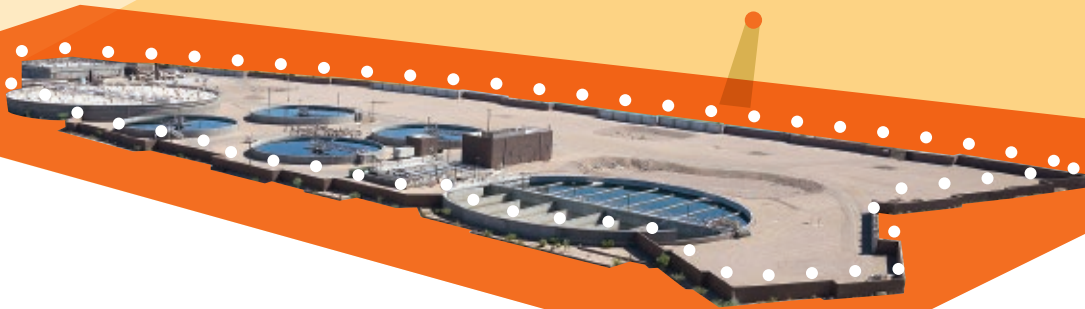
LEVEL OF “ROTTEN EGG” SMELL (HYDROGEN SULFIDE, OR H<sub>2</sub>S, IN PARTS PER BILLION) ASSOCIATED WITH RECLAMATION PROCESS

Actual concentration (ppb) for 99% of measures

As part of the upgrades, odor is monitored continuously at the facilities and at numerous points along the surrounding fencelines. At Agua Nueva, 55 of the 60 monitoring points are on the fenceline. Levels of H<sub>2</sub>S at Agua Nueva were very low in 2015, with 99% of the measures taken throughout the year being less than 0.5 parts per billion (ppb). This concentration is far less than the 10 ppb allowed by the facility permit.
