CHARTING WETLAND CONDITIONS OF THE LOWER SANTA CRUZ RIVER

2016 Water Year

This fourth report examines changes in indicators of river health along a 23-mile stretch of the river during the 2016 water year (October 1, 2015–September 30, 2016). Facility upgrades were completed in December 2013, thus this report captures conditions during the second full water year after project completion.

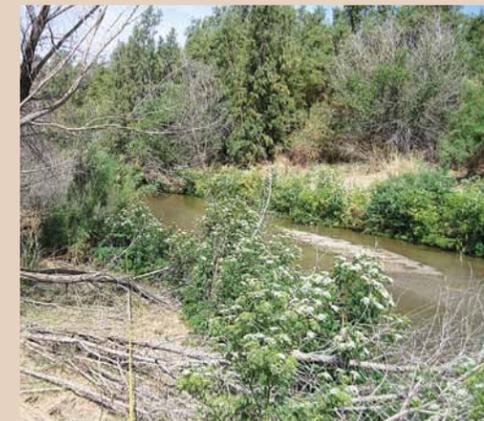
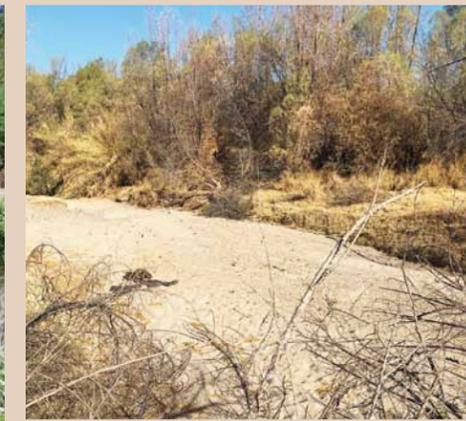
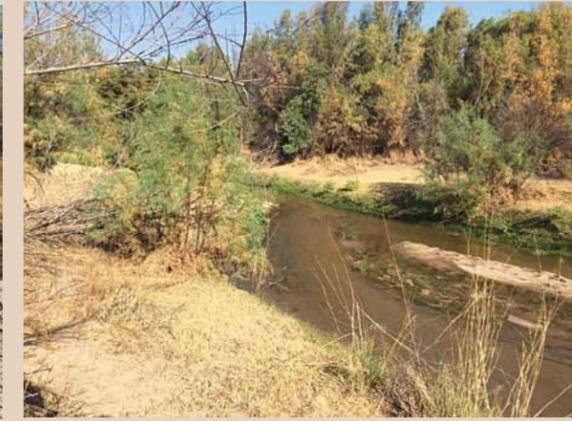
MONITORING SITE AT TRICO MARANA ROAD 2013–2016

Before the facility upgrades, the river was flowing to the end of the study area as seen here near Trico Marana Road, May 2013.

Increasingly dry conditions from reductions in flow extent in 2015 caused saltcedar leaves to turn brown and fall near Trico Marana Road, June 2015.

Plant communities vary with presence of water. Saltcedar is “green” again with flowing conditions in the river near Trico Marana Road in June 2016.

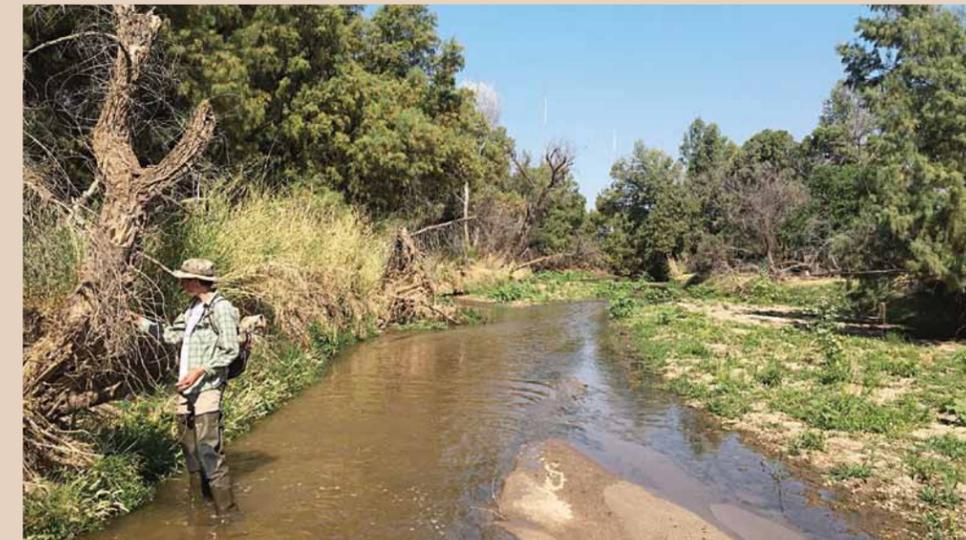
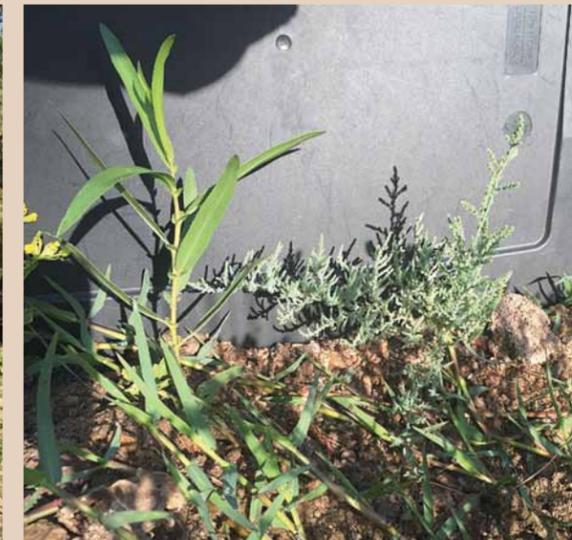
Dead willow trees, like the one above left, are a visible reminder of how important water is for life. Increasingly variable flow conditions will challenge plants at this site. Newly sprouted seedlings were observed during the 2016 survey, but time will tell if they become mature trees.

Goodding’s willow (left) and saltcedar (right) saplings observed near Trico Marana Road, June 2016.

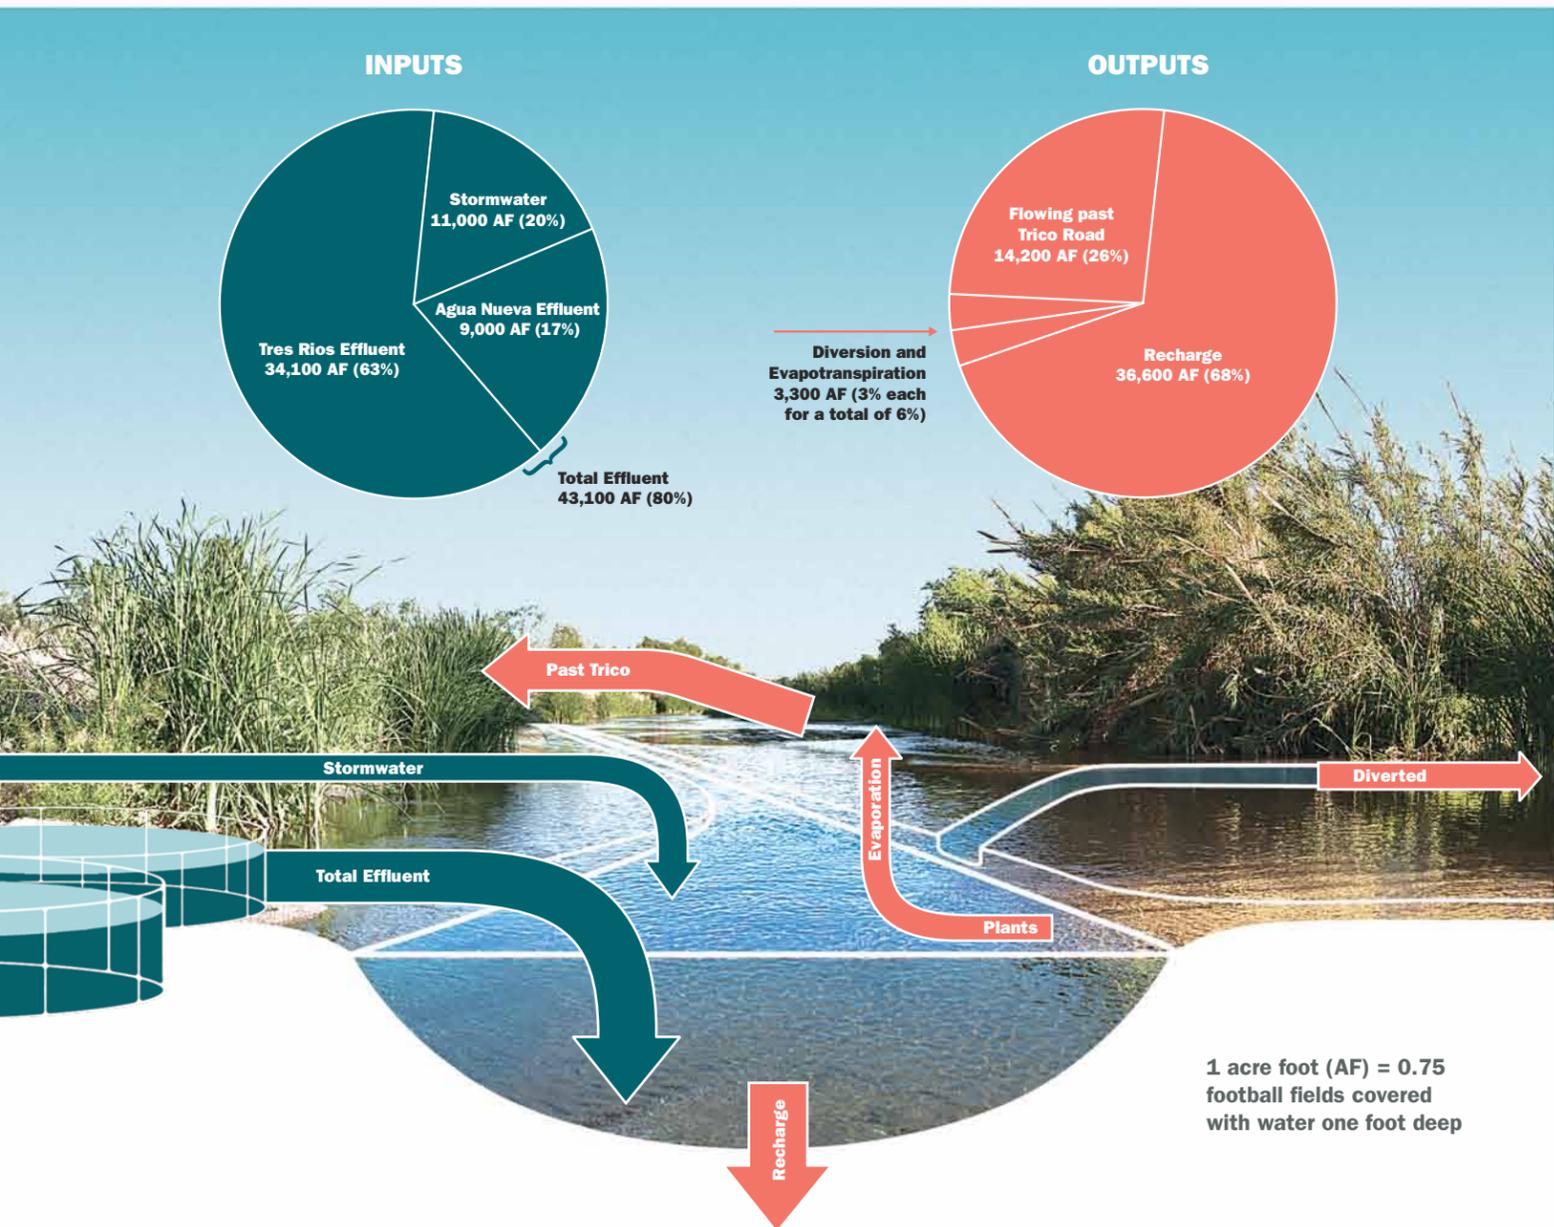
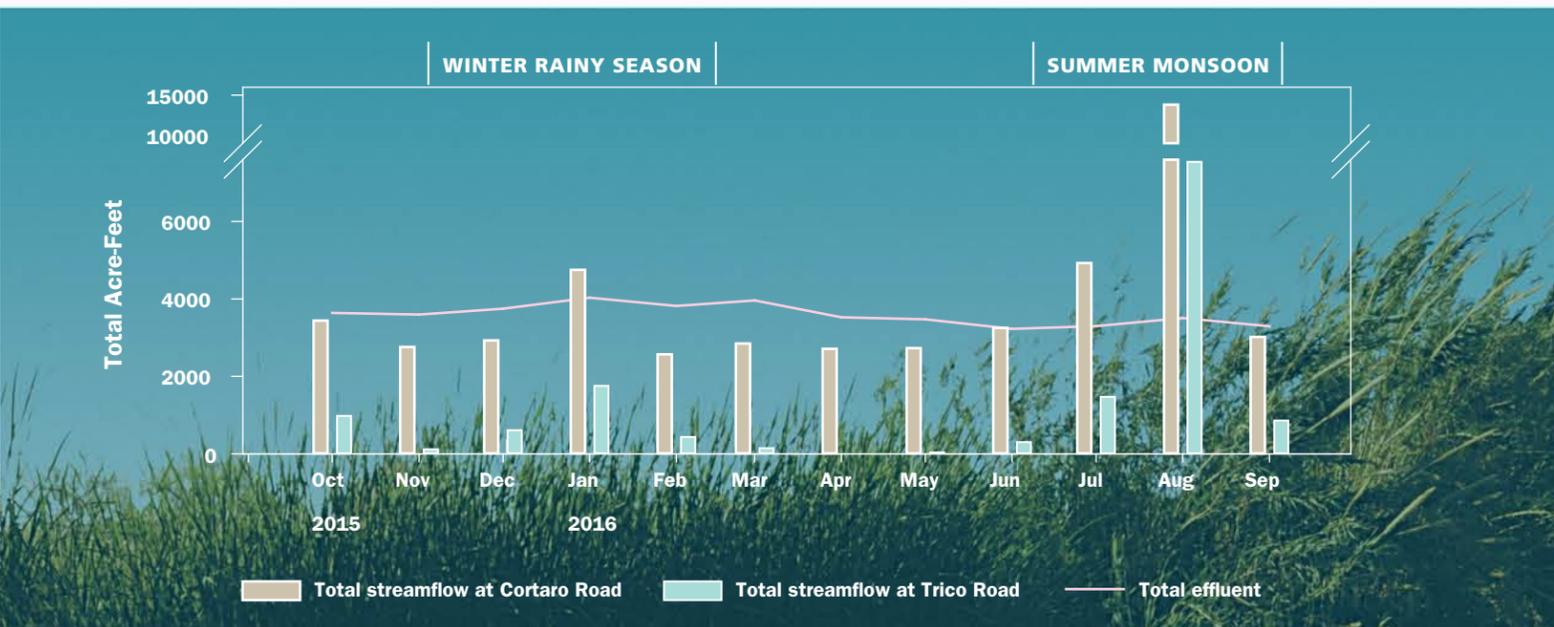
2016 WATER BUDGET

Total input of water to the Lower Santa Cruz was 54,100 AF and 5% higher than the 2013 baseline. This increase is due to greater stormwater flows, which contributed 20% of the input in 2016 compared to only 8% in 2013. Effluent was still the primary source of water, with a total of 43,100 AF released into the river. This volume represented an 8% reduction from the 47,000 AF released in 2013. Less effluent was released into the river because more was diverted into nearby basins

to recharge local aquifers. In terms of output, more water is recharging rather than flowing past Trico Road. The 14,200 AF flowing past Trico Road in 2016 was considerably lower than the 31,000 AF in 2013. This change is likely from the increased rate of infiltration resulting in part from improved water quality which helped reduce the “clogging layer” in the riverbed (see page 14). The fact that 2015 and 2016 had the highest calculations of river recharge in the past four years, with 19,600 AF more recharge in 2016 than in 2013, provides further evidence of a sustained increase in rate of infiltration.

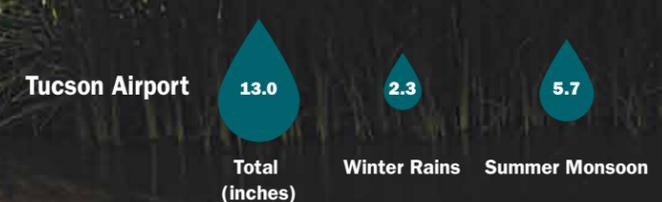
Streamflow is measured at gage stations at Cortaro Road and Trico Road, which are downstream of the Agua Nueva and Tres Rios reclamation facilities (see map page 2). Data sources for streamflow, rainfall, and water budget include National Weather Service, Pima County Regional Flood Control District, Pima County Regional Wastewater Reclamation Department, Tucson Water, and U.S. Geological Survey.

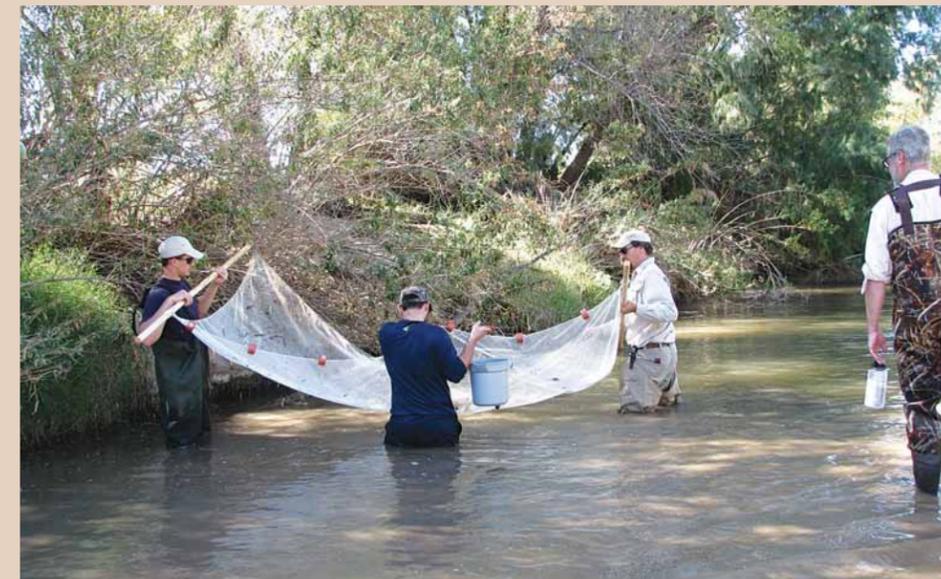
The fall 2016 fish survey found four non-native fish species in the river.

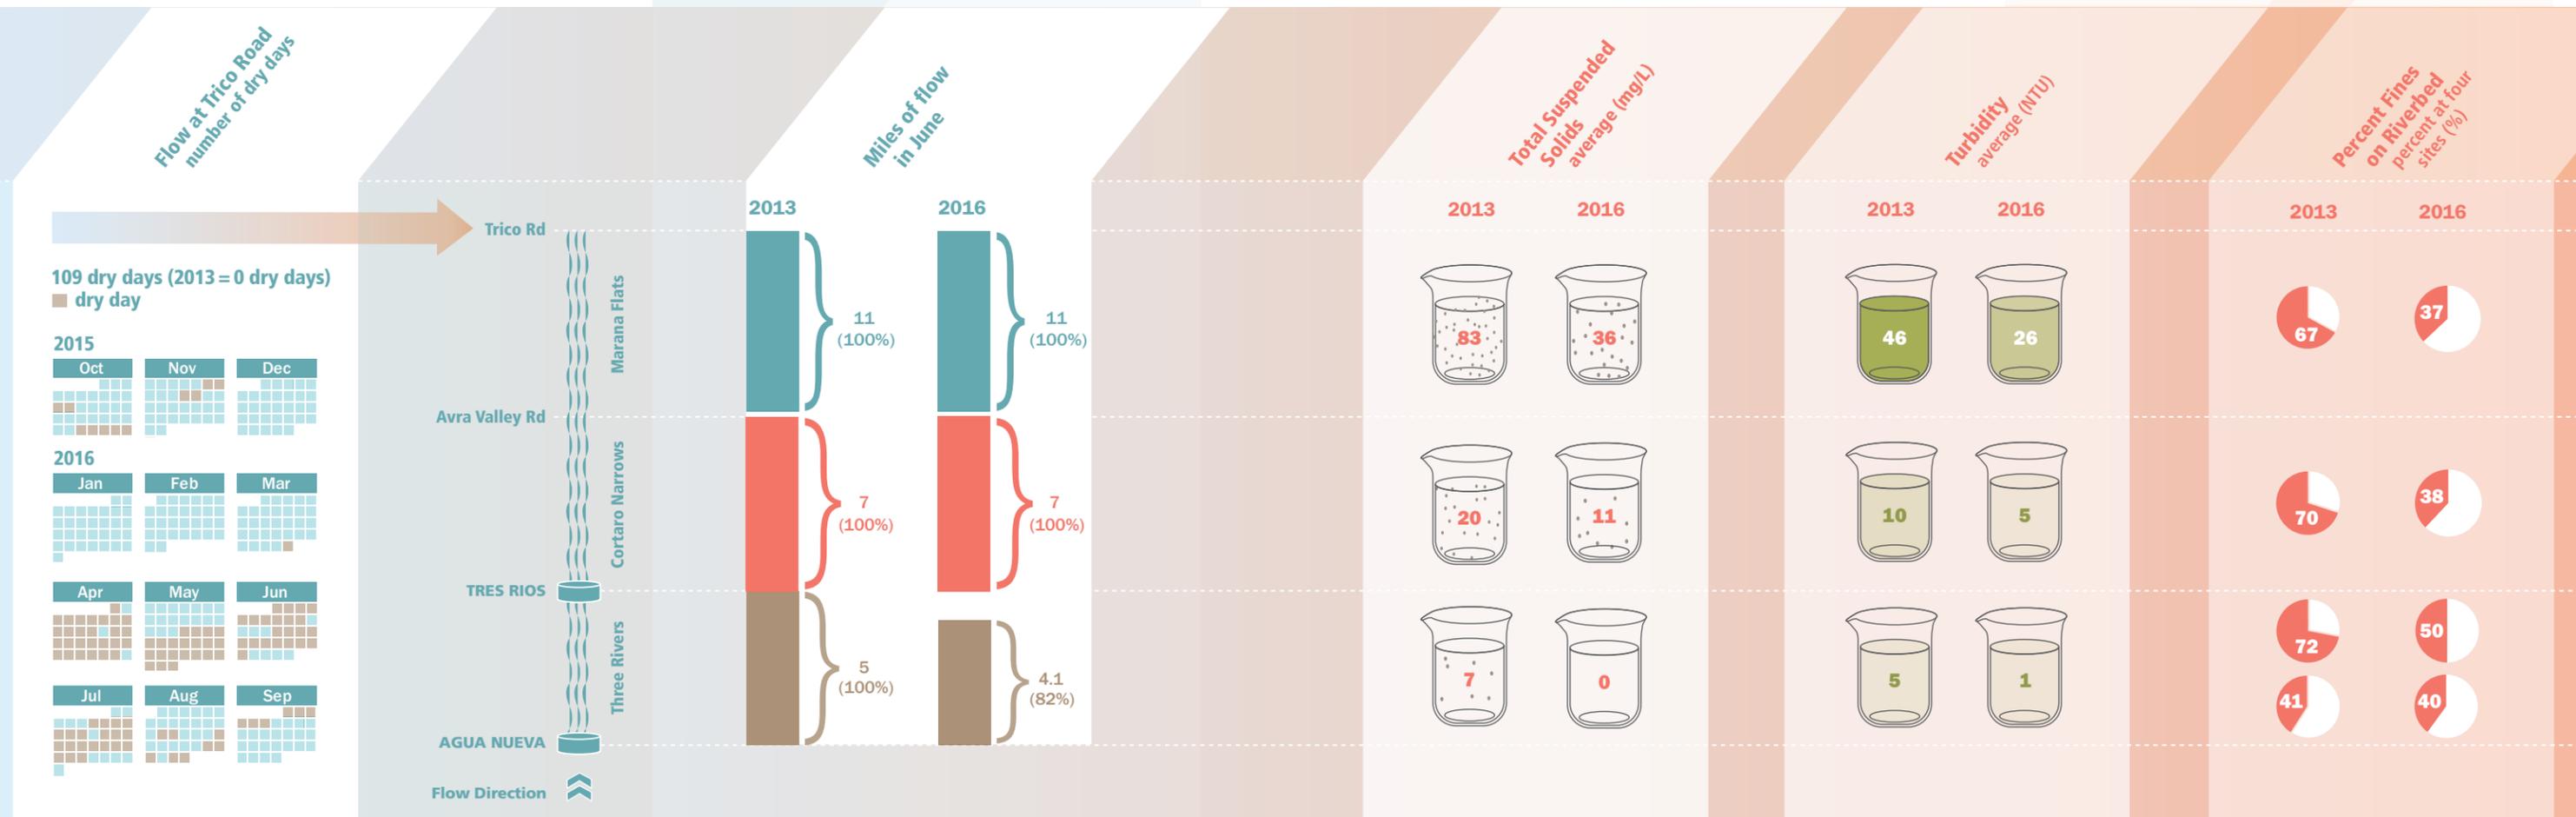
2016 RESULTS Flowing stretch of river is shorter

Flow extent decreased since 2013. When measured as miles of flow in June, before the summer monsoon, Three Rivers did not flow through the entire reach. Only days before this assessment, flood conditions in Marana Flats broke through a berm diverting river water for irrigation. Otherwise, Marana Flats would likely have had reduced miles of flow as in June of 2015 and 2014. When looking at daily flow at Trico Road, there were 109 days when the river was dry and did not flow to the end of the study area. This is less than the 244 days in 2015 but similar to the 94 days in 2014. Decreased flow extent is primarily due to increased infiltration (see water budget page 8), though natural influences and human management are also factors. Learn more about changes in flow extent and view data from 2013–2016 at www.tiny.cc/lr16.

Water clarity was assessed during normal times when the river was not flooding (murky conditions are normal during storm flows). Overall water clarity has improved since the 2013 baseline prior to the facility upgrades. Suspended particles in the water, as measured by total suspended solids, declined. Turbidity evaluates the ease of seeing through the water, with high scores representing cloudier water. Average turbidity has decreased, indicating improved water clarity. The percent fines that settle out of the water onto the riverbed decreased at all sites in 2016, suggesting improved conditions for aquatic life on the riverbed. Learn more about changes in water clarity and view data from 2013–2016 at www.tiny.cc/lr16.

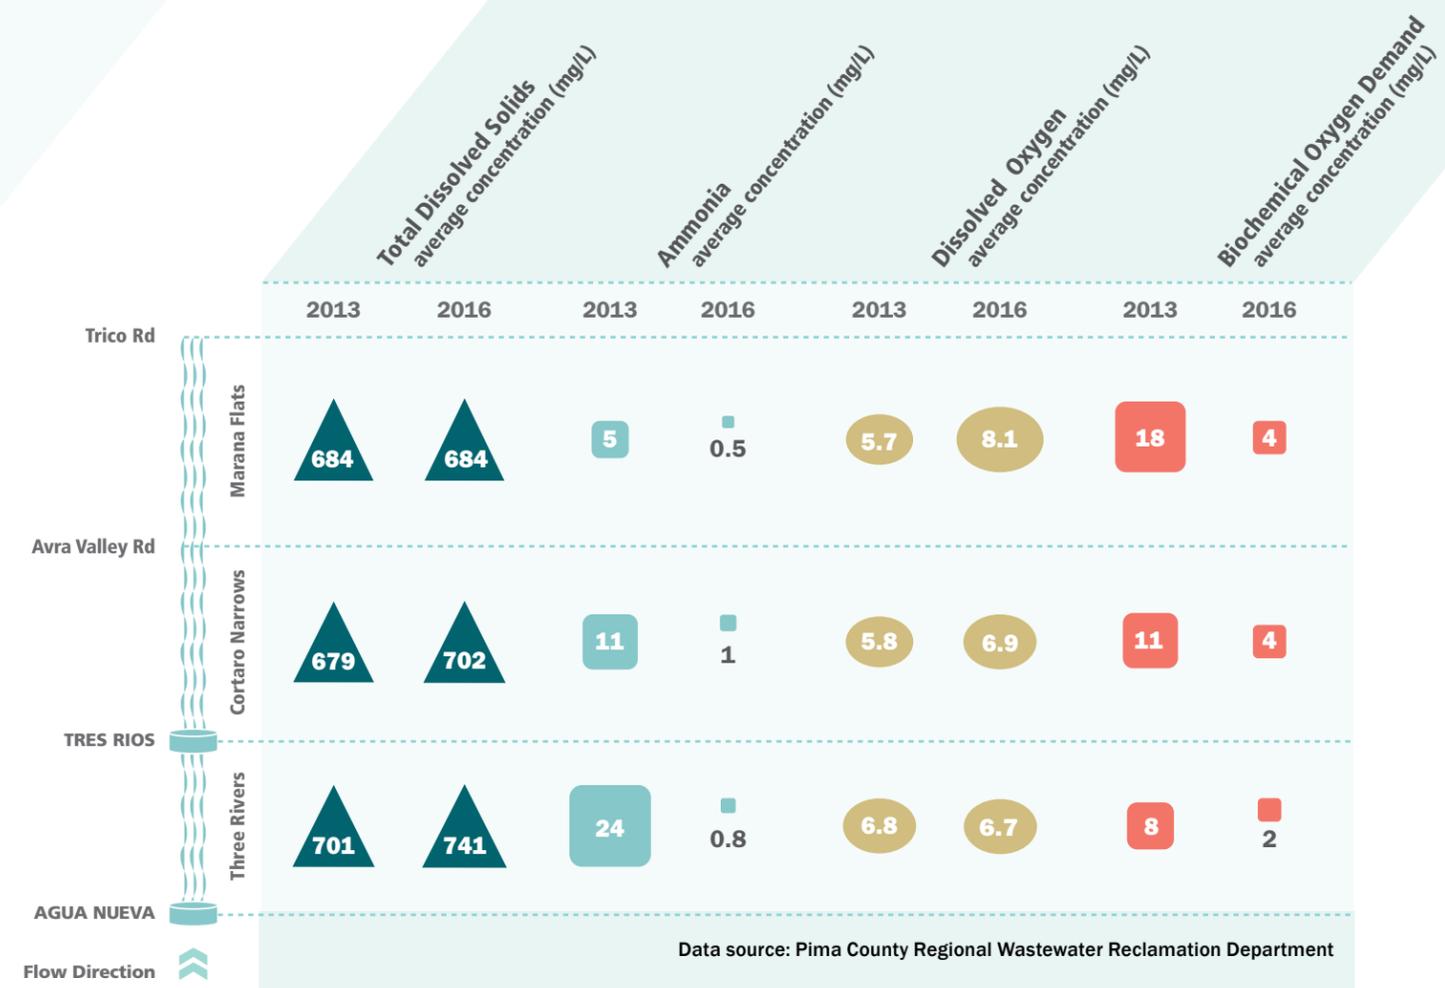
Improved water quality with reduced nitrogen and more dissolved oxygen

The upgraded wastewater treatment process improved the water quality in the river. Ammonia (NH₃) is one form of nitrogen that is toxic to fish at high concentrations and is more common in rivers dominated by effluent. Average concentrations of ammonia significantly declined with the new treatment process. Lower concentration of ammonia and other nutrients is likely a major factor in the reduced clogging layer in the riverbed. Reduced clogging has, in turn, resulted in increased recharge (page 8) and reduced flow extent (page 12).

Fish and other aquatic animals need dissolved oxygen to survive. Levels of dissolved oxygen remained high enough for fish and were highest in Marana Flats. Biochemical oxygen demand estimates the amount of dissolved oxygen used to break down organic matter. If organics are abundant, microorganisms breaking them down use up oxygen in the water and leave little for other aquatic life. Biochemical oxygen demand has declined, suggesting lower organic pollutant levels in the river and more oxygen for aquatic life.

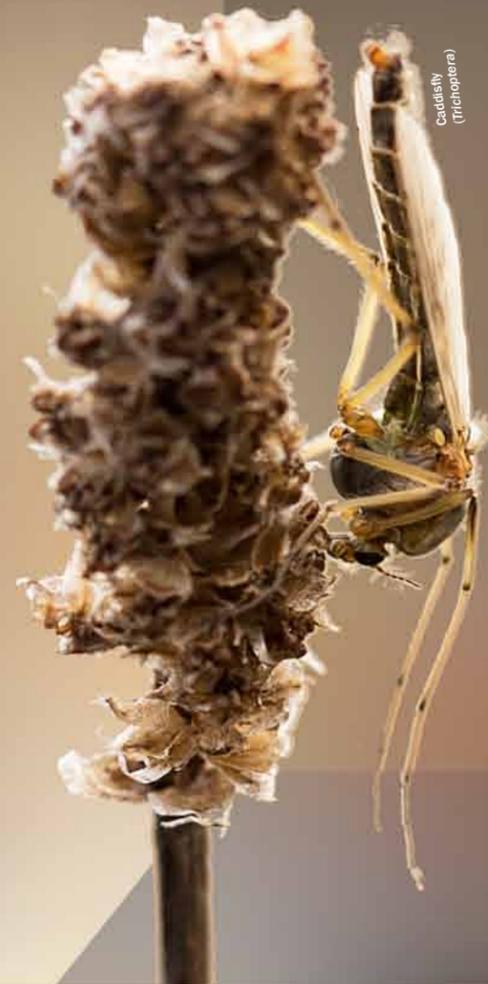
Caddisfly (Trichoptera)

Caddisflies (adult pictured here) start life in the water and, like mayflies, are sensitive to pollution. Surveys in 2016 found the first caddisfly larvae in the river, providing further evidence of improved water quality.
