— 2018 —
WATER YEAR

ENVISIONING
BINATIONAL
COLLABORATION

CHARTING SANTA CRUZ RIVER CONDITIONS—NOGALES WASH TO AMADO
SUPPLEMENTARY REPORT FOR 2008 TO 2018 WATER YEARS

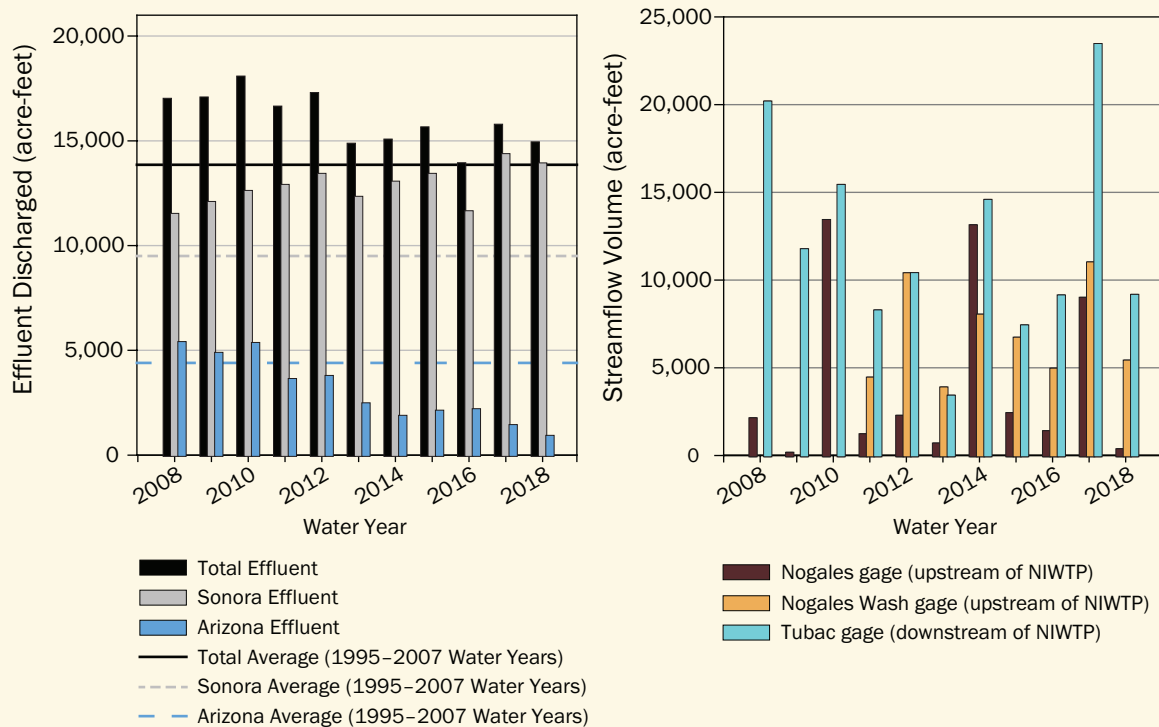
The total volume of effluent released annually into the river has varied, but has decreased by an average of 2,000 acre-feet (over 650 million gallons) since 2013. This represents about a 12% decrease compared to 2008. Although diversions of wastewater to the new Los Alisos Treatment

plant in Nogales, Sonora began in 2013, this decrease in effluent volume primarily results from reduced volume of wastewater coming from Nogales, Arizona. Over time, there could be further reductions of effluent with increased diversions of wastewater to the Los Alisos treatment plant in Nogales, Sonora.

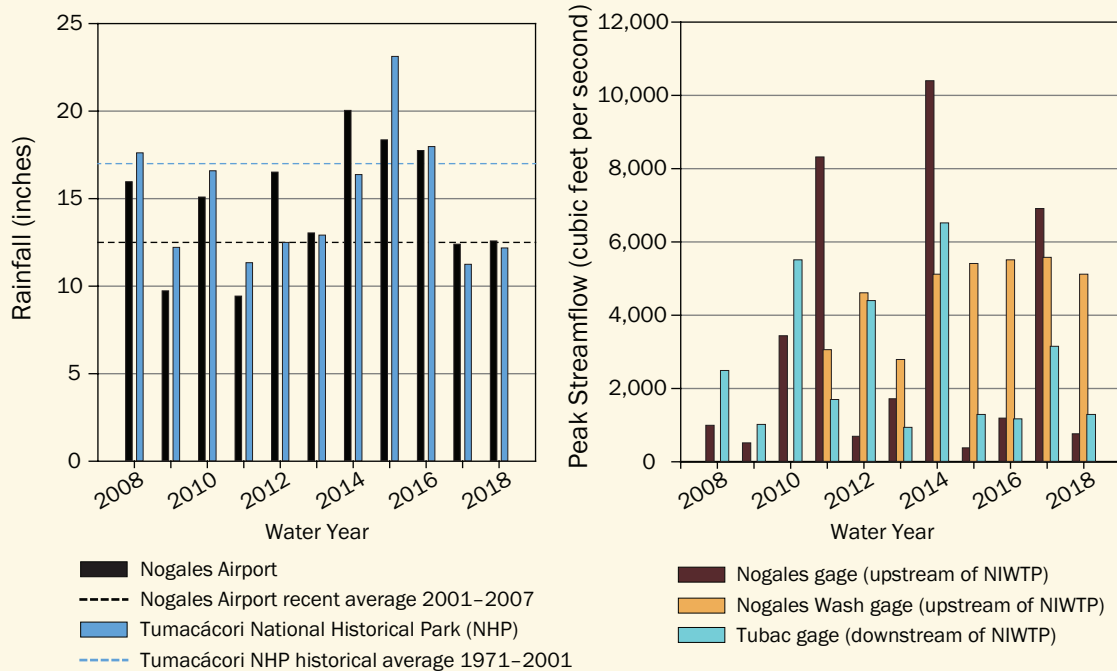
Streamflow and Rainfall cont.

Streamflow is measured daily in Tubac, near the international border, and since 2011, along Nogales Wash. Overall, total volume of streamflow at the Tubac gage has decreased since 2008. The 2017 water year is the most recent peak in total volume of water passing this gage, largely because of high flows during the summer monsoon.

Total rainfall has hovered around the recent average at Nogales Airport. Sixteen miles to the northwest, rainfall near Tumacácori National Historical Park has been lower than the historical average in this area.

Peak streamflow has varied with location. Flooding conditions have generally been higher upstream of the treatment plant than in Tubac with the largest flood recorded at the Nogales gage near the international border. Flows in Tubac have been more variable, with the highest peak flow occurring in 2014. Nogales Wash has seen an increase in peak flow volume that has been fairly stable since 2014.

With overall effluent volume remaining fairly constant, the decrease in total volume of stream flow could be due to several factors including changing weather patterns, floods, variability in groundwater levels, and reduced nutrient pollution. Cleaner water promotes infiltration of water through the riverbed by breaking down old clogging layers, preventing new layer from forming, and ultimately recharging the aquifer.

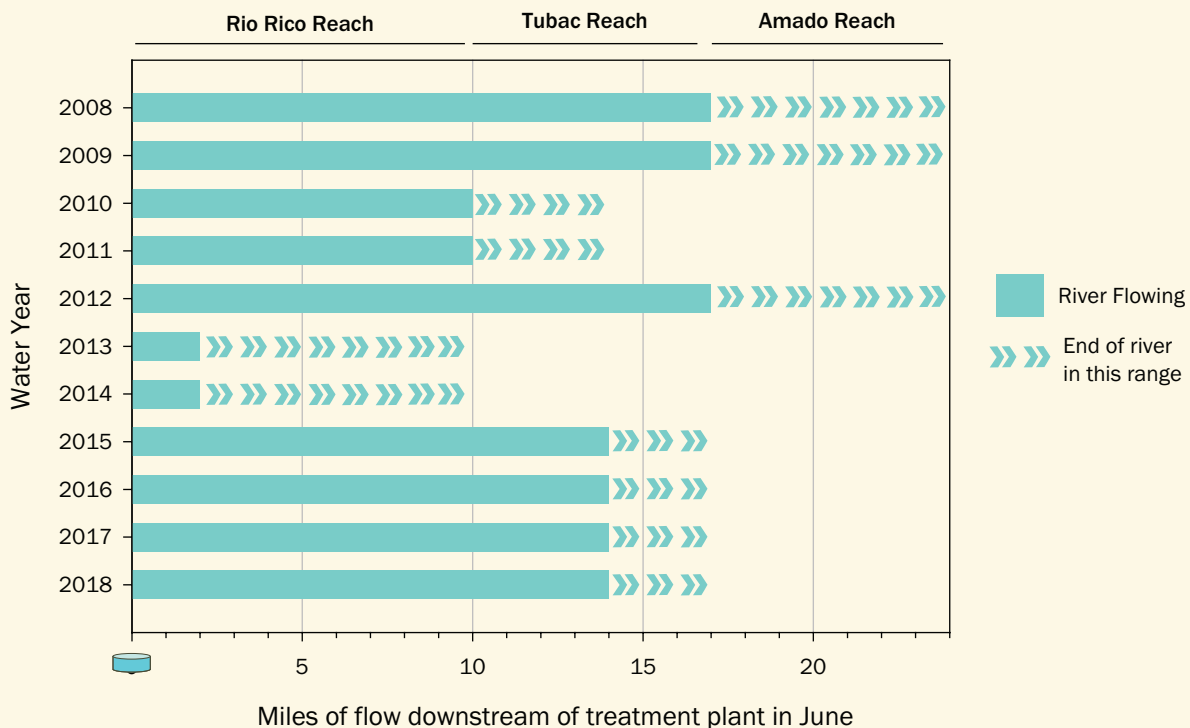
Miles of flow in June has decreased since the 2008 baseline. Prior to 2010, the river flowed 17 miles and into the Amado reach regularly in June. Since the volume of effluent released into the river did not significantly decrease after the 2009 upgrade, increased recharge from improved water quality is likely a major factor for the decreased flow extent in 2010 and 2011. A further reduction in miles of flow was observed in 2013 and 2014. This coincides with the timing of diversions of wastewater to a new wastewater facility in Sonora, Mexico which began in 2013. However, the total volume of effluent released into the river has decreased only by an average of 2,000 acre-feet per year, with this decrease largely attributed to decreased wastewater coming from Nogales, Arizona. Since 2014, flow extent in June has increased and stabilized.

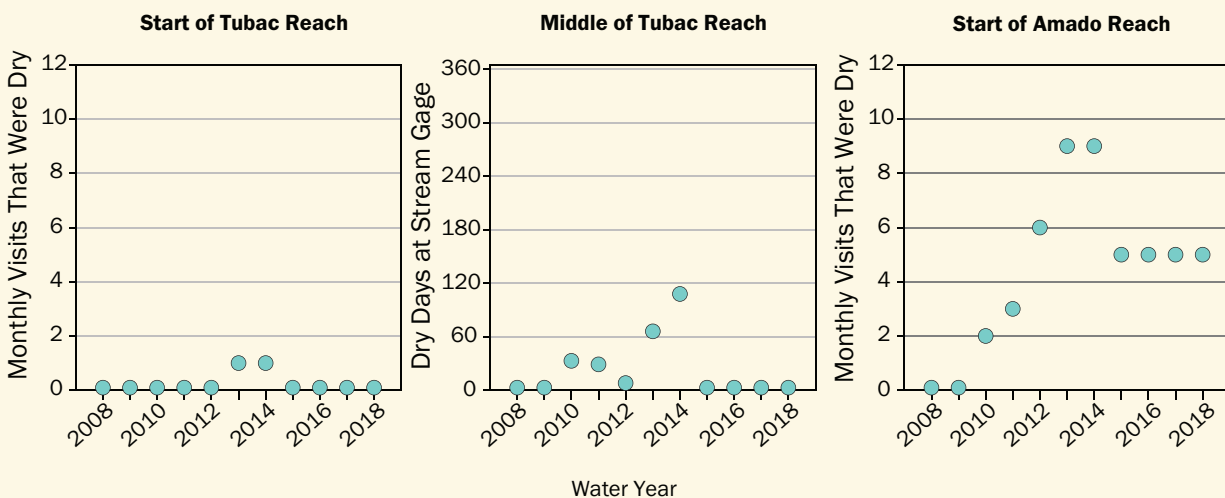
Dry days or visits have become more common at the far downstream end of the reach, indicating that flow extent has

decreased. Prior to 2010, the river flowed every day at the Tubac stream gage with no zero flow days recorded since July of 2003. Since 2010, the number of dry days has increased, peaking at nearly 120 in the 2014 water year.

A similar pattern of increased dryness is seen at the start of the Amado reach. Though measured monthly rather than daily, the number of dry visits has increased. Only one dry visit was observed between 2005 and 2009. In contrast, dry visits peaked during the 2013 and 2014 water years with 9 of 12 monthly visits dry. Since 2014, dry days and visits have decreased and stabilized.

Nogales Wash has had stable flows. Only three of the monthly monitoring visits at Nogales Wash found no flow. These were during the June visits of 2011, 2013, and 2014.

Note: Data from the Rio Rico reach are not displayed. No dry visits observed during the 2008–2018 water years.

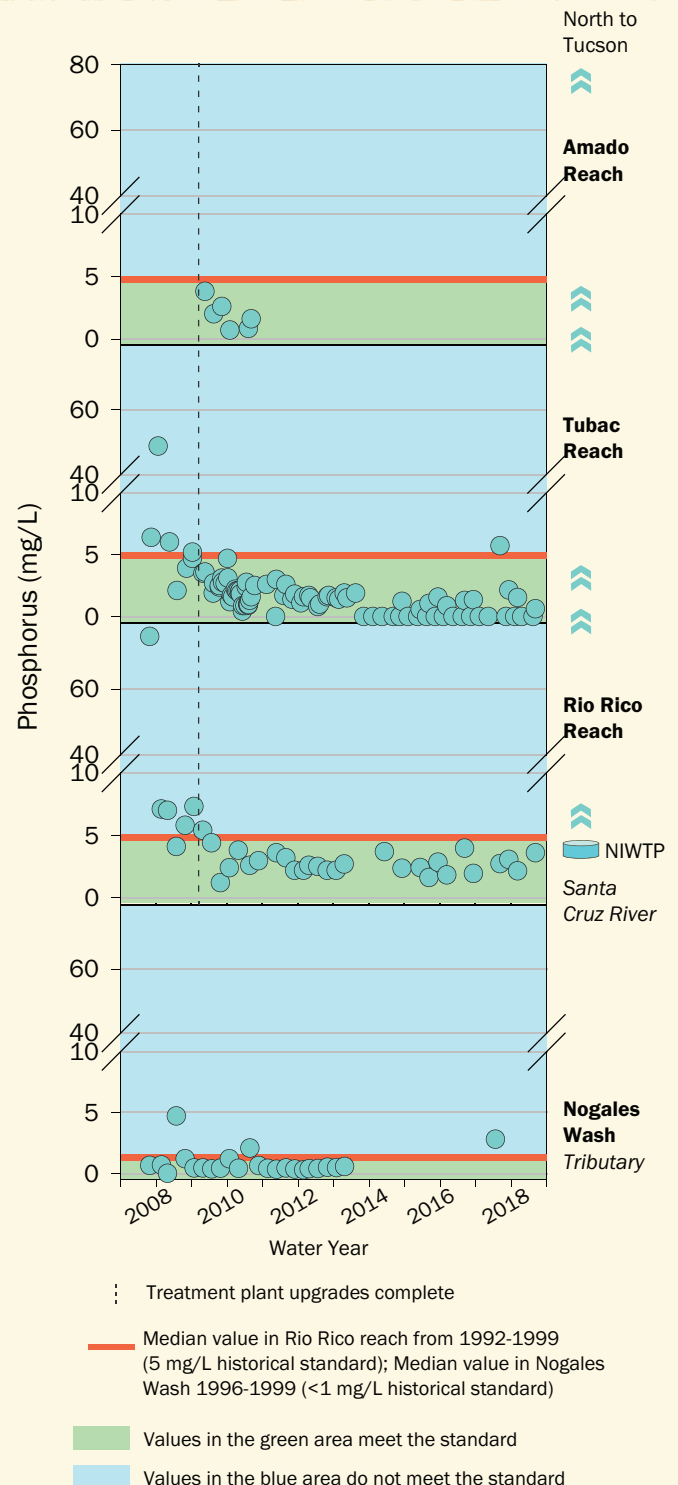
Phosphorus levels declined over the years in the Rio Rico and Tubac reaches, most notably after the upgrades to the treatment plant were complete in 2009. Data are limited for the Amado reach but measures of total phosphorus are below the historical standard.

Nogales Wash has limited data and treatment plant upgrades did not impact conditions. All but five samples met the historical standard. The only sample since 2013 was taken in 2017 during a sewage breach when untreated wastewater was flowing out of the International Outfall Interceptor and into Nogales Wash.

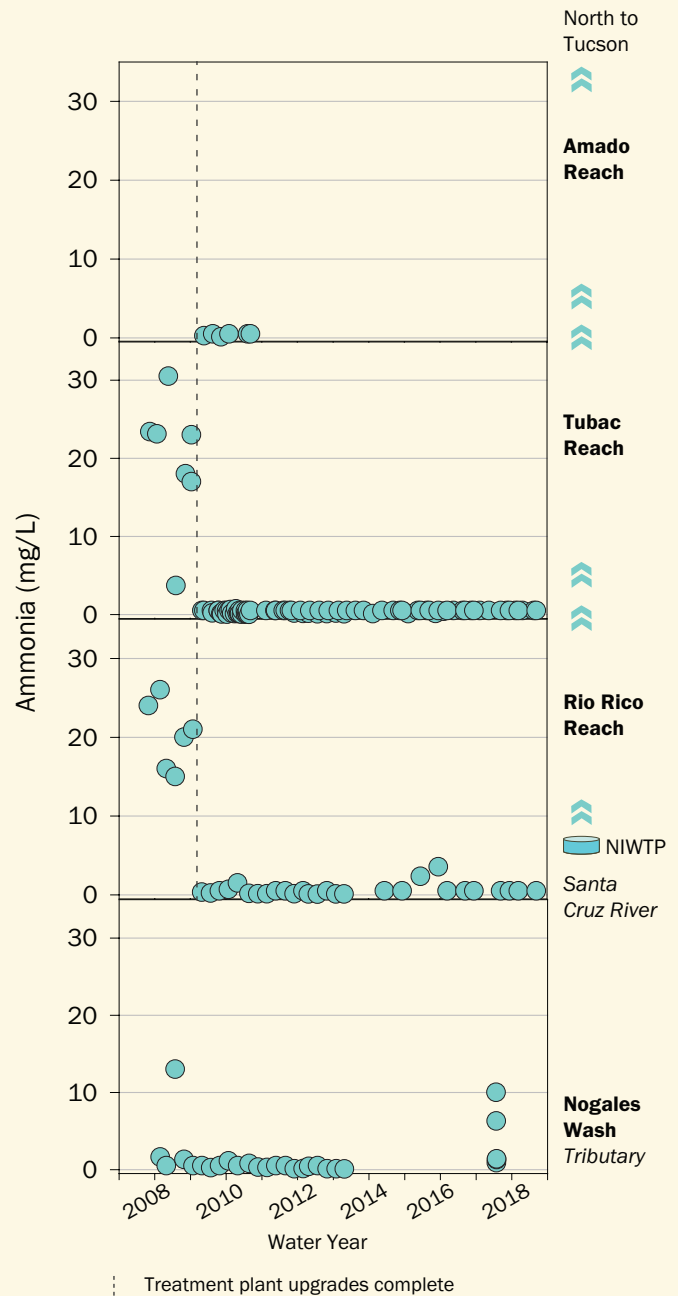
Ammonia decreased dramatically and was often not detected in the Rio Rico and Tubac reaches after the treatment plant upgrade was complete in 2009. This improved water quality led to beneficial conditions for fish and other aquatic wildlife. Although data are limited for the Amado reach during this period, between 2000 and 2007 measures of ammonia averaged 10 mg/L and followed a similar pattern to the Rio Rico and Tubac reaches. The decreased ammonia likely reduced the clogging effect in the river bed and was a factor in the reduced flow extent observed since 2009.

Nogales Wash was not impacted by the upgrades to the treatment plant. Ammonia levels here were low, averaging 1.4 mg/L from 2008–2013. Measures of ammonia from 2017 were taken during a sewage breach when untreated wastewater was flowing out of the International Outfall Interceptor and into Nogales Wash.

Note - Ammonia standards vary with temperature and pH and can't be graphed as a single line.

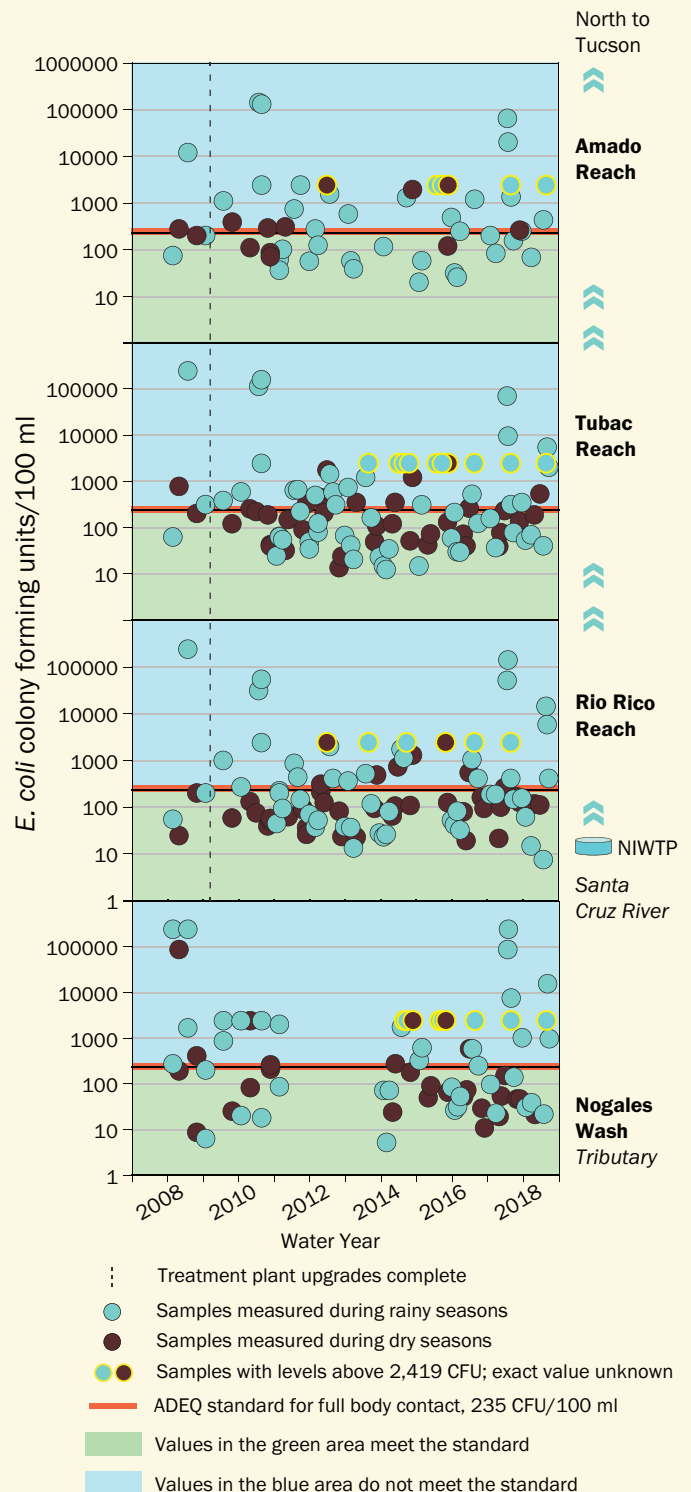
E. coli levels varied seasonally and were similar in all three reaches of the river and in Nogales Wash. The Nogales International Wastewater Treatment Plant has always removed bacteria prior to release of effluent in the Santa Cruz, thus levels of *E. coli* in the effluent did not change after the upgrades were complete. Levels of *E. coli* exceeded the standard most often during the rainy seasons. High levels during the rainy season suggest that rain is washing fecal contamination into the river from multiple sources within the watershed. Preliminary research identifies humans, livestock, and wildlife among the sources of contamination.

Several of the exceedances in Nogales Wash from 2017 were from samples taken during a sewage breach when untreated wastewater was flowing out of the International Outfall Interceptor and into Nogales Wash.

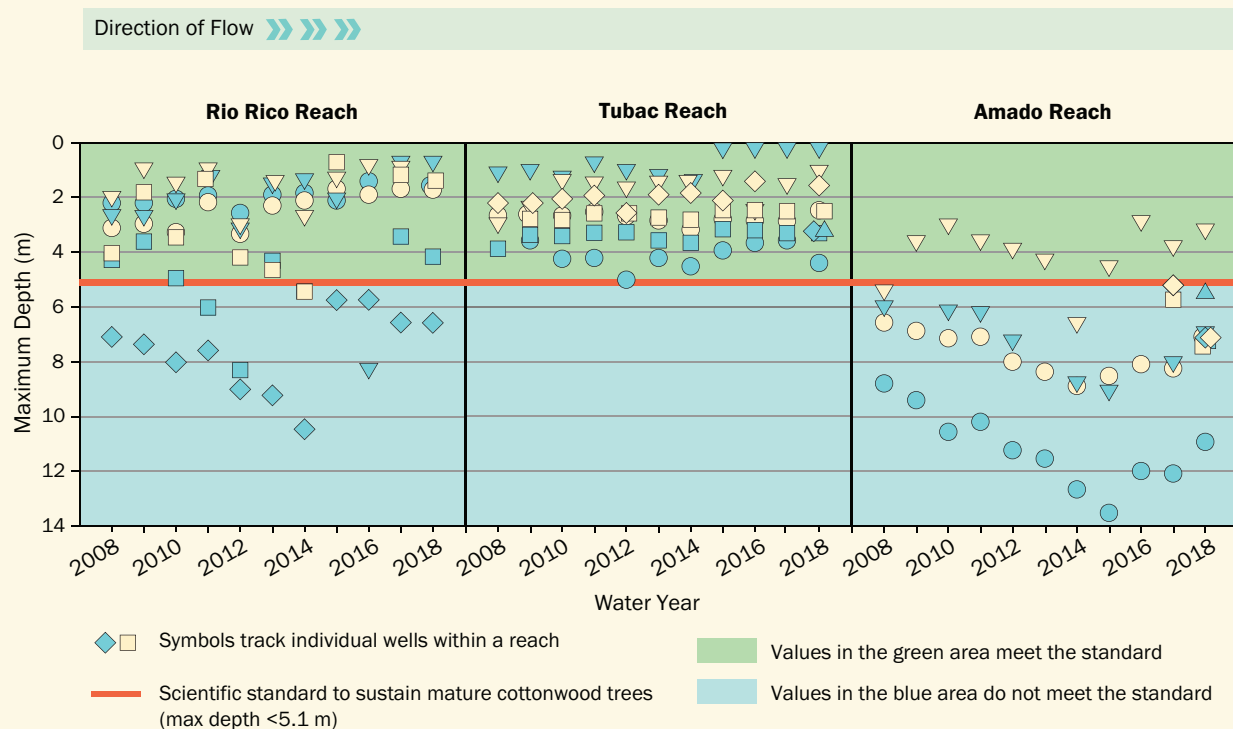
Number of depth measurements over the years varied by well. Some wells were measured only once a year while others were measured daily. All depth to groundwater measurements are determined relative to areas that may support cottonwoods. The Tubac reach appears to have the most stable depth to groundwater measures. Rio Rico and Amado likely had increased recharge in recent years with shallower depths recorded. In Rio Rico, the wells with measurements below the standard are located near the beginning of the reach and represent wells closest to the release of effluent. In contrast, several wells in the Amado reach that were below the standard are located at the far end of the reach and represent wells that are furthest away from the release of effluent. The best conditions for supporting cottonwoods may be along the Tubac reach where geologic and hydrologic conditions are optimal and the recharge of effluent is possibly highest.

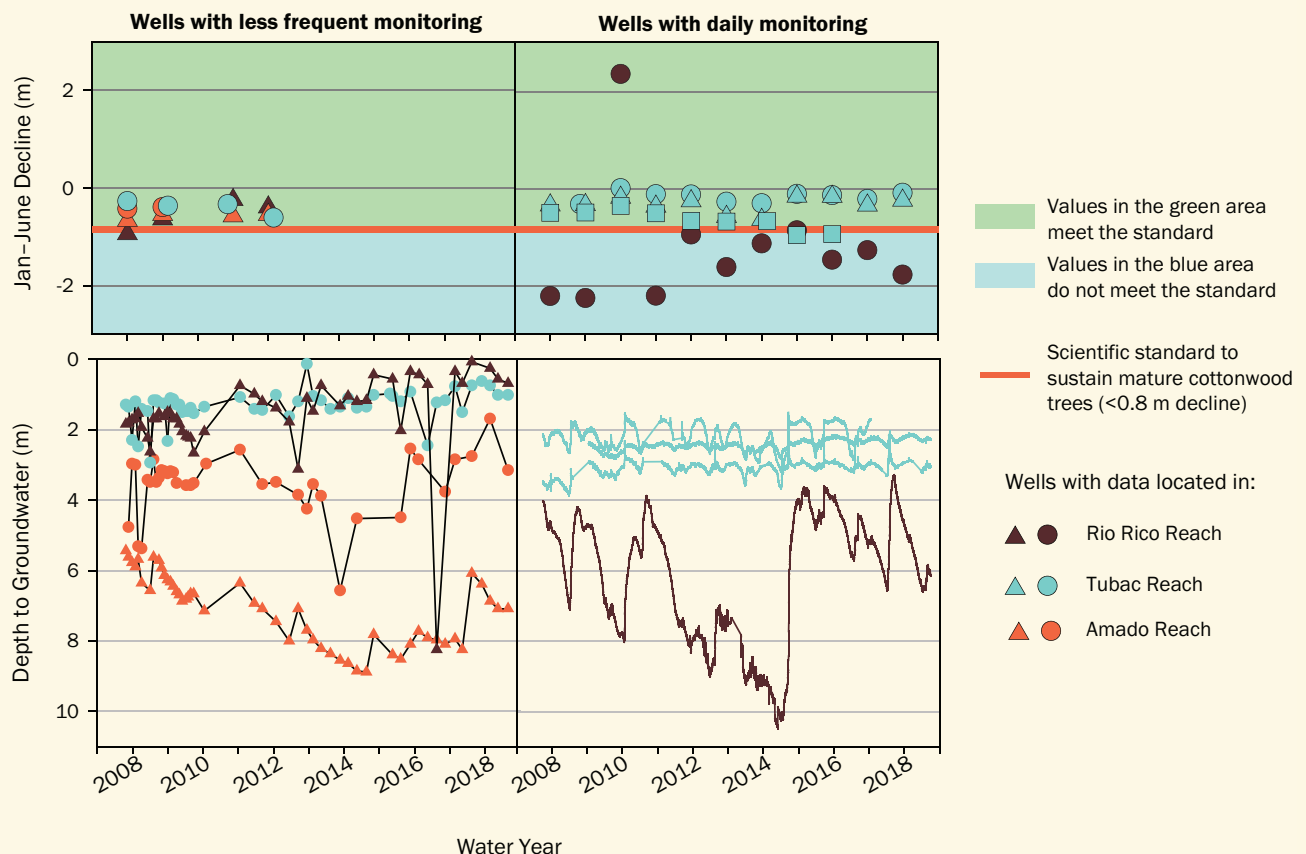
The number of wells with enough data to calculate the change in depth to groundwater from January to June varied over the years. Some wells with less frequent monitoring did not have enough data or data were collected at the incorrect

time to determine the decline. As with maximum depth to groundwater, variability in depth to groundwater in the Tubac reach appears stable and the January to June standard was met at four well locations. Groundwater variability was less stable in the Rio Rico and Amado reaches, though data are limited. Rio Rico depths to groundwater varied between two wells. The well with less frequent monitoring is close to the Tubac reach and met the standard. The Rio Rico well with daily monitoring is near the effluent release and has greater fluctuations in water levels, often failing to meet the decline standard. Although both of the wells in the Amado reach met the standard, overall depth to groundwater may not support cottonwoods. Sonoran Institute launched a groundwater monitoring program in the Amado reach in 2018 that will help provide additional data on groundwater levels.
