# a living river

CHARTING SANTA CRUZ RIVER CONDITIONS  
NORTHWEST TUCSON TO MARANA

SUPPLEMENTARY REPORT FOR 2013 TO 2017 WATER YEARS

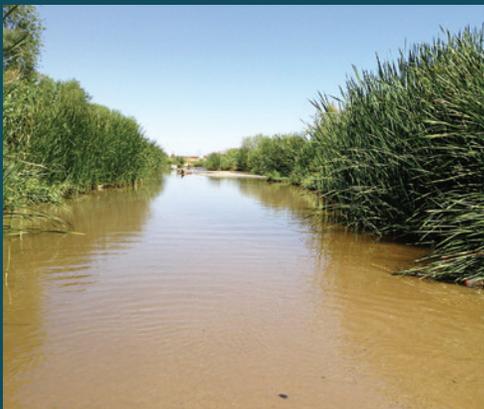
Cloudy water, before upgrade

- **Water clarity much improved:** Sediments and other particles carried in the water decreased, resulting in clear river water on normal non-flooding days. Elevated sediment levels in the water can increase water temperature, thereby decreasing available dissolved oxygen.

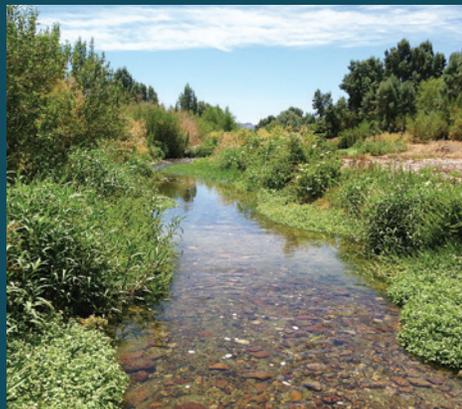
Clear water, after upgrade

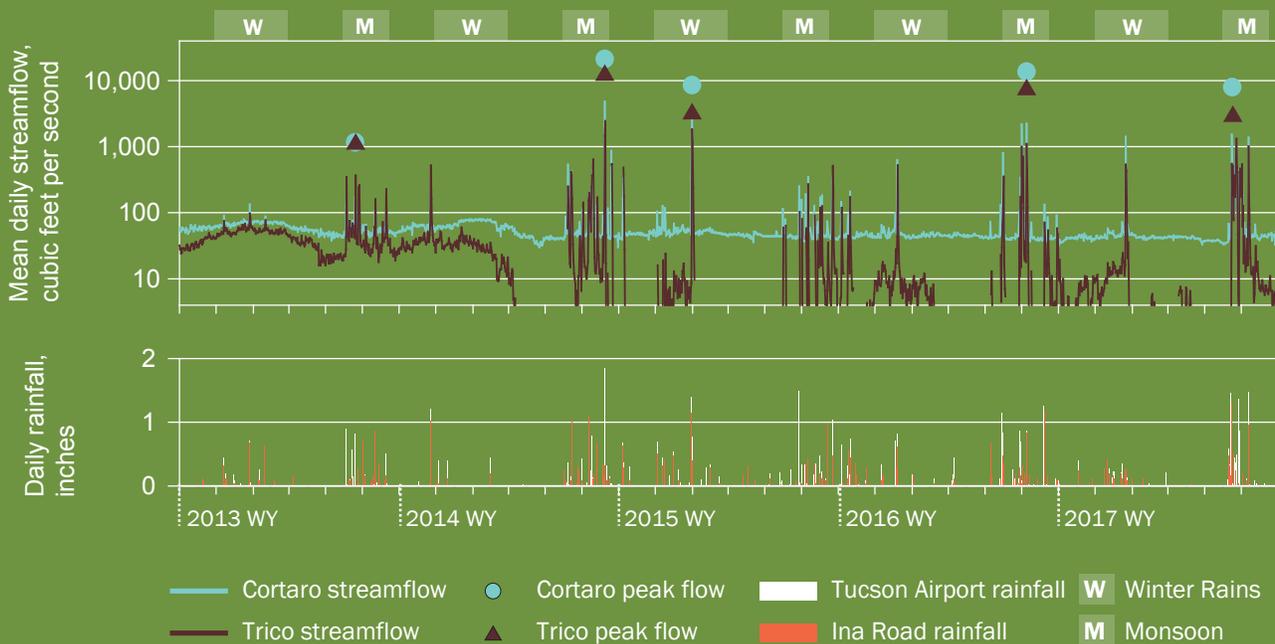
### 2013–2017 RAINFALL

Rainfall totals from the Tucson International Airport (TIA) and near the river at Ina Road provide a general idea of when stormwater may have increased streamflow.

**TIA** recorded an average of 11 inches of rain. The most rain fell in 2016 and 2015 with 13 and 14 inches respectively. The historical average is 11.2 inches from 1949 to 2011.

**Ina Road** recorded an average of 8 inches of rain. The most rain fell in 2016 and 2015 with 11 and 9 inches respectively. The recent average is 7.95 inches from 2002 to 2012.

### 2013–2017 STREAMFLOW

Streamflow is measured with gages at Cortaro Road and Trico Road, which are downstream of the Agua Nueva and Tres Rios Reclamation Facilities. Streamflow, measured in cubic feet per second (cfs), is the volume (cubic feet) of water flowing past a fixed point in a specific time period (1 second). Measuring streamflow daily tracks seasonal floods.

At Cortaro Road, mean daily streamflow has remained similar over the years, though flood peaks have been higher since 2013. Flows at Trico Road have changed significantly. Like Cortaro Road, the peak flows have increased. However, mean daily streamflow has declined since the facility upgrades were complete in December of 2013. By the 2015 water year, most flows passing by Trico Road are limited to the rainy seasons when there is additional stormwater.

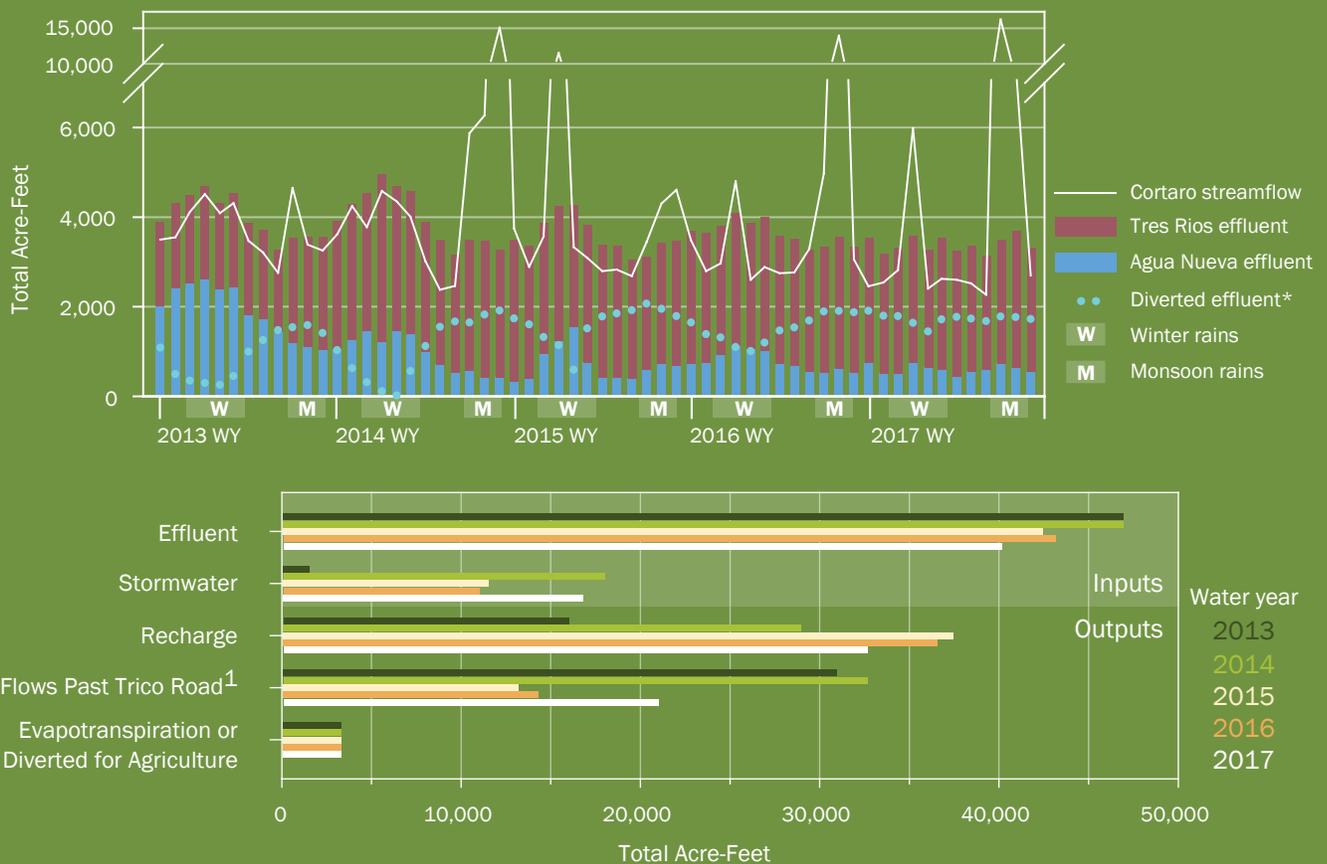
## 2013 – 2017 WATER BUDGET

A water budget estimates the water inputs and outputs. Inputs are effluent and stormwater, while outputs include water that does one of the following: flows past Trico Road (the end of the study area), evaporates or is used by wetland vegetation (a process called evapotranspiration), is diverted for agricultural use, or sinks into the riverbed to recharge local groundwater. Volumes are totaled in acre-feet (AF), the

number of acres that would be covered with water one foot deep. Total recharge volume is for effluent only and does not include stormwater. Totals for evapotranspiration and diversions are not directly measured. They are estimates and viewed as fairly constant from year to year in the calculations for the managed recharge projects located along the Lower Santa Cruz River.

\* Includes effluent that doesn't go to the river; either it is diverted to the reclaimed system for irrigation or to recharge basins located outside the river channel.

<sup>1</sup> Excluding days with stormwater, the volume of only effluent flowing past Trico Road is: 2013 = 26,800 AF; 2014 = 13,400 AF; 2015 = 2,100 AF; 2016 = 3,800AF; 2017 = 3,700AF

Effluent provides most of the flow in the river. Effluent releases from Agua Nueva have decreased for two reasons. First, the facility upgrade completed in December of 2013 resulted in some wastewater being redirected to Tres Rios and released further downstream. Second, more effluent was diverted, before release into the river, into nearby basins to recharge local aquifers. Effluent inputs were reduced by an average of 11% from the 2013 baseline. Total inputs, however, have increased with higher volumes of stormwater. Even with greater inputs, recharge has increased significantly, likely from higher infiltration rates into the riverbed after improved water quality. Increased infiltration has also reduced the amount of water that flows past Trico Road. Exact volumes of water diverted for agriculture and used by wetland vegetation are not known. These volumes are treated as constants in the calculations of recharge that occurs along the river.

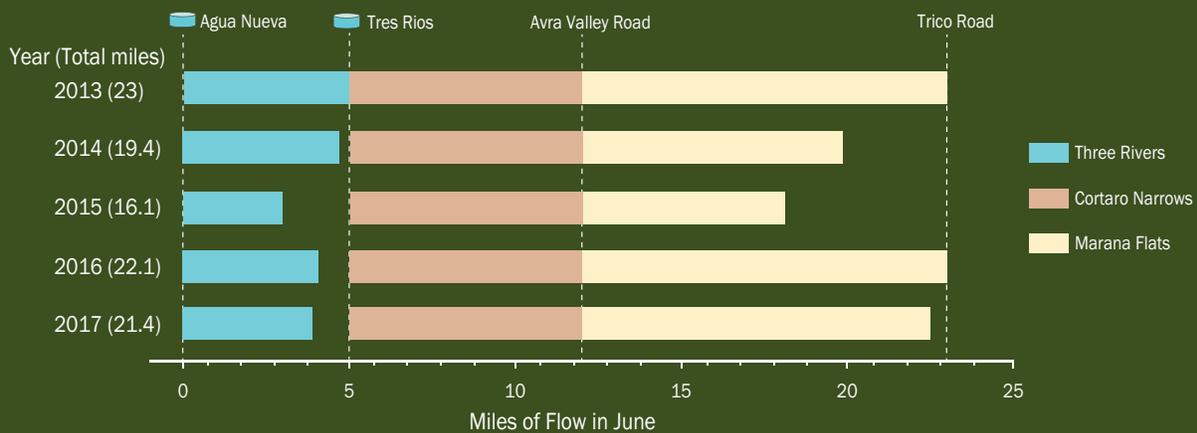
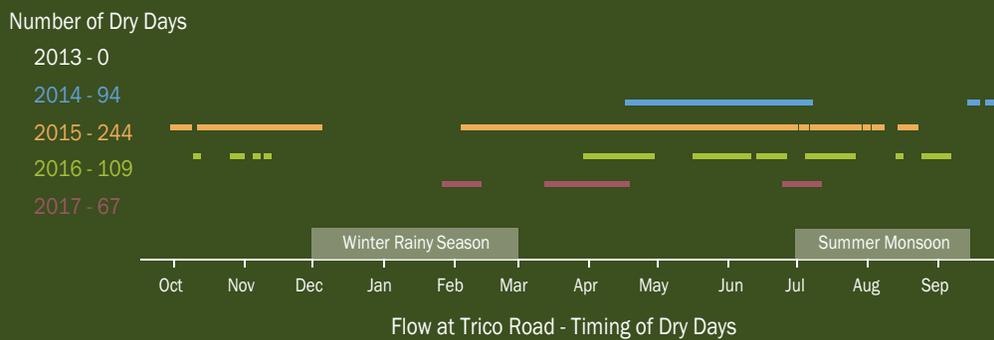
**Miles of flow in June** in each reach prior to the monsoon season determines the minimum extent of flow during the driest time of year. This is typically measured on one morning in mid-June. **Flow at Trico Road**, located at the farthest end of the study area, estimates daily changes in maximum flow extent through the three reaches by counting the “dry days,” or days with no streamflow.

Flow extent decreased and varied seasonally after the December 2013 upgrades. In June, prior to the start of the summer monsoon, only Cortaro Narrows flowed through the whole reach. Dry days at Trico Road have increased. Reduced flow extent is likely due to increased recharge, though water management is also an important factor. Agua Nueva released less effluent into the river, contributing to drying in Three Rivers. Marana Flats drying is more complex. In this reach, water is diverted by an earthen berm for irrigation of agriculture and for recharge at Marana High Plains, a constructed basin adjacent to the river. The berm failed just before the June 2016 survey, and likely increased miles of flow. Failure of this berm several times in 2016 may have also decreased the dry days at Trico Road. Conversely, failure of a different berm increased dry days in 2015. This occurred when a large flood in September 2014 moved the location of the low-flow channel and breached a berm along the El Rio Preserve, a former borrow pit near the start of Marana Flats. This allowed water to flow into the pit and form “Lake Marana.” The river stopped flowing into the lake in January 2015 when a flood moved the low-flow channel again, demonstrating nature’s contribution to water management.

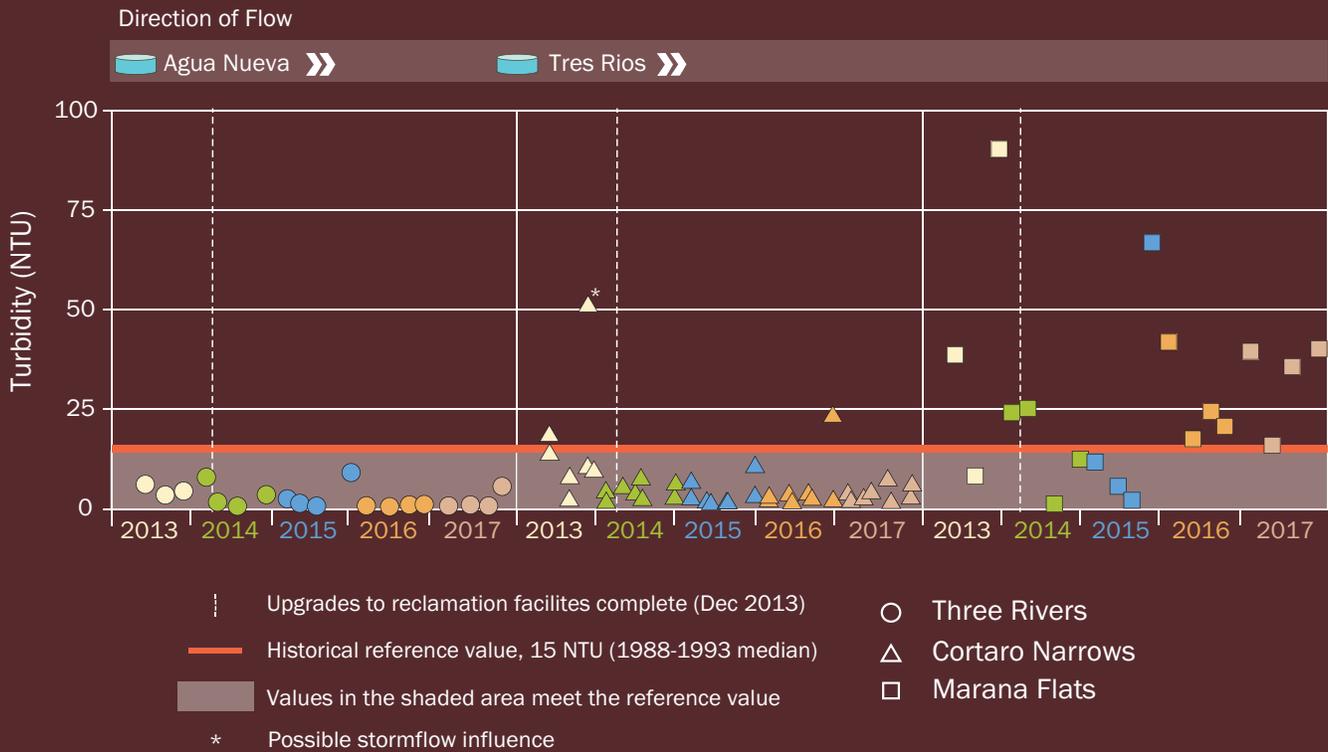
capture prey. **Turbidity** measures water clarity, or how far you can see through the “dust storm,” and is reported in Nephelometric Turbidity Units (NTU). High NTU indicates the water is cloudy and hard to see through. The 1988–1993 median level of turbidity in the Cortaro Narrows reach was 15 NTU. ADEQ does not have a standard for turbidity, so this assessment uses 15 NTU as a historical reference value.

Turbidity was measured a total of 77 times. Overall, the reference value was met 61 times (79%). Turbidity decreased most notably in Marana Flats immediately after the upgrade was complete, though it has been higher and more variable in the last two years.

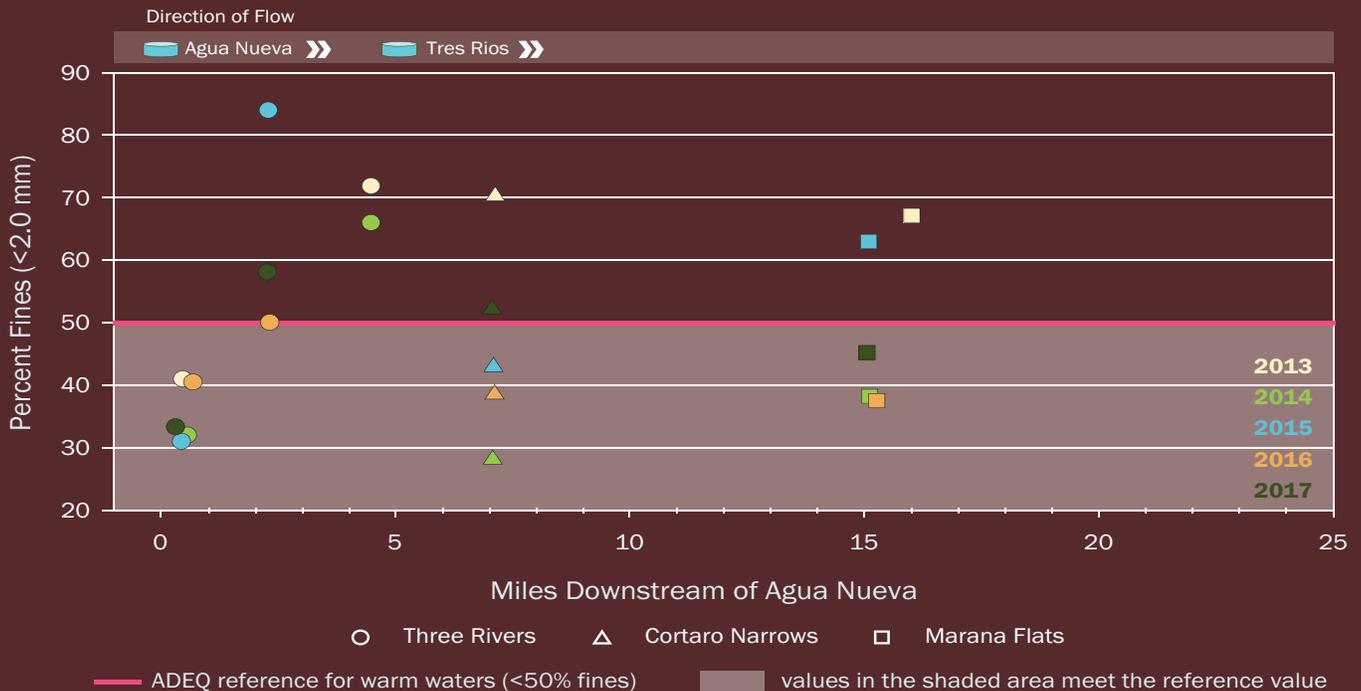
**Percent fines** is an estimate of the portion of the riverbed comprised of small sediments ( $\leq 2$  mm in diameter). Fines, or “muck,” that settle out of the storm onto the riverbed can become so abundant that they smother aquatic life and habitat. ADEQ does not have a standard for rivers dominated by effluent. This assessment uses the reference value for warm-water rivers, <50%.

Percent fines were estimated at all of the sites where macroinvertebrate samples were collected. Overall there was a reduction in the percent fines covering the riverbed at these sites. Due to reductions in flow extent, survey sites located at around 4 miles and 16 miles downstream of Agua Nueva had to be shifted upstream to around 3 miles (in 2015) and 15 miles (in 2014) respectively. There was greater variability in levels of percent fines at these sites, perhaps due to variable flow conditions in these areas. For example, more particles may settle out of river flows that have slowed as extent has diminished.

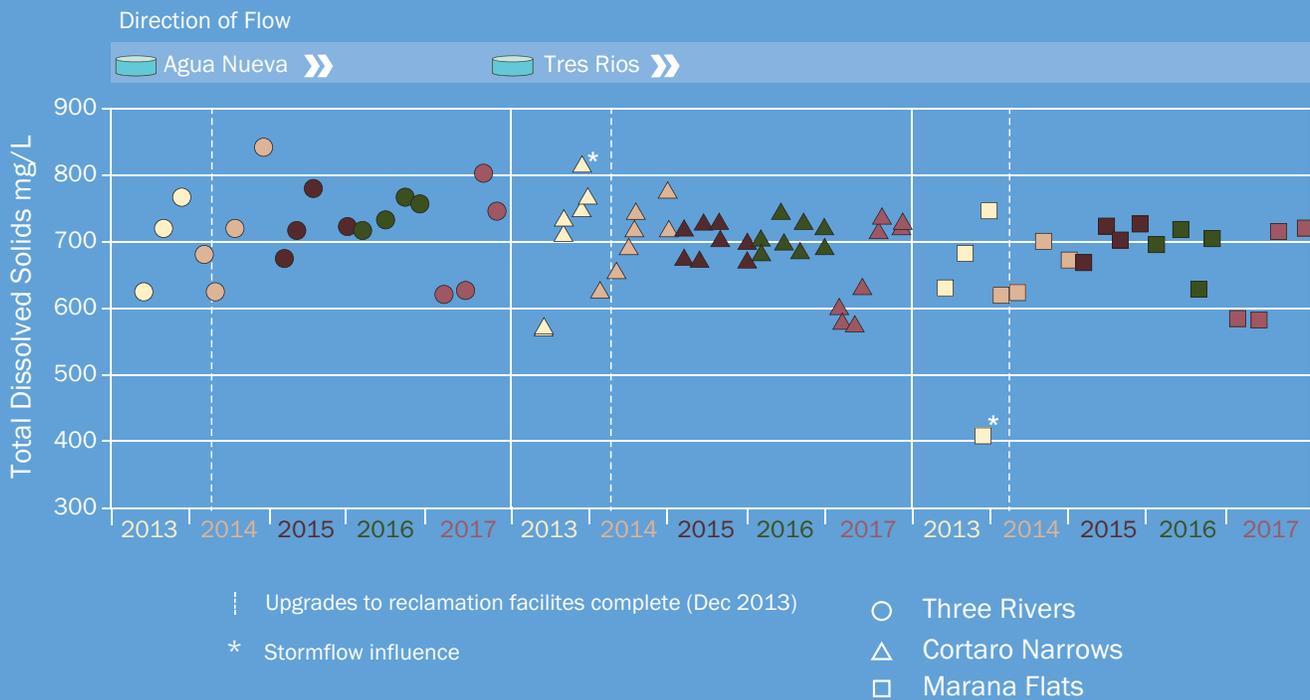
Colorado River water in the Tucson area. The Colorado River has greater TDS, mostly in form of dissolved salts, than the local groundwater. Because there is no standard for TDS (often standards are for individual elements that contribute to TDS), the results from the 2013 water year will serve as a baseline.

Total dissolved solids (TDS) were measured 77 times. Overall, levels of TDS were similar in all three reaches. Generally TDS hasn't changed very much, though variability in TDS levels has increased again in 2017 for unknown reasons. The lowest measure of TDS was in Marana Flats. This sample was collected on a day where there was possible stormwater influence. Thus, the addition of water with lower TDS levels may have diluted the levels in this reach of the Santa Cruz River. Samples of stormwater are collected upstream of Agua Nueva when possible. Four samples collected (one each year during the summer monsoon for 2013–2016) averaged 280 mg/L. No stormwater sample was collected in 2017.

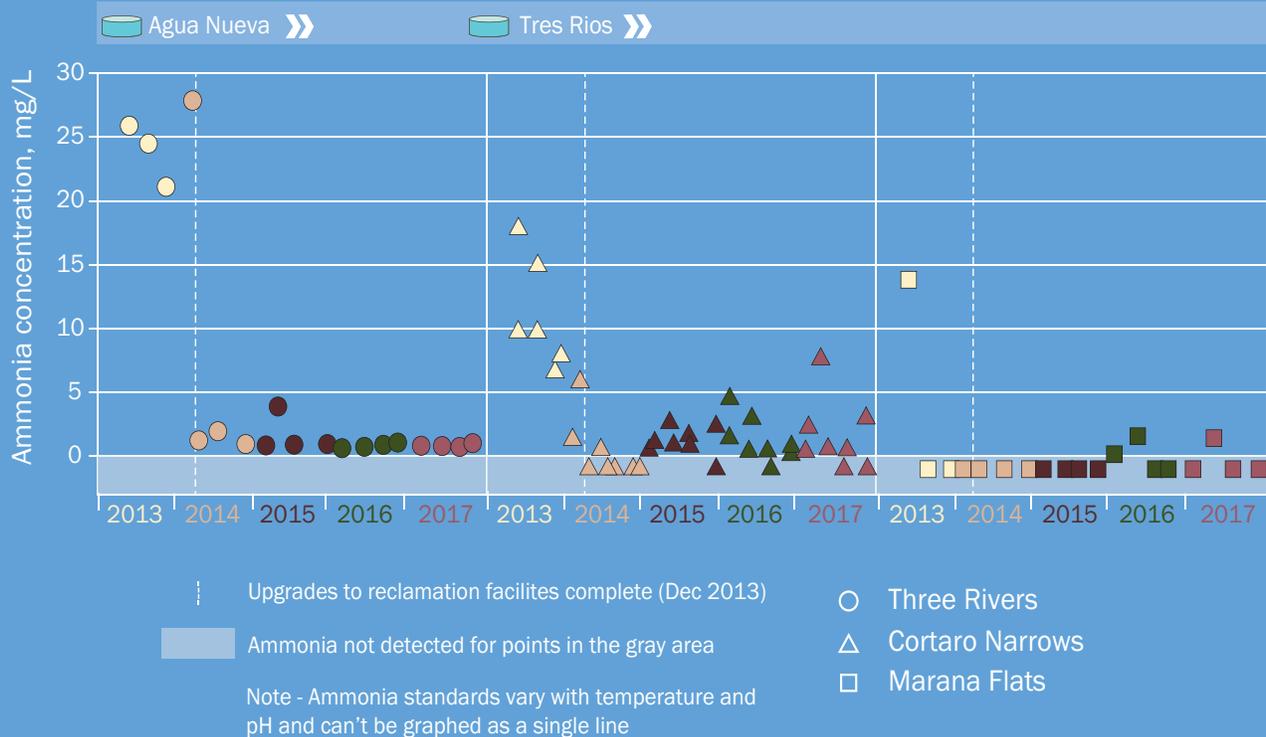
**Ammonia** (NH<sub>3</sub>) is one form of nitrogen that can be toxic to fish. Even at low concentrations, ammonia can reduce hatching success, among other impacts. The ADEQ standard for ammonia varies with pH (level of acidity) and temperature. As pH and temperature increase, the toxicity of ammonia increases; thus, the acceptable level of ammonia decreases with high pH and temperature.

Ammonia was measured 76 times along the river. Overall the standard was met 52 of the 70 times (68%). Levels of ammonia have dropped significantly after the upgrade was complete in 2013. Levels of ammonia also decreased with distance from the reclamation facilities, as it breaks down into other forms of nitrogen while moving downstream. Although there were exceedances of the ammonia standard before and after the upgrade, the magnitude of the average exceedance has dropped significantly (average exceedance above standard: *before upgrade* = 14 mg/L, *after upgrade* = 1.2 mg/L). Nitrogen removal is a complex process, and Pima County Regional Wastewater Reclamation Department is vigilantly investigating and working to eliminate ammonia exceedances.

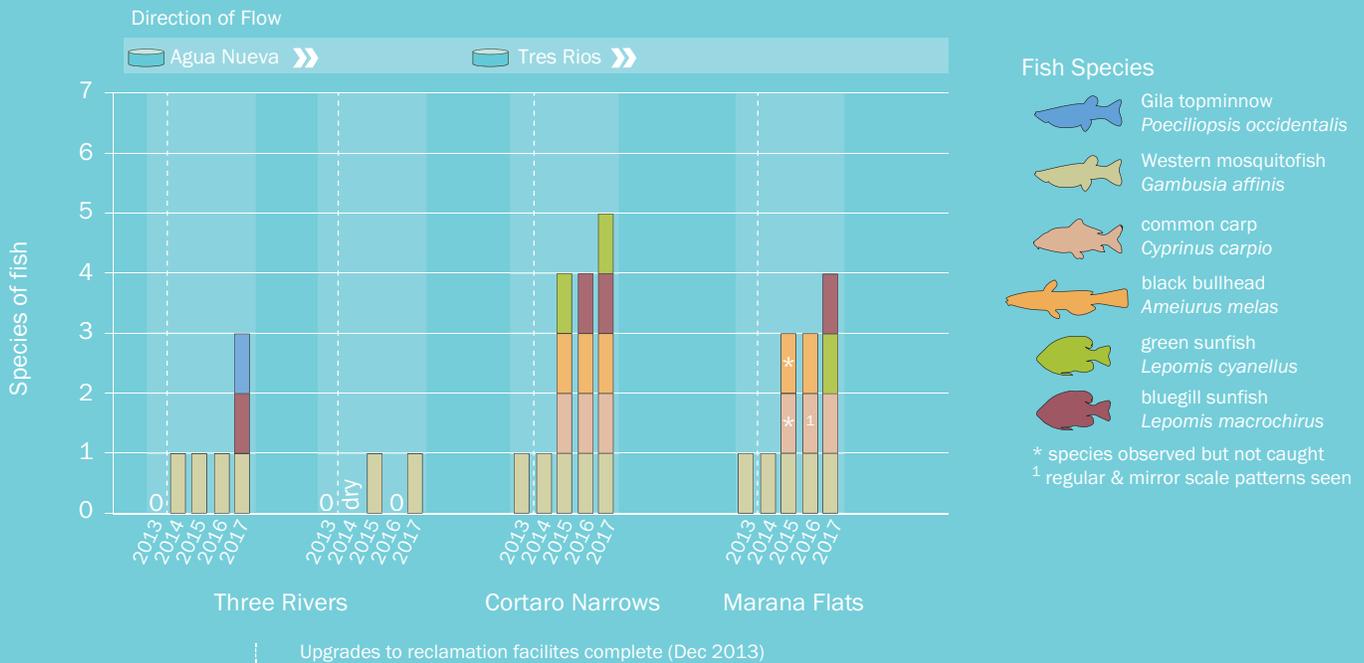
Fish surveys were conducted annually in the fall at the same four locations that macroinvertebrates were surveyed. Surveys aim to detect all fish species present at a location. Improvements in water quality have allowed fish to thrive. Overall, number of fish species observed increased from one to six. All are non-native, except for the endangered Gila topminnow, which was found in the river in 2017. Exactly how this native fish returned is unknown. Gila topminnow are found in the Santa Cruz near Nogales and may have been carried in large flood flows down to the Three Rivers reach. Although flood flows connected these two stretches of Santa Cruz River for two days in July 2017, initial genetic analysis suggests the Gila topminnow in the river near Tucson are most similar to fish found in the Cienega Creek watershed.

Cortaro Narrows may provide the best habitat for fish since the survey location in this reach has recorded the highest numbers of fish species. Fish presence has recently increased in Three Rivers. Flows in Three Rivers are often very shallow and may favor smaller fish like the Western mosquitofish and Gila topminnow. Though the media reported presence of large fish, likely common carp, in spring of 2014, these larger species were not observed or captured until the 2015 survey. A large flood in September 2014 may have washed them past Trico Road and beyond the study area.

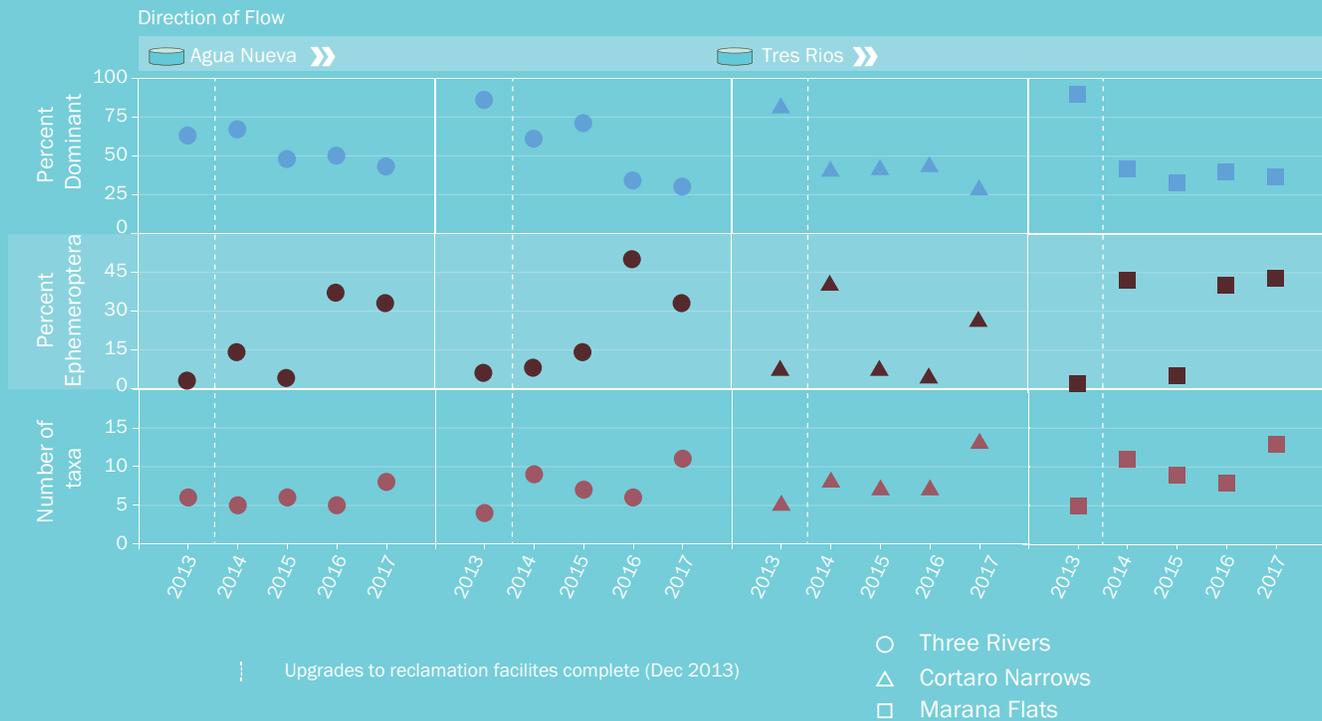
is commonly used to help track changes in water quality. Regardless of sensitivity to pollution, if a single species or group accounts for more than 50% of the community, this lack of diversity suggests a stream is impaired. Another way to look at diversity is simply looking at the total number of different invertebrate taxa found in the samples collected.

The aquatic invertebrate community was surveyed annually at the same four locations that fish were surveyed. Overall, there were signs of improvement. Diversity was higher after the upgrades were complete, with number of taxa at each site increasing. Increased diversity is also demonstrated by the smaller percentage of the community composed of a single group. If the dominant group is more than 50% of the community, river life is thought to be impaired. Improvements are also supported by the increase in the percent of the community comprised of pollution-sensitive species from the order Ephemeroptera. The 2017 water year reached the highest levels of diversity across all sites with the highest number of taxa recorded and the lowest recorded percentage of the dominant group.

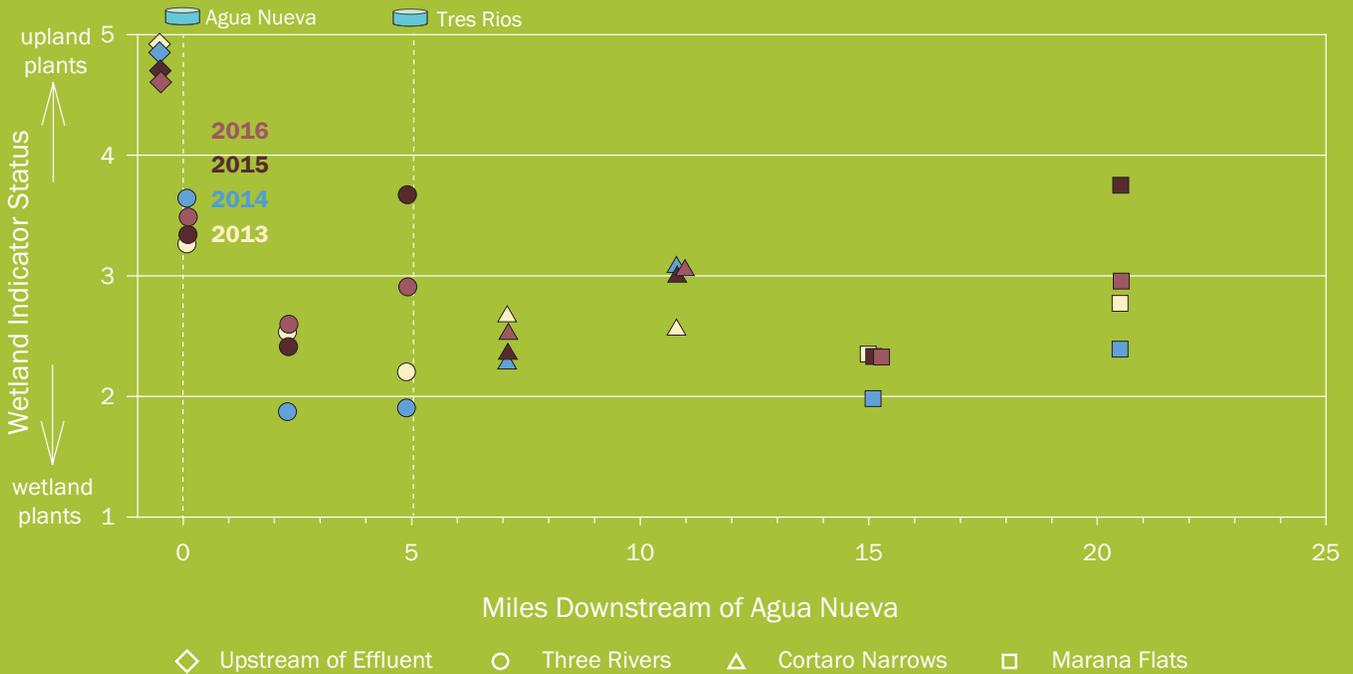
**Wetland indicator status** measures abundance of stream-side plants that vary in their need for permanent water in the river channel. Scores range from 1 to 5. Low scores (<4) indicate that the majority of plants at a given location are wetland plants like watercress and cattails, which depend on consistent presence of water in the river. High scores

**Not measured in 2017.** Wetland indicator status (WIS) was determined for eight total locations along the river. Overall, scores have remained similar at most sites. Scores averaged 2.7 downstream of Agua Nueva. This suggests greater presence of wetland plants instead of upland plants as the river flowed away from the reclamation facilities. Just upstream of the study area, a reference site had the highest scores and was dominated by upland plants. Two sites (approximately 5 and 20 miles downstream) appeared to shift toward more upland plants with increased scores in 2015. This may be in part explained by changes in flow extent, as these sites experienced dry conditions more frequently in water year 2015. However, these same sites were wet again when surveyed in 2016, and stream-side plants shifted back toward wetland plants.

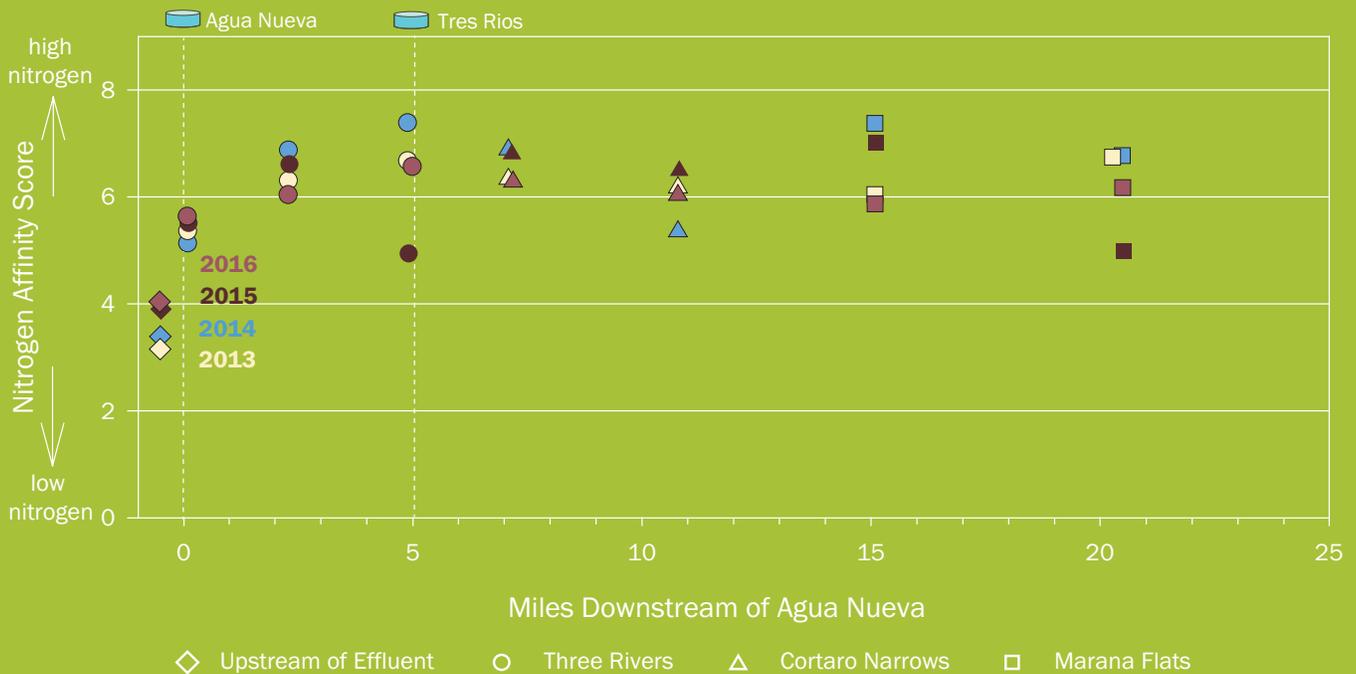
and different grasses. High scores (>5) indicate that the majority of plants grow well with high levels of nitrogen, like cattails and common sunflowers. Changes in nitrogen affinity scores likely reflect changes in water quality, either an increase or decrease in nutrients in the water. Results from the 2013 water year will serve as a baseline.

**Not measured in 2017.** Nitrogen affinity score was determined for eight total locations along the river. Overall, scores have remained similar at most sites. Scores averaged 6.2 downstream of Agua Nueva. This suggests that stream-side plants that grow well in high nitrogen environments were most common immediately downstream of the reclamation facilities. Just upstream of the study area a reference site had the lowest scores and was dominated by plants that grow well with low levels of nitrogen. Two sites (approximately 5 and 20 miles downstream) appeared to shift toward more low-nitrogen plants in 2015. Though we may expect this shift from reduced nutrient pollution, reduction in water presence and soil moisture may be the bigger factor. Both of these sites experienced dry conditions more frequently in water year 2015 and were dry at time of survey in 2015. These same sites shifted back towards nitrogen-loving plants in 2016, when water was present again at time of survey. So both nitrogen affinity and wetland indicator seem to indicate presence of permanent water in the channel or high soil moisture. This is supported by a high correlation of the nitrogen scores with wetland scores; plants with high nitrogen scores had very low wetland scores, or more simply, the wetland plants in our area love nitrogen.

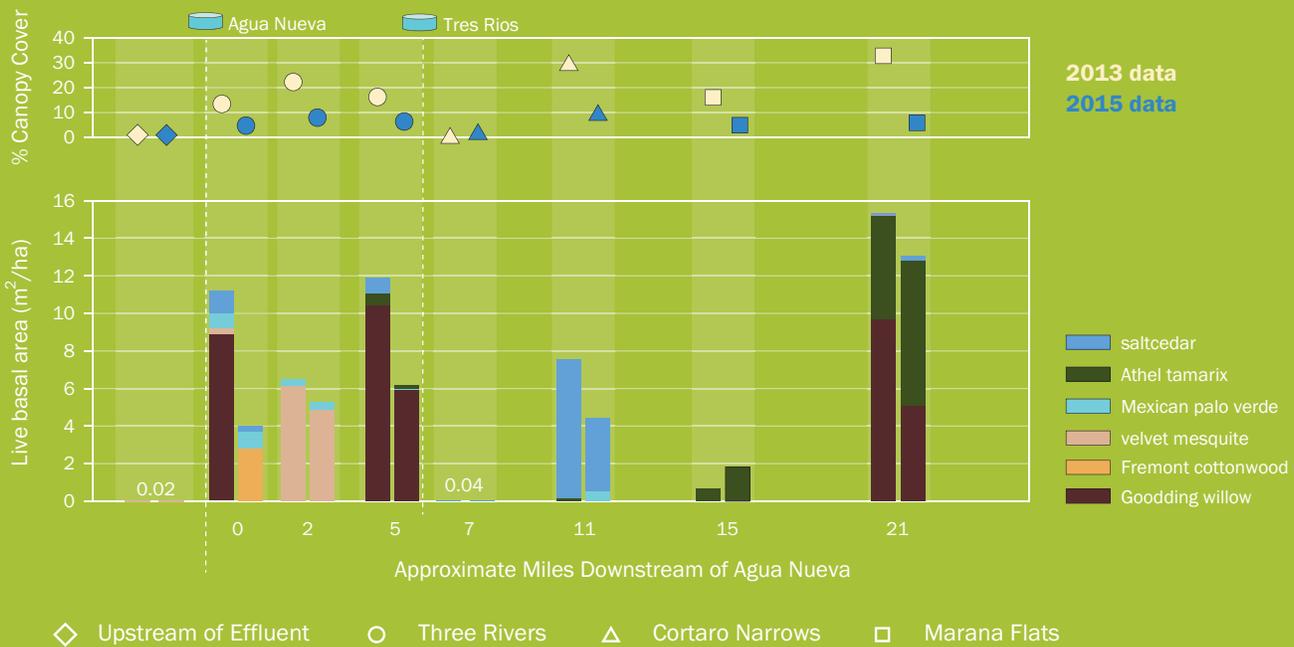
**Riparian tree cover** measures the abundance of adult trees along the river and in the adjacent floodplain. High tree cover indicates the presence of sufficient soil moisture to support riparian trees. Tree cover is commonly reported as basal area. Basal area, measured in square meters per hectare (m<sup>2</sup>/ha), is the area covered by trees in one hectare (10,000 m<sup>2</sup>, or approximately two football fields). In addition, riparian tree species differ in their tolerance to declines in soil moisture. Native cottonwoods and willows have shallow roots

**Not measured in 2017.** Overall tree cover, as measured by basal area and percent canopy cover, decreased between 2013 and 2015 (trees were not measured in 2016). Most notable was the decrease in cover of Goodding’s willow. Decrease in cover of mature trees is likely the result of decreased flow extent. There may not have been enough moisture to support more shallow rooted trees like Goodding’s willow. More monitoring will be needed to determine if effluent continues to support mature riparian trees in all three reaches, and whether the community shifts to deeper rooted trees such as velvet mesquite and non-native tamarix species.

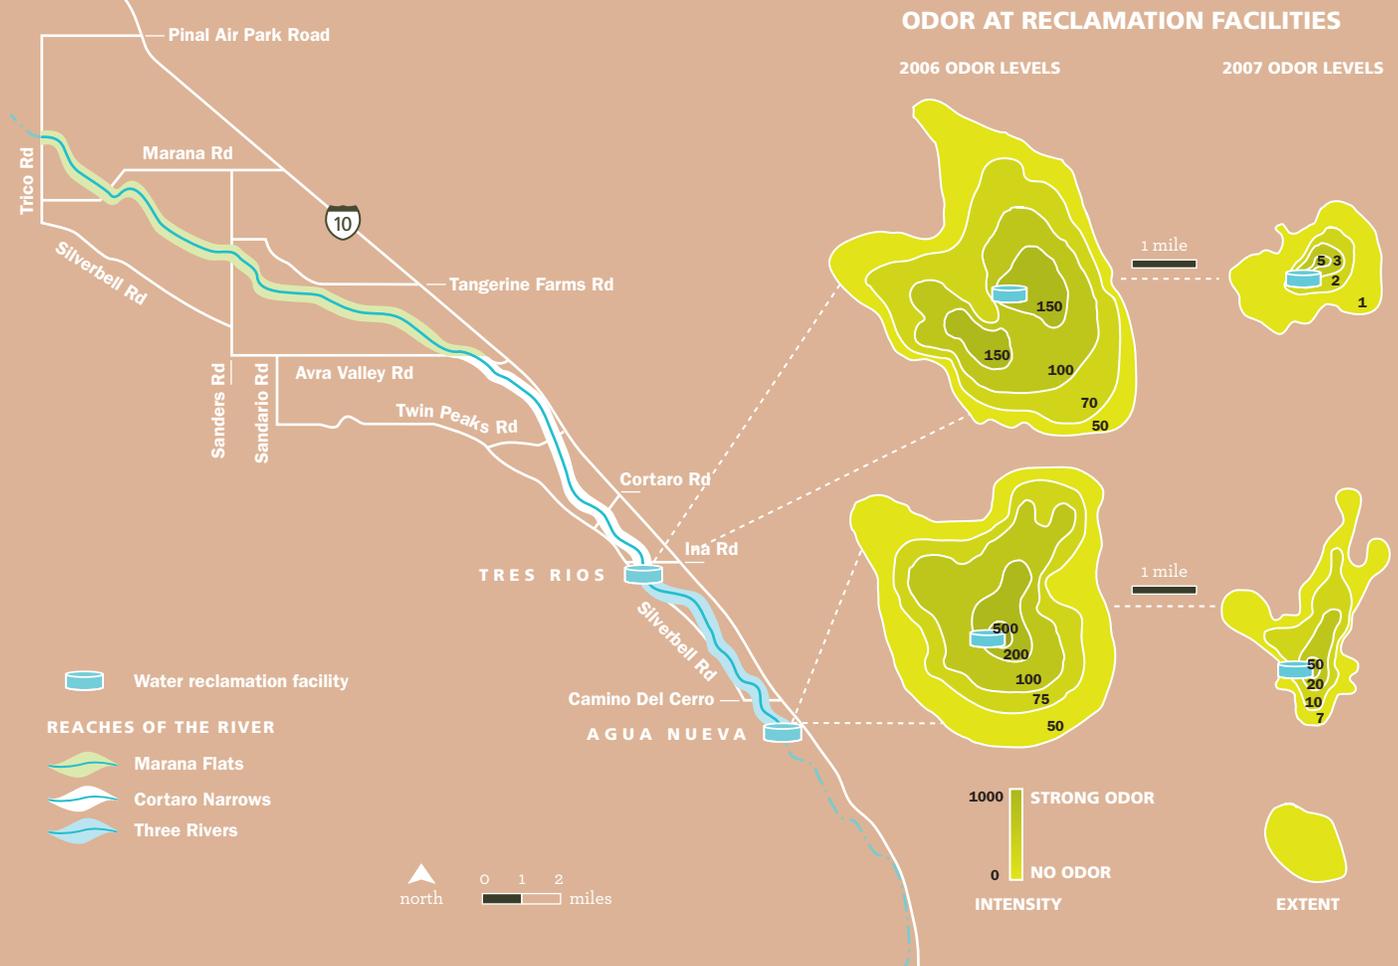
hydrogen sulfide (H<sub>2</sub>S) or the “rotten egg” smell. **Odor at the reclamation facilities** tracks changes in odors linked to the reclamation process. Minimizing both the extent and intensity of disagreeable odors coming from the facilities was one of the goals of the reclamation facility upgrades.

**Data not yet available for 2017.** Initial facility improvements in 2007 reduced both the extent and intensity of odor emanating from the reclamation facilities. Data to map extent and intensity of odors over the last three years is not available. However, anecdotal data from people recreating in the area indicate that odors are either gone or barely noticeable compared to past conditions. As of 2016, odor is monitored continuously at the facilities and at numerous points along the surrounding fence-lines. Levels of H<sub>2</sub>S at Agua Nueva remained very low in 2016, with an average of 0.03 parts per billion (ppb) for the over 4 million measures taken. Levels of H<sub>2</sub>S at Tres Rios were also low with an average of 0.69 ppb for over 3.5 million measures of odor. These concentrations are far less than the 10 ppb allowed by the facility permits. Detailed odor data of this kind is not available for years prior to the upgrades, thus comparisons to previous H<sub>2</sub>S levels are not possible.
