CHARTING WETLAND CONDITIONS OF THE LOWER SANTA CRUZ RIVER

Supplementary Data for 2013 to 2015 Water Years

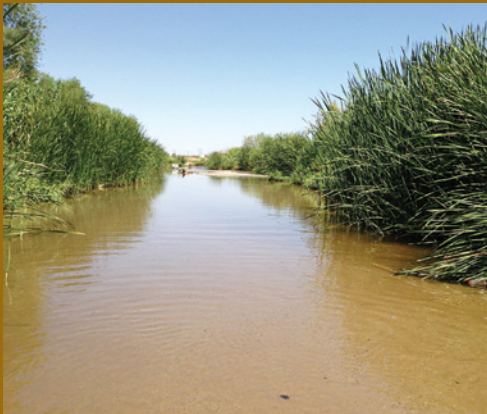
Cloudy water, before upgrade

- **Water clarity much improved:** Sediments and other particles carried in the water decreased, resulting in clear river water on normal non-flooding days. Elevated levels of materials in the water can increase water temperature, thereby decreasing available dissolved oxygen.

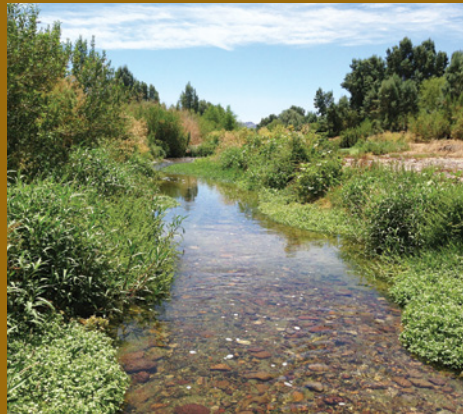
Clear water, after upgrade

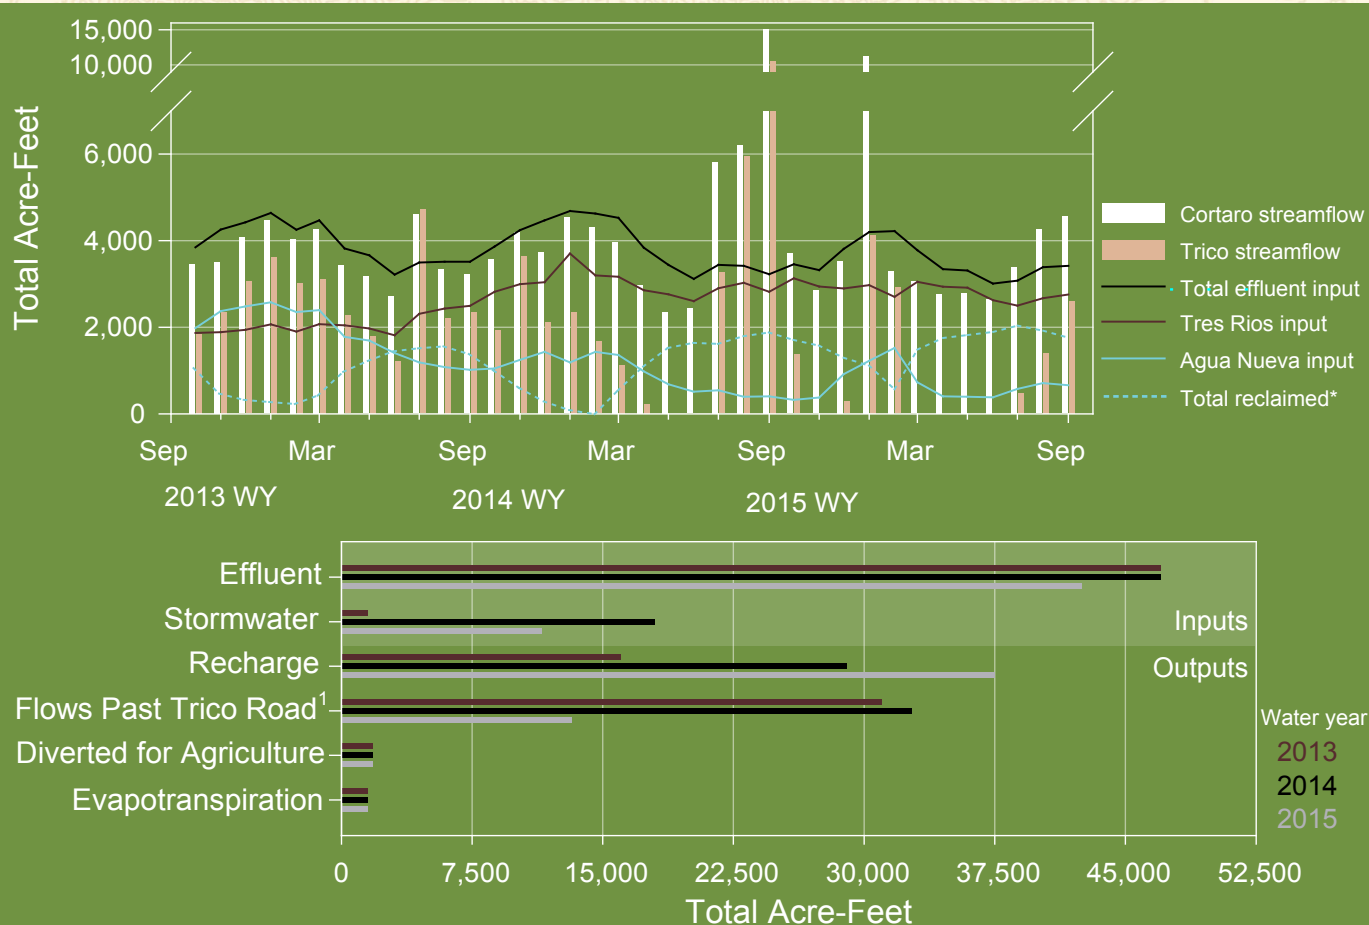
## 2013 - 2015 WATER BUDGET

A water budget estimates the water inputs and outputs. Inputs are effluent and stormwater, while outputs include water that does one of the following: flows past Trico Road (the end of the study area), evaporates or is used by wetland vegetation (a process called evapotranspiration), is diverted for agricultural use, or sinks into the riverbed to recharge local groundwater. Volumes are totaled in acre-feet (AF), the

number of acres that would be covered with water one foot deep. Total recharge volume is for effluent only and does not include stormwater. Totals for evapotranspiration and diversions are not directly measured. They are estimates and viewed as fairly constant from year to year in the calculations for the managed recharge projects located along the Lower Santa Cruz River.

\* Includes effluent that doesn't go to the river; either it is diverted to the reclaimed system for irrigation or to recharge basins located outside the river channel.

<sup>1</sup> Excluding days with stormwater, the volume of only effluent flowing past Trico Road is as follows: 2013 = 26,800 AF; 2014 = 13,400 AF; 2015 = 2,100 AF

Effluent inputs were reduced by 10% in 2015. This is largely because more water was diverted, before release into the river, to supply nearby basins with water to recharge local aquifers. Total inputs, however, have increased with higher volumes of stormwater. Even with greater inputs, recharge has increased significantly, likely from increased infiltration rates in the riverbed after improved water quality. Increased infiltration has also reduced the amount of water that flows past Trico Road. Exact volumes of water diverted for agriculture and used by wetland vegetation are not known. Reported here are the volumes that were treated as constants in the calculations of recharge that occurs along the river.

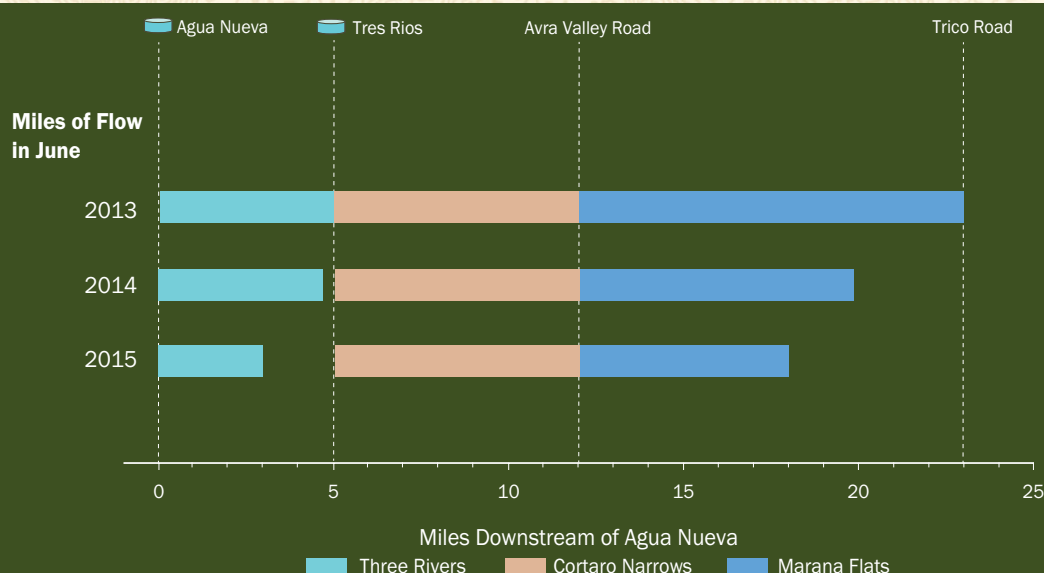
**Miles of Flow** in each reach prior to the monsoon season determines the minimum extent of flow during the driest time of year. This is typically measured in mid-June.

**Flow at Trico Road**, located at the farthest end of the study area, estimates daily changes in maximum flow extent through the three reaches by counting the “dry days” or days with no streamflow.

### Flow at Trico Road

2013	2014	2015
Number of Dry Days	0	94	244

Flow extent decreased. In June, prior to the start of the monsoons, only Cortaro Narrows had flow through the whole reach. Throughout the year, there were fewer days when flow made it to Trico Road. Reduced flow extent is likely due to increased infiltration. Reductions in effluent released from Agua Nueva also contributed to changes in Three Rivers. Some wastewater was redirected to Tres Rios and released further downstream, and more effluent supplied recharge basins near Agua Nueva.

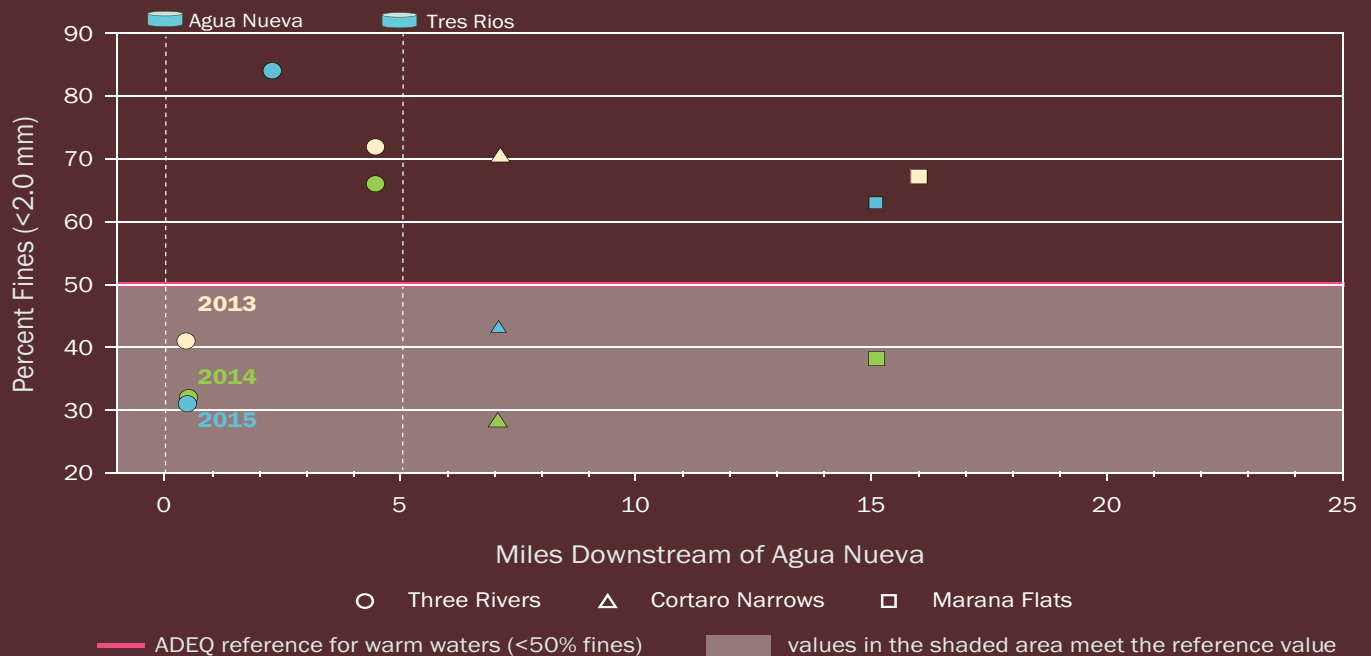
may not be able to see well enough to capture prey. **Percent fines** is an estimate of the portion of the riverbed comprised of small sediments ( $\leq 2$  mm in diameter). Fines, or “muck”, that settle out of the storm onto the riverbed can become so abundant that they smother aquatic life and habitat. ADEQ does not have a standard for rivers dominated by effluent.

Percent fines were estimated at all of the sites where macroinvertebrate samples were collected. Overall there was a reduction in the percent fines covering the riverbed at these sites. The increase in percent fines at two sites in 2015 may be the result of more particles settling out of river flows that have slowed down with reductions in flow extent. The reduced flow extent is further demonstrated by the need to shift these same sites upstream due to dry conditions at time of survey.
