CHARTING WETLAND CONDITIONS OF THE LOWER SANTA CRUZ RIVER

Supplementary Data For 2013 to 2016 Water Years

THE LOWER SANTA CRUZ RIVER A LIVING ECOSYSTEM

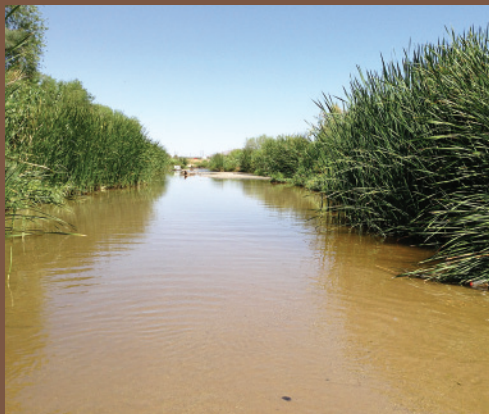
Cloudy water, before upgrade

- **Water clarity much improved:** Sediments and other particles carried in the water decreased, resulting in clear river water on normal non-flooding days. Elevated sediment levels in the water can increase water temperature, thereby decreasing available dissolved oxygen.

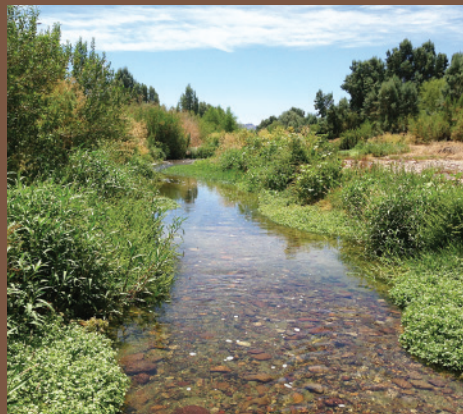
Clear water, after upgrade

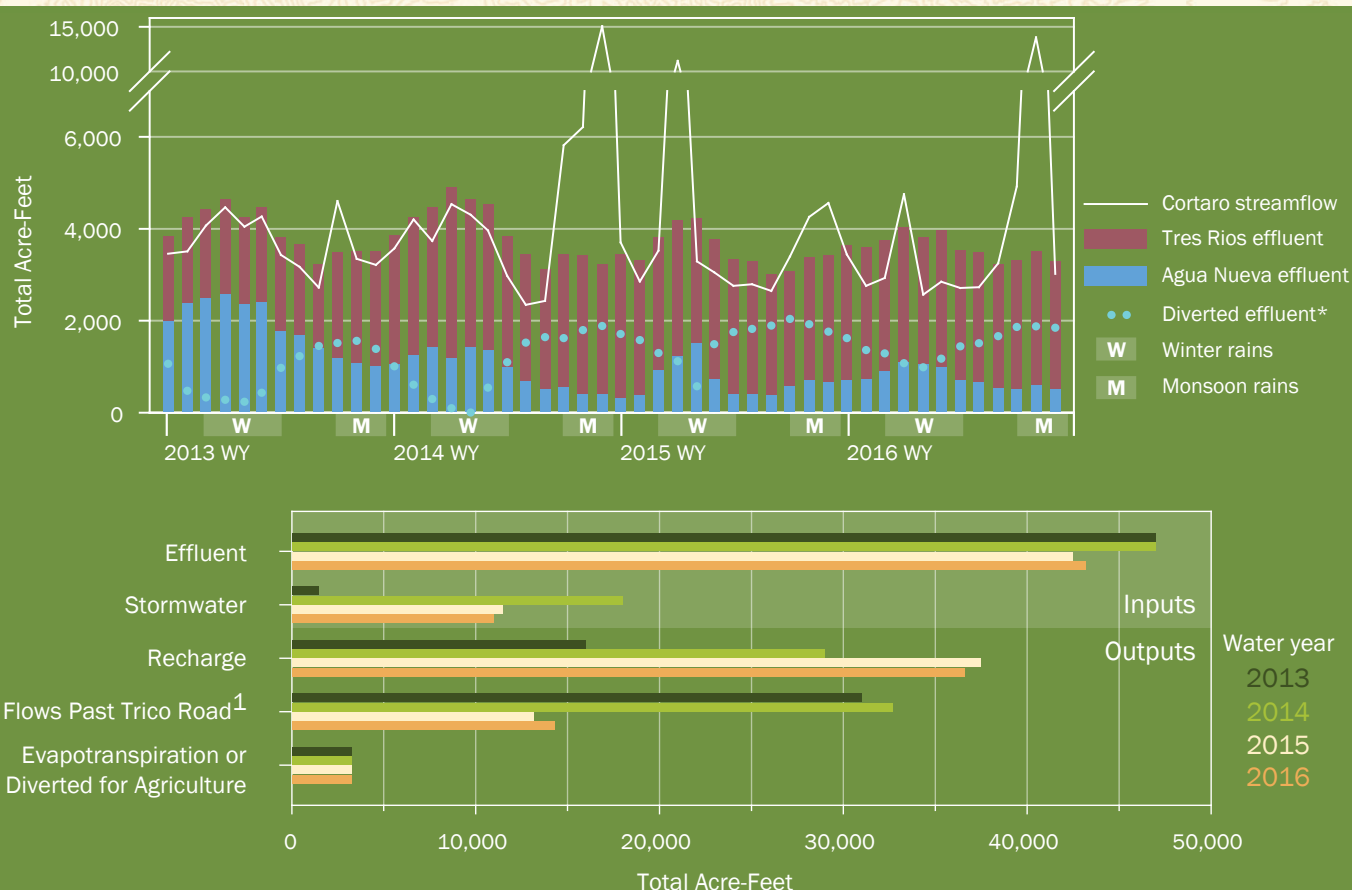
2013 - 2016 WATER BUDGET

A water budget estimates the water inputs and outputs. Inputs are effluent and stormwater, while outputs include water that does one of the following: flows past Trico Road (the end of the study area), evaporates or is used by wetland vegetation (a process called evapotranspiration), is diverted for agricultural use, or sinks into the riverbed to recharge local groundwater. Volumes are totaled in acre-feet (AF), the

number of acres that would be covered with water one foot deep. Total recharge volume is for effluent only and does not include stormwater. Totals for evapotranspiration and diversions are not directly measured. They are estimates and viewed as fairly constant from year to year in the calculations for the managed recharge projects located along the Lower Santa Cruz River.

* Includes effluent that doesn't go to the river; either it is diverted to the reclaimed system for irrigation or to recharge basins located outside the river channel.
¹ Excluding days with stormwater, the volume of only effluent flowing past Trico Road is: 2013 = 26,800 AF; 2014 = 13,400 AF; 2015 = 2,100 AF; 2016 = 3,400AF

Effluent provides most of the flow in the river. Effluent releases from Agua Nueva have decreased for two reasons. First, the 2014 facility upgrade resulted in some wastewater being redirected to Tres Rios and released further downstream. Second, more effluent was diverted, before release into the river, into nearby basins to recharge local aquifers. Effluent inputs were reduced by 10% in 2015 and 8% in 2016 from the 2013 baseline. Total inputs, however, have increased with higher volumes of stormwater. Even with greater inputs, recharge has increased significantly, likely from higher infiltration rates into the riverbed after improved water quality. Increased infiltration has also reduced the amount of water that flows past Trico Road. Exact volumes of water diverted for agriculture and used by wetland vegetation are not known. These volumes are treated as constants in the calculations of recharge that occurs along the river.

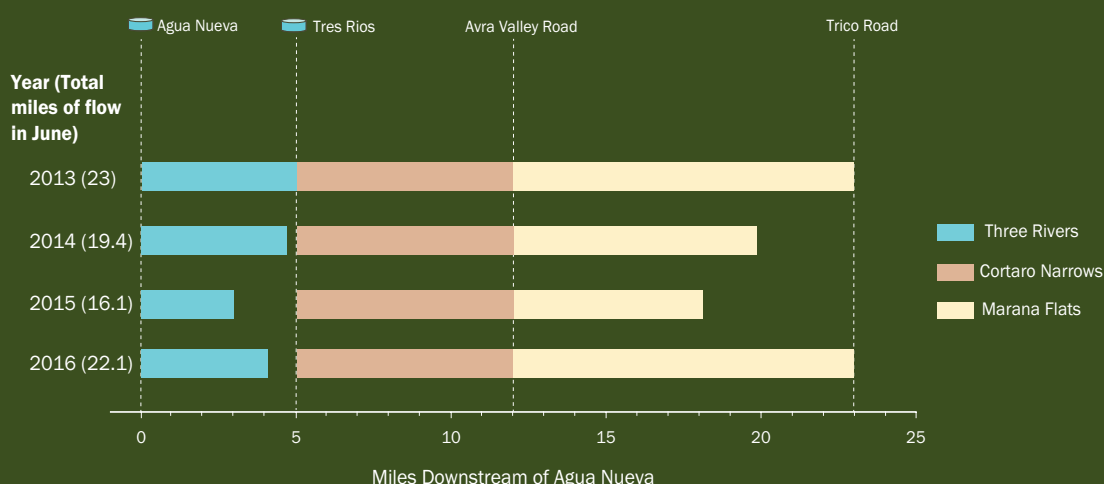
Flow at Trico Road

Miles of flow in June in each reach prior to the monsoon season determines the minimum extent of flow during the driest time of year. This is typically measured on one morning in mid-June. **Flow at Trico Road**, located at the farthest end of the study area, estimates daily changes in maximum flow extent through the three reaches by counting the “dry days,” or days with no streamflow.

2013	2014	2015	2016
Number of Dry Days	0	94	244	109

Flow extent decreased and varied seasonally after the 2014 upgrades. In June, prior to the start of the summer monsoon, only Cortaro Narrows flowed through the whole reach. Dry days at Trico Road have increased. Reduced flow extent is likely due to increased recharge, though water management is also an important factor. Agua Nueva released less effluent into the river, contributing to drying in Three Rivers. Marana Flats drying is more complex. In this reach, water is diverted by an earthen berm for irrigation of agriculture and for recharge at Marana High Plains, a constructed basin adjacent to the river. The berm failed just before the June 2016 survey, and likely increased miles of flow. Failure of this berm several times in 2016 may have also decreased the dry days at Trico Road. Conversely, failure of a different berm increased dry days in 2015 by diverting flow into a pit. This occurred when a large flood in September 2014 moved the location of the low-flow channel and breached a berm along the El Rio Preserve, a former borrow pit near the start of Marana Flats. This allowed water to flow into the pit and form “Lake Marana.” The river stopped flowing into the lake in January 2015 when a flood moved the low-flow channel again, demonstrating nature’s contribution to water management.

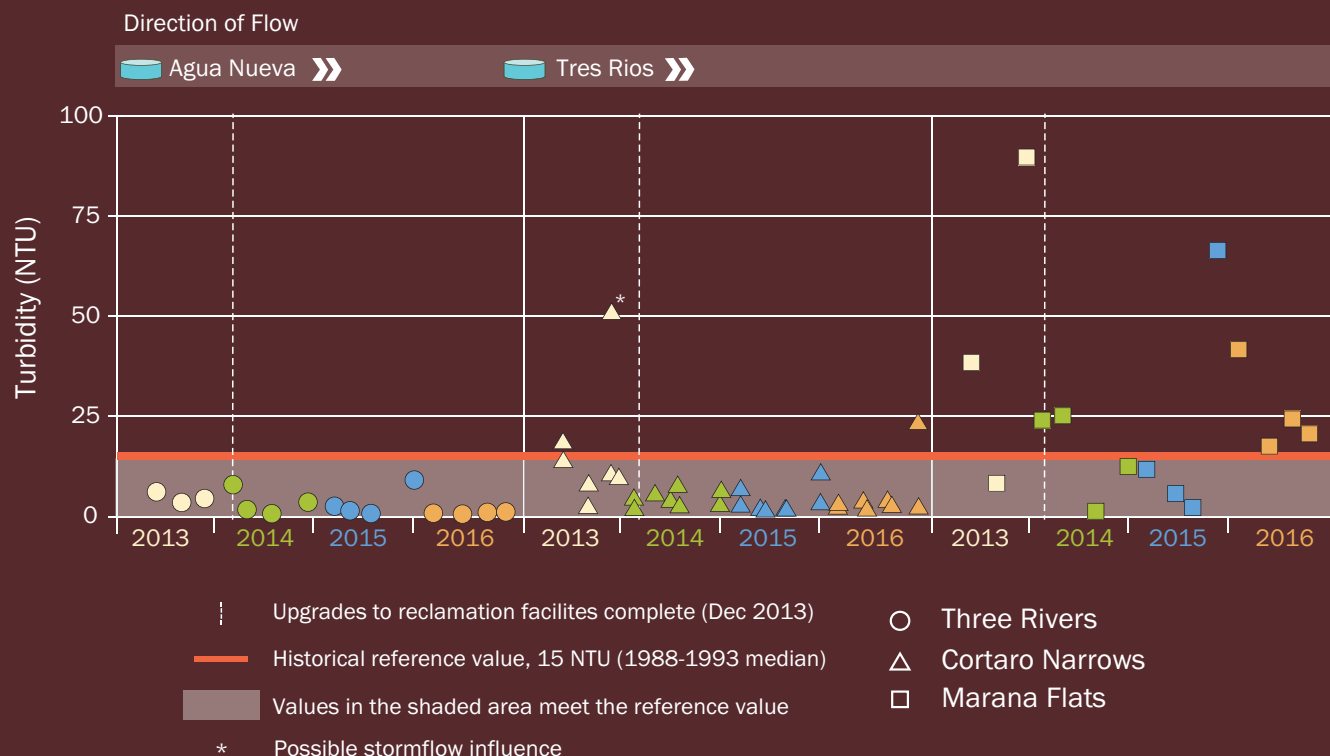
capture prey. **Turbidity** measures water clarity, or how far you can see through the “dust storm,” and is reported in Nephelometric Turbidity Units (NTU). High NTU indicates the water is cloudy and hard to see through. The 1988-1993 median level of turbidity in the Cortaro Narrows reach was 15 NTU. ADEQ does not have a standard for turbidity, so this assessment uses 15 NTU as a historical reference value.

Turbidity was measured a total of 49 times. Overall, the reference value was met 61 times (80%). Turbidity decreased most notably in Marana Flats after the upgrade was complete, though it has been higher and more variable in the last year.

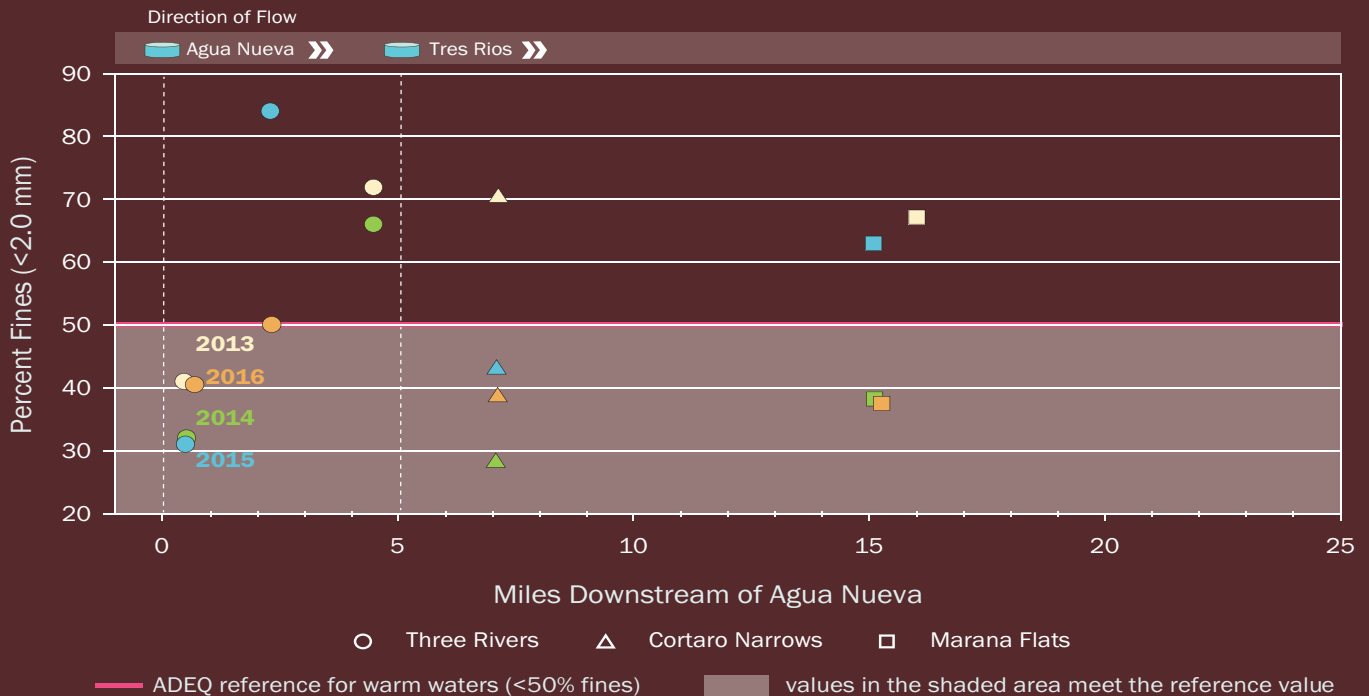
Percent fines is an estimate of the portion of the riverbed comprised of small sediments (≤ 2 mm in diameter). Fines, or “muck,” that settle out of the storm onto the riverbed can become so abundant that they smother aquatic life and habitat. ADEQ does not have a standard for rivers dominated by effluent. This assessment uses the reference value for warm-water rivers, $<50\%$.

Percent fines were estimated at all of the sites where macroinvertebrate samples were collected. Overall there was a reduction in the percent fines covering the riverbed at these sites. Due to reductions in flow extent, survey sites located at around 4 miles and 16 miles downstream of Agua Nueva had to be shifted upstream to around 3 miles (in 2015) and 15 miles (in 2014) respectively. There was greater variability in levels of percent fines at these sites, perhaps due to variable flow conditions in these areas. For example, more particles may settle out of river flows that have slowed as extent has diminished.

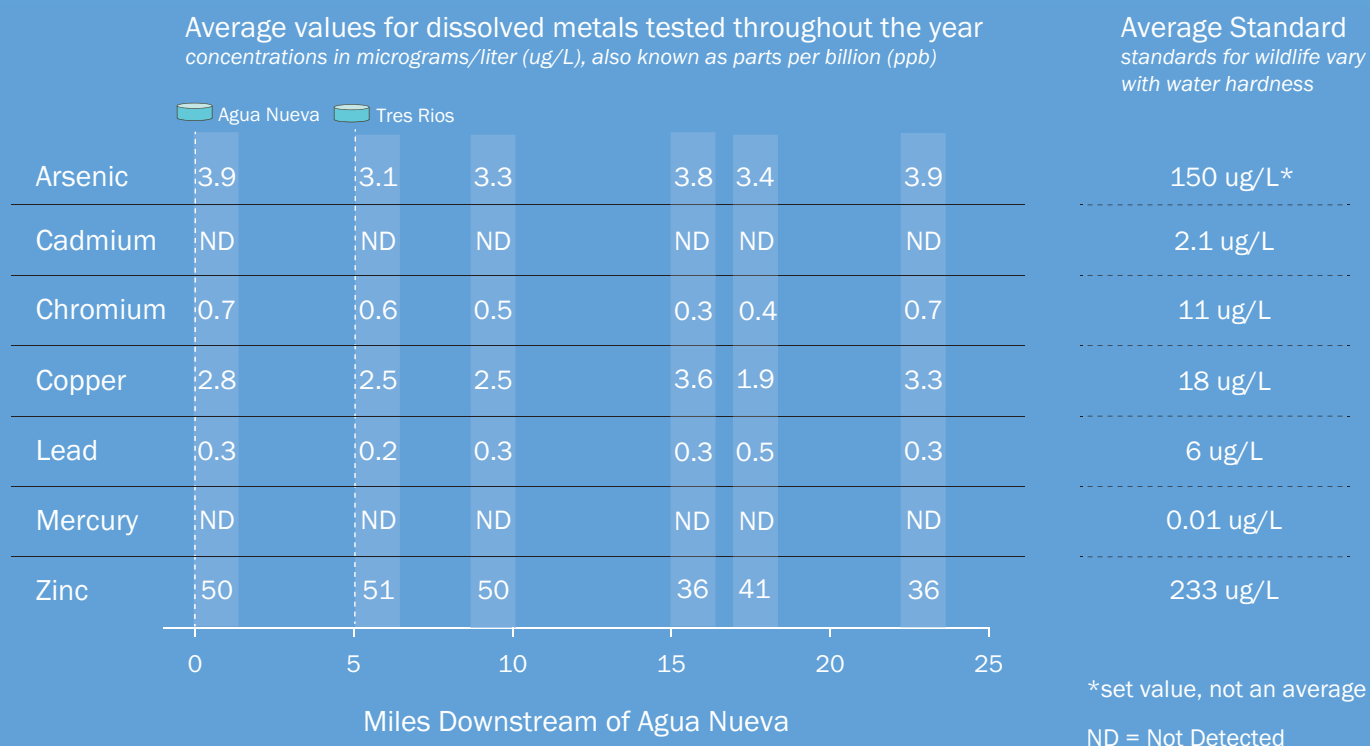
metals through numerous sources, including mine drainage, roadways, and by the release of metals naturally occurring in near-surface rocks and sediments. ADEQ has set standards for the protection of aquatic wildlife. Results for the following metals are compared to their appropriate standard: arsenic, cadmium, chromium, copper, lead, mercury, and zinc.

All samples tested over the four years have met the appropriate standard for the following dissolved metals: arsenic, cadmium, chromium, copper, lead, mercury, selenium, and zinc.

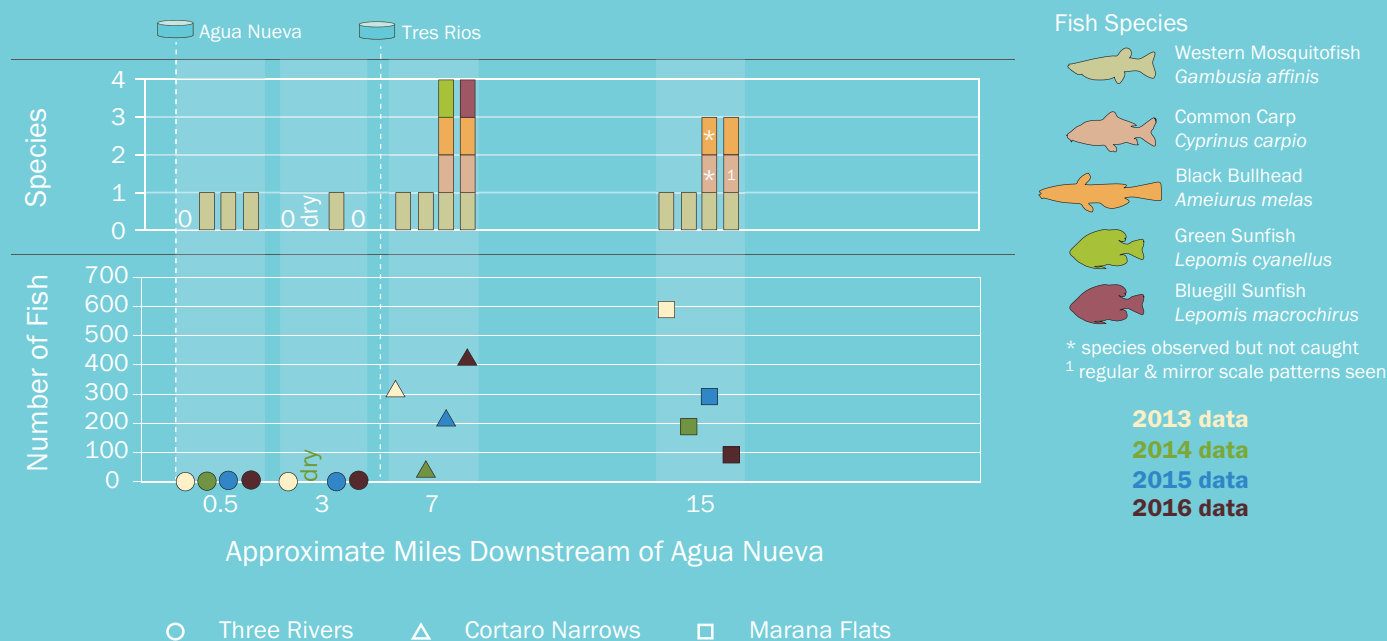
Fish surveys were conducted annually in the fall at the same four locations that macroinvertebrates were surveyed. The aim was to detect species and general fish numbers, but not population numbers. Improvements in water quality have allowed fish to thrive again. Cortaro Narrows may provide the best habitat for fish since the survey location in this reach has recorded the highest numbers of fish and species. Overall, number of fish species observed has increased from one to five. Though large fish, likely Common carp, were seen in spring of 2014, these larger species were not observed or captured until the 2015 survey. A large flood in September 2014 may have killed these species or washed them past Trico Road and beyond the study area. This flood may also explain the lower overall number of fish captured in 2014.

Fish presence has expanded upstream to Three Rivers, though only Western Mosquitofish were found in very low numbers in this reach. Flows in Three Rivers are often very shallow and may not provide habitat for the other larger species. In time, large floods may bring back native species, since the Longfin Dace and Gila Topminnow are found in the Upper Santa Cruz in Santa Cruz County.

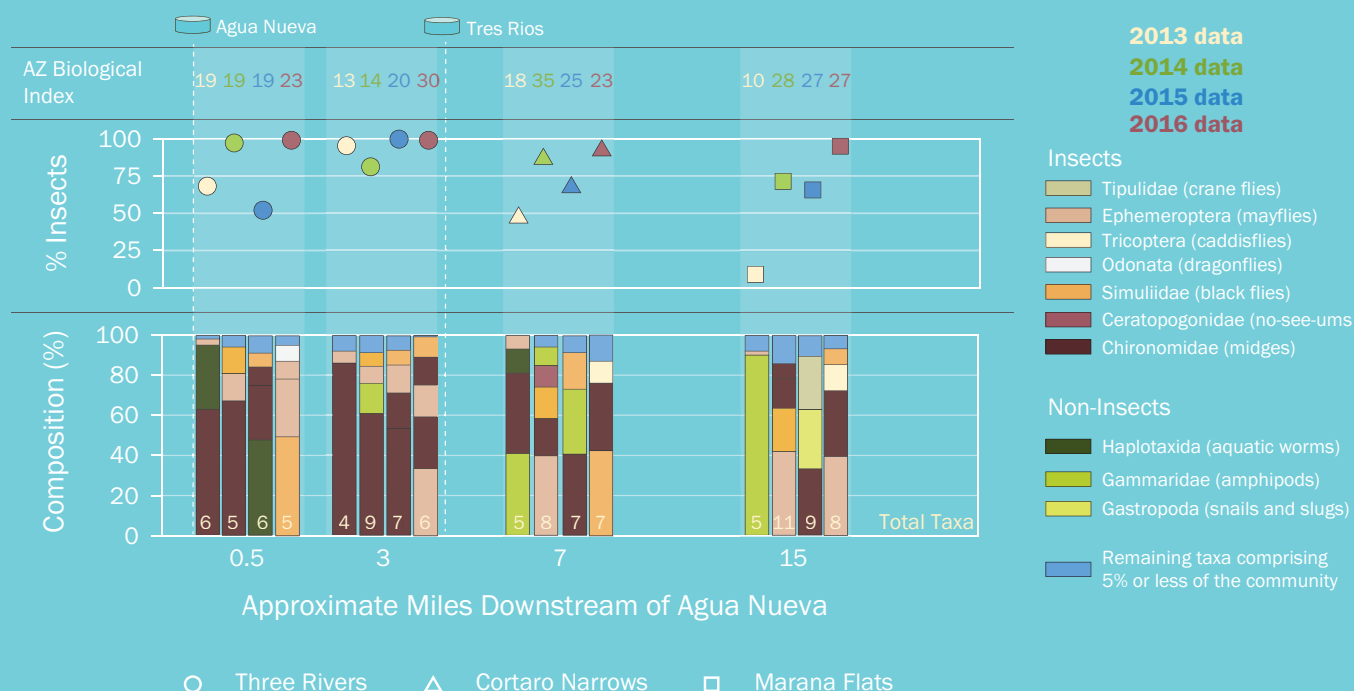
Regardless of sensitivity to pollution, if a single species or group accounts for more than 50% of the community, this lack of diversity suggests a stream is impaired. Lastly, the ADEQ index of biological integrity defines standard conditions for aquatic invertebrates in warm-water streams: a value of >50 meets the standard, 40-49 is inconclusive, <39 is impaired. The index does not apply to effluent-dominated rivers, but is a reference to track improvements over time.

The aquatic invertebrate community was surveyed annually at the same four locations that fish were surveyed. Overall, there were signs of improvement. Diversity was higher after the upgrades were complete, with number of taxa at each site increasing. Increased diversity is also demonstrated by the smaller percentage of the community composed of a single group. If the dominant group is more than 50% of the community, river life is thought to be impaired. While this increased diversity is supported by an increase in the biological index scores, the scores remain below 39 and suggest that river life is impaired. Marana Flats may have shown the most change and most consistent improvement in terms of composition, % insects, and overall index. Continued monitoring will determine the level of improvements at all the sites.

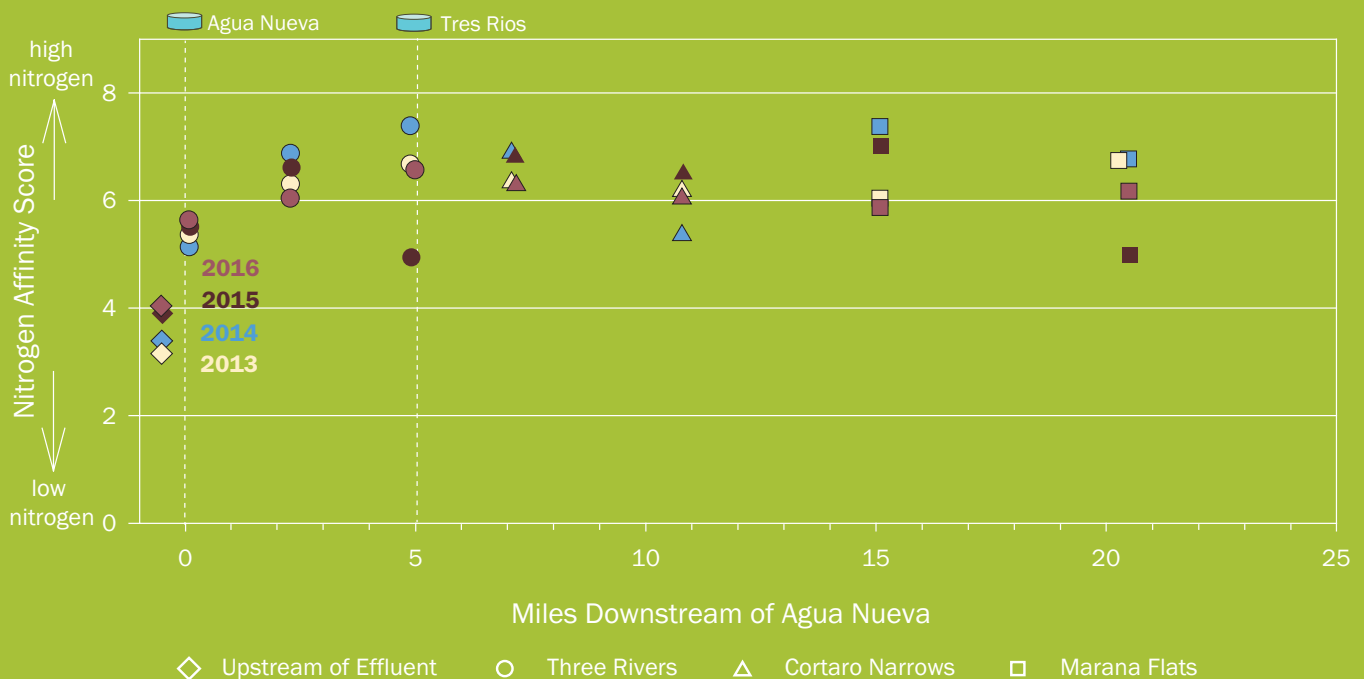
and different grasses. High scores (>5) indicate that the majority of plants grow well with high levels of nitrogen, like cattails and common sunflowers. Changes in nitrogen affinity scores likely reflect changes in water quality, either an increase or decrease in nutrients in the water. Results from the 2013 water year will serve as a baseline.

Nitrogen affinity score was determined for eight total locations along the river. Overall, scores have remained similar at most sites. Scores averaged 6.2 downstream of Agua Nueva. This suggests that stream-side plants that grow well in high nitrogen environments were most common immediately downstream of the reclamation facilities. Just upstream of the study area a reference site had the lowest scores and was dominated by plants that grow well with low levels of nitrogen. Two sites (approximately 5 and 20 miles downstream) appeared to shift toward more low-nitrogen plants in 2015. Though we may expect this shift from reduced nutrient pollution, reduction in water presence and soil moisture may be the bigger factor. Both of these sites experienced dry conditions more frequently in water year 2015 and were dry at time of survey in 2015. These same sites shifted back towards nitrogen-loving plants in 2016, when water was present again at time of survey. So both nitrogen affinity and wetland indicator seem to indicate presence of permanent water in the channel or high soil moisture. This is supported by a high correlation of the nitrogen scores with wetland scores; plants with high nitrogen scores had very low wetland scores, or more simply, the wetland plants in our area love nitrogen.

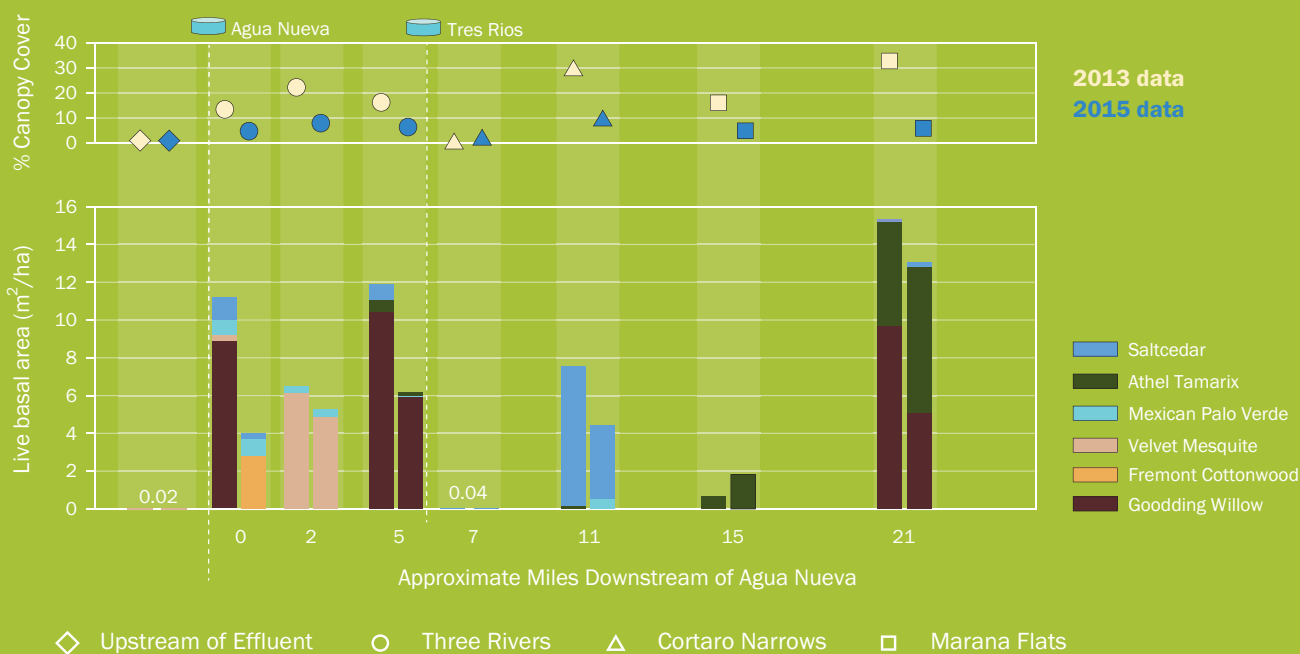
and are more sensitive to reductions in soil moisture. Velvet mesquite and non-native tamarix species, such as Athel tamarix and saltcedar, have deeper roots and can tolerate a greater range of soil moisture. Trees grow slowly, and amount of cover is not likely to change on an annual basis, unless vegetation is affected by sustained drying or large floods. Tree cover was measured in 2015, and results from the 2013 water year serve as a baseline.

Overall tree cover, as measured by basal area and percent canopy cover, decreased between 2013 and 2015 (trees were not measured in 2016). Most notable was the decrease in cover of Goodding's Willow. Decrease in cover of mature trees is likely the result of decreased flow extent. There may not have been enough moisture to support more shallow rooted trees like Goodding's Willow. More monitoring will be needed to determine if effluent continues to support mature riparian trees in all three reaches, and whether the community shifts to deeper rooted trees such as velvet mesquite and non-native tamarix species.
