SANTA CRUZ RIVER CONDITIONS NOGALES WASH TO AMADO 2023

2008 TO 2022 WATER YEARS

A LIVING RIVER - SANTA CRUZ RIVER NOGALES WASH TO AMADO Supplementary Report—2023

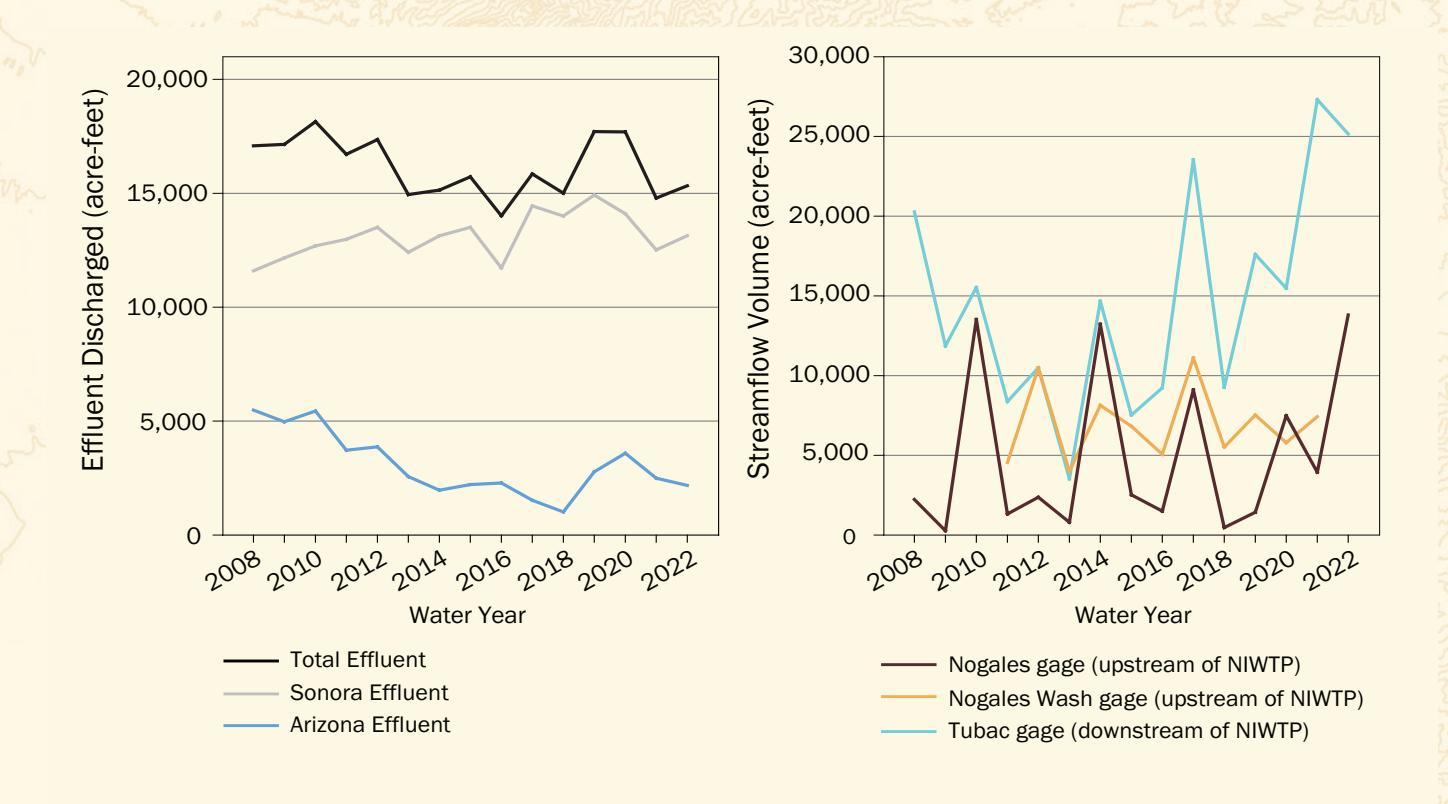
The total volume of effluent released annually into the river has varied. Between 2013 and 2018, the volume released decreased by an average of 2,000 acre-feet (over 650 million gallons). This represents about a 12% decrease compared to 2008. Although diversions of wastewater to

the Los Alisos Treatment plant in Nogales, Sonora began in 2013, this decrease in effluent volume appears to result from reduced volume of wastewater attributed to Nogales, Arizona. In 2019 and 2020, the total effluent released returned to levels comparable to 2008. Exact reasons for this increase are unknown, though frequent failure of pumps diverting flows to the Los Alisos Treatment Plant is likely one factor. The increased volume was temporary, and in 2021 releases returned to a lower level similar to what was seen between 2013 and 2018.

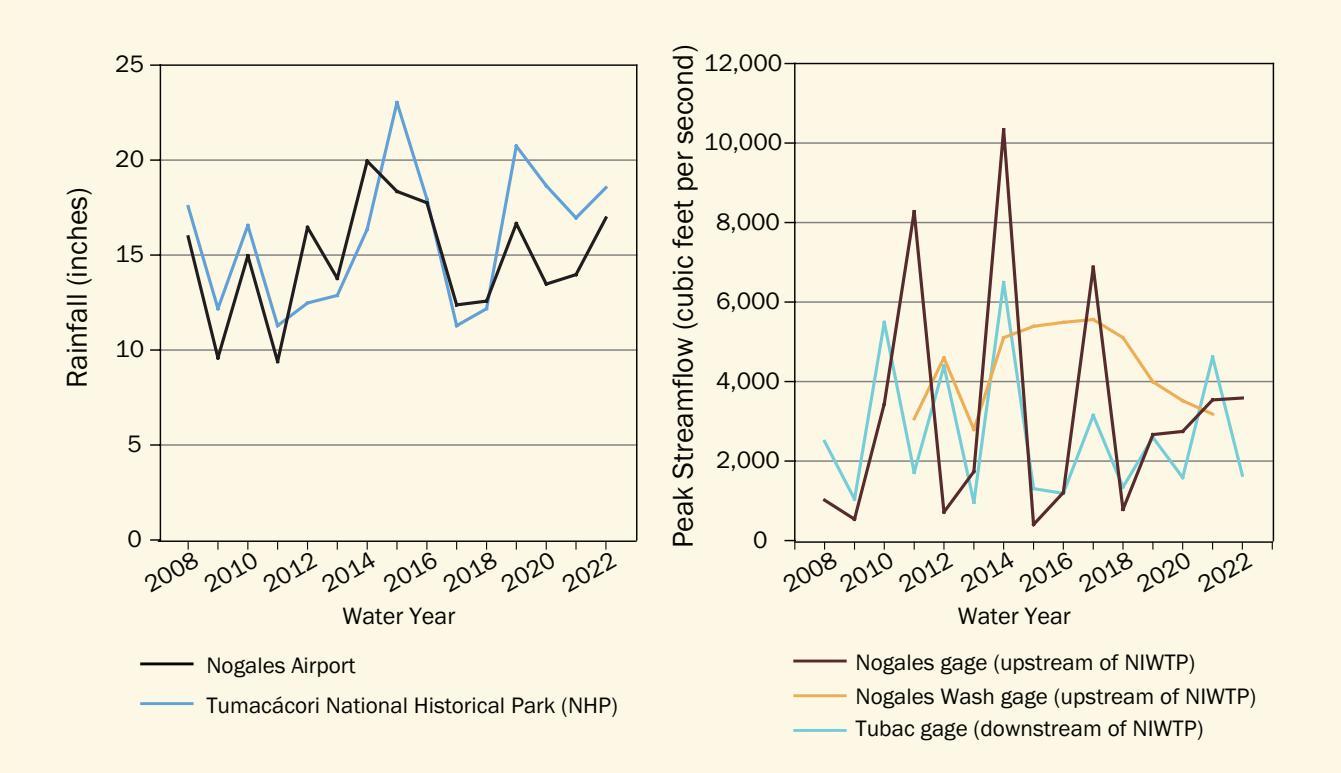
Streamflow is measured daily in Tubac, near the international border, and along Nogales Wash (2011–2021). Overall, total volume of streamflow has been variable at all three locations. The greatest total volume of streamflow was measured in Tubac in the 2021 water year, with most streamflow occurring during the summer monsoons. Although it did not reach the same level, streamflow in 2022 remained higher than previous years, with a spike in August.

Total rainfall has hovered around an average of 15 inches at Nogales Airport. Sixteen miles to the northwest, rainfall near Tumacácori National Historical Park has been similar and averaged 16 inches. Rainfall in 2022 was greater than 2021, and followed a similar pattern in both years with most of the rain falling during the summer monsoon season.

Peak streamflow has varied with location. Flooding conditions have often been higher upstream of the treatment plant than in Tubac with the largest flood recorded at the Nogales gage near the international border. Flows in Tubac have been variable, with the highest peak flow occurring in 2014. Between 2014 and 2018, peak streamflow in Nogales Wash was fairly stable, although it has been decreasing since.

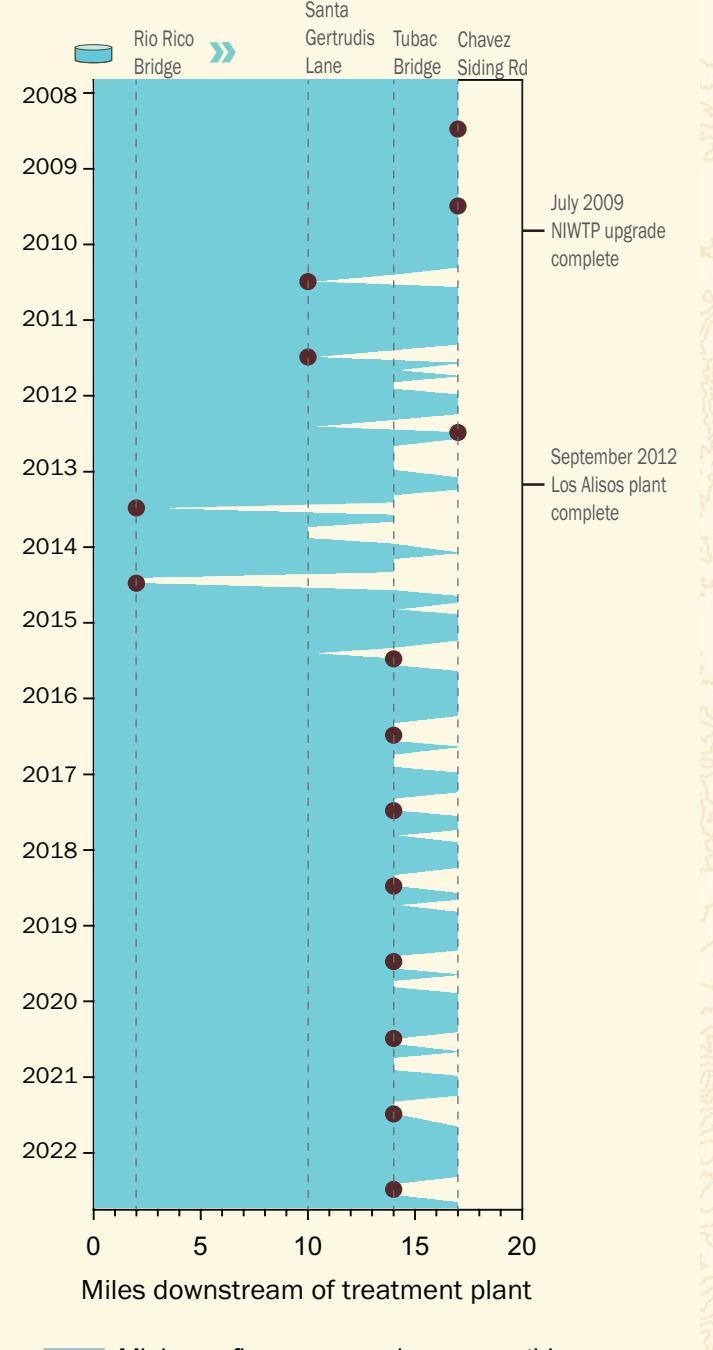
Minimum flow measured once monthlyMinimum flow in June

Prior to 2010, the river flowed 17 miles from the treatment plant to the Amado reach, even in June. Since the volume of effluent released into the river did not significantly decrease after the 2009 upgrade, increased recharge from improved water quality is likely a major factor for the decreased flow extent in 2010 and 2011. The shortest measures of flow extent were observed in 2013 and 2014. This coincides with the start of wastewater diversions to the Los Alisos wastewater facility in Sonora, Mexico in 2012. However, the reductions in total volume of effluent released into the river between 2013 and 2018 are largely attributed to decreased wastewater coming from Nogales, Arizona (see Streamflow and Rainfall). Since 2014, flow extent has increased and stabilized, reaching at least 14-17 miles at different times through the year. The June flows have consistently reached at least 14 miles during this time as well.

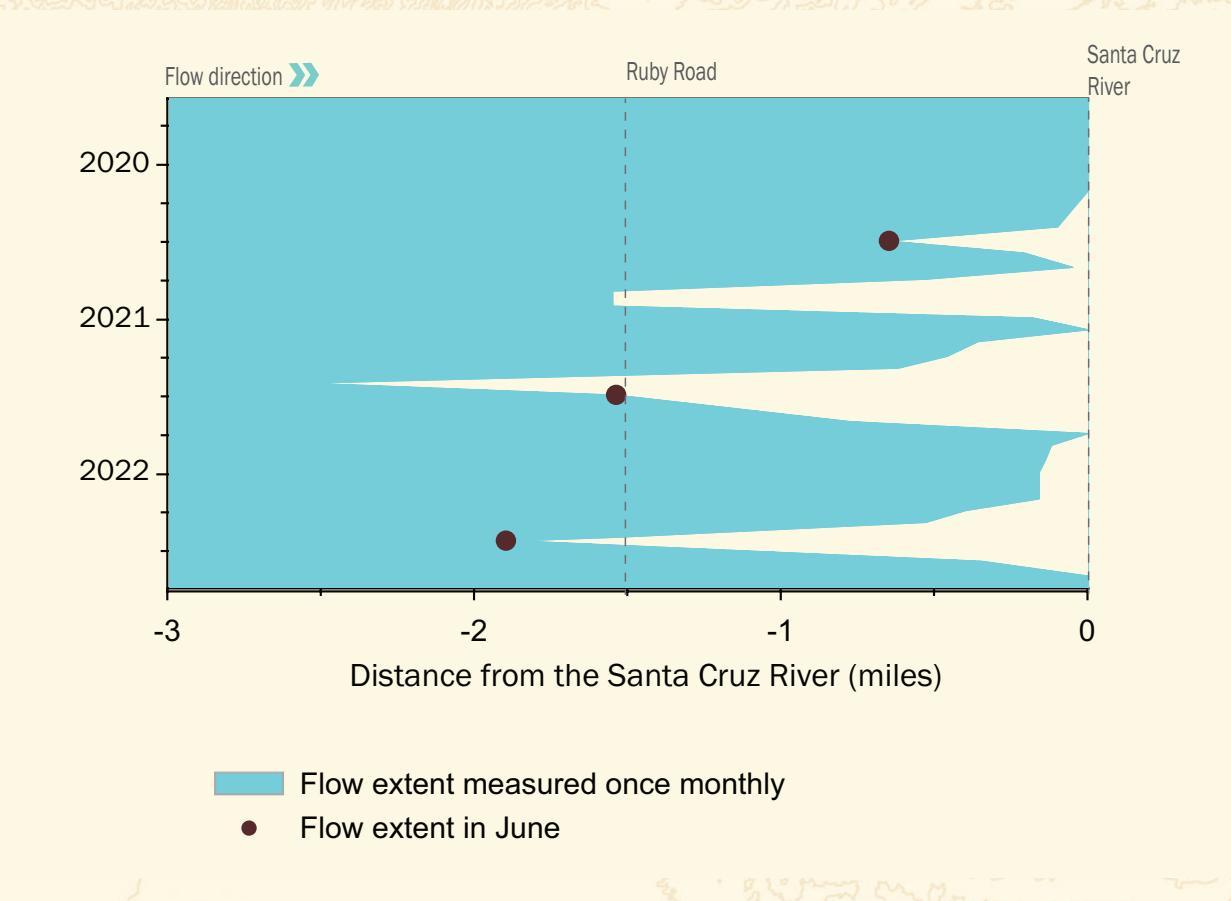
Between 2008 and 2019, Nogales Wash had water during all but three monthly visits to the monitoring site at Ruby Road. Dry conditions were observed only during June 2011, July 2013, and June 2014.

The expanded monitoring since 2019 initially revealed stable flows reaching all the way to the Santa Cruz River. These flows have been more variable since 2020, and do not always reach the river. In May of 2021, the flow retreated as far back as 2.5 miles from the confluence, and the Ruby Road site was dry two months in a row. In June 2022, the flow ceased almost 2 miles from the river, but had met the river again by August.

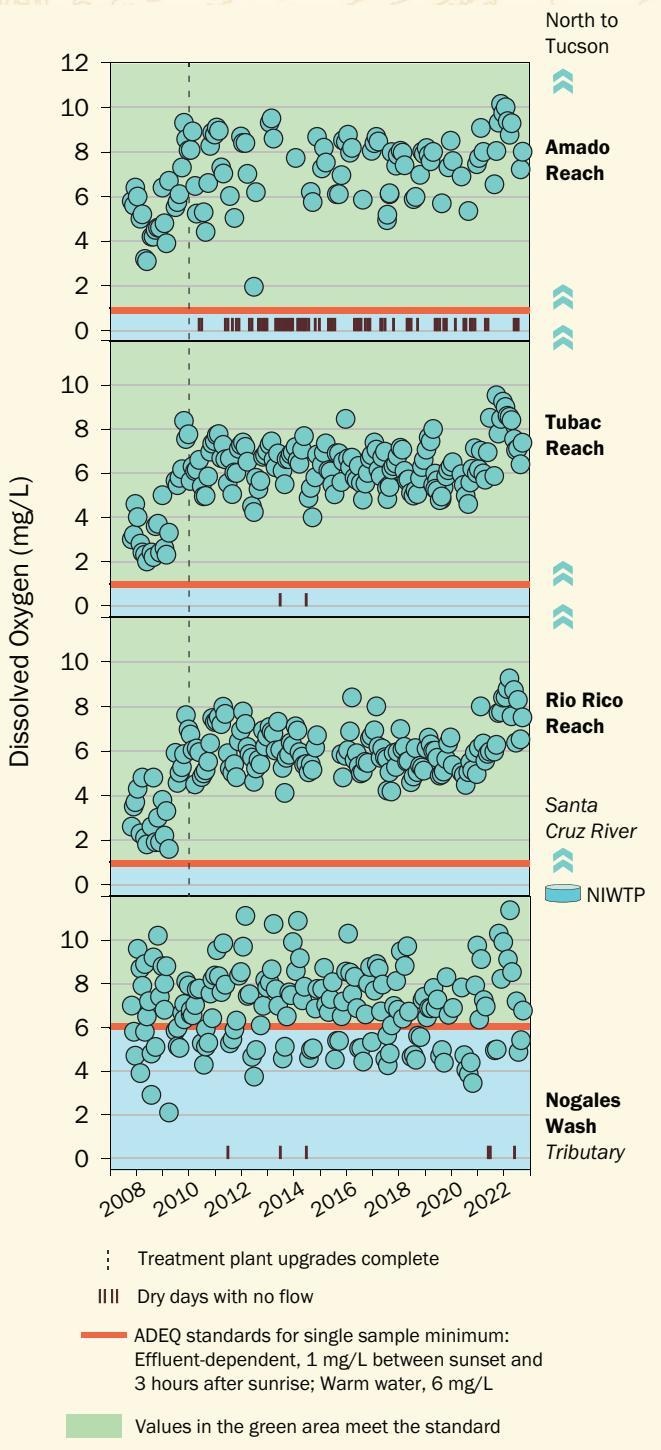
Levels of dissolved oxygen have met the standard in all three reaches of the Santa Cruz. Dissolved oxygen increased after upgrades to the treatment plant were completed in 2009. Although there have been more days with no flow in the Amado reach in recent years, when water is present, levels of dissolved oxygen have met the standard.

In Nogales Wash, levels of dissolved oxygen have been stable and 118 of 173 samples have met the warm water standard (they attained the standard 68% of the time). Treatment plant upgrades did not impact conditions in Nogales Wash.

In 2022, dissolved oxygen levels increased at all test sites, both in the river and Nogales Wash, the reason for which is unknown at this point.

Values in the blue area do not meet the standard

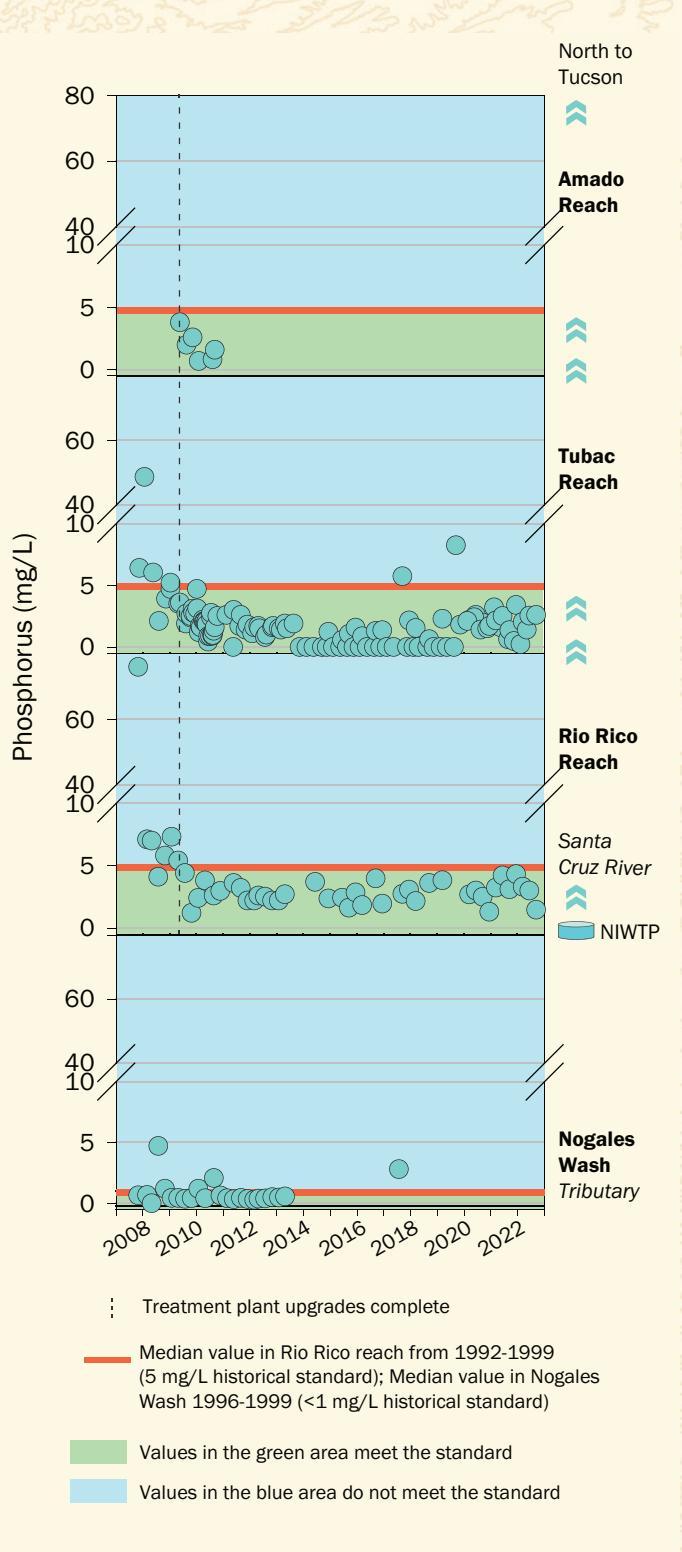
Phosphorus levels declined in the Rio Rico and Tubac reaches, most notably after the upgrades to the treatment plant were complete in 2009. Aside from a couple of samples in the Tubac reach, levels have remained low. In the Amado reach this data is unavailable after 2011, but measures of total phosphorus are below the historical standard.

Nogales Wash has limited data and treatment plant upgrades did not impact conditions. All but five samples met the historical standard. The only sample since 2013 was taken in 2017 during a sewage breach, when untreated wastewater was flowing out of the International Outfall Interceptor and into Nogales Wash.

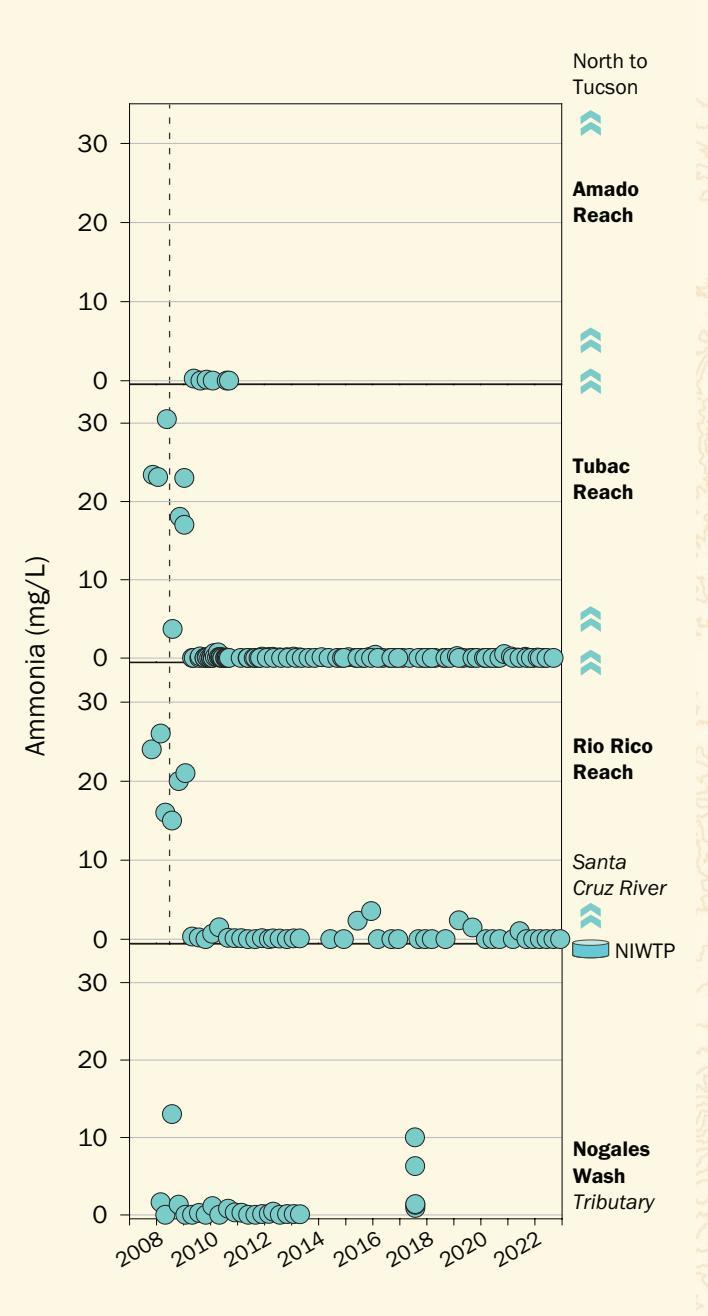
Ammonia decreased dramatically and was often not detected in the Rio Rico and Tubac reaches after the treatment plant upgrade was complete in 2009. This improved water quality led to beneficial conditions for fish and other aquatic wildlife. Although data are limited for the Amado reach during this period, between 2000 and 2007 measures of ammonia averaged 10 mg/L and followed a similar pattern to the Rio Rico and Tubac reaches. The decreased ammonia likely reduced the clogging effect in the river bed and was a factor in the reduced flow extent observed since 2009.

Since the treatment plant upgrade, only 5 sampling events have detected elevated ammonia levels that averaged 2.25 mg/L in the Rio Rico reach. Removal of ammonia is complex. The NIWTP uses a multi-step process that features alternating oxygenated and oxygen-free zones and must regularly optimize processes to maintain the delicate balance of oxygen needed for maximum ammonia removal.

Nogales Wash was not impacted by the upgrades to the treatment plant. Ammonia levels here were low, averaging 1.4 mg/L from 2008–2013. Measures of ammonia from 2017 were taken during a sewage breach when untreated wastewater was flowing out of the International Outfall Interceptor and into Nogales Wash.

Treatment plant upgrades complete

Note - Ammonia standards vary with temperature and pH and can't be graphed as a single line.

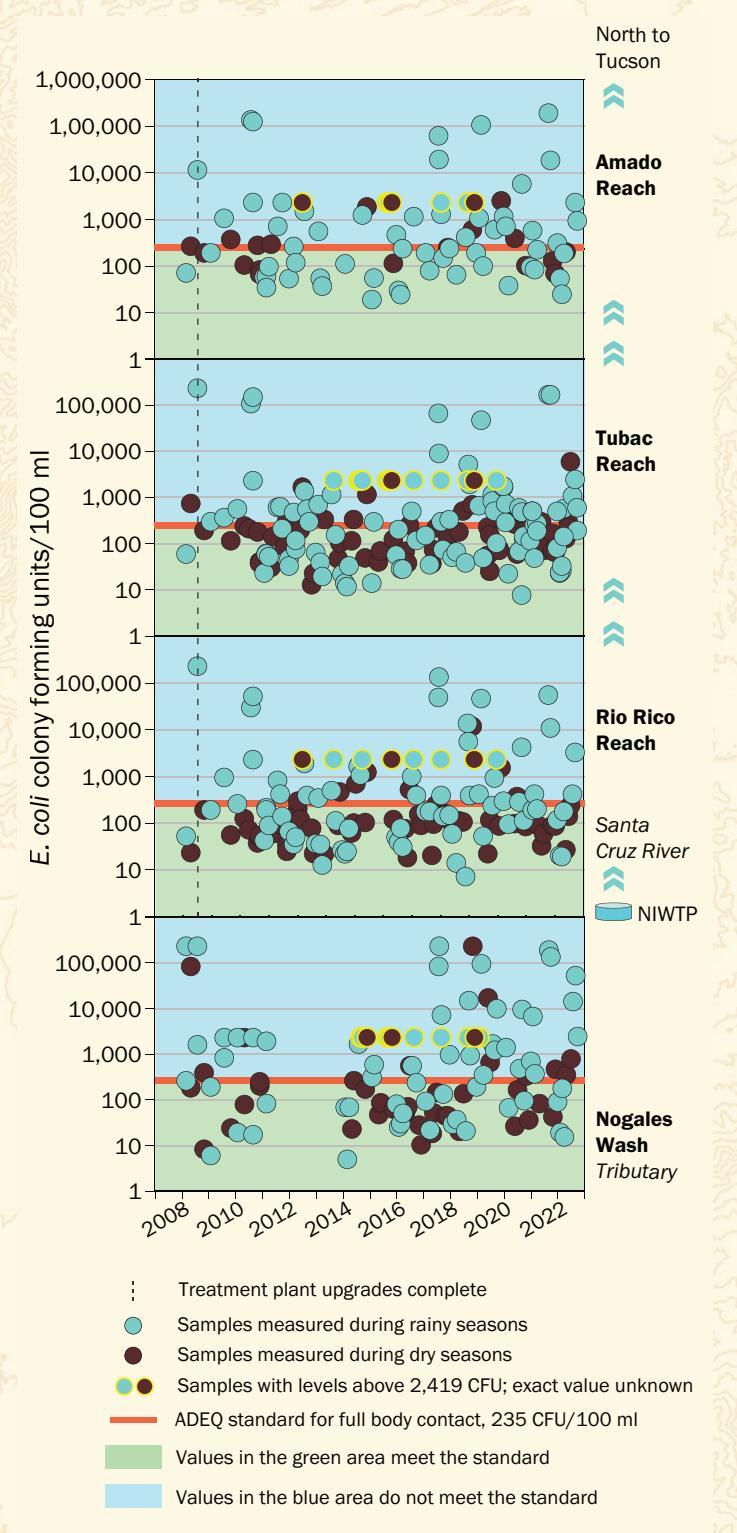
*E.* coli levels varied seasonally and were similar in all three reaches of the river and in Nogales Wash. The Nogales International Wastewater Treatment Plant has always treated for bacteria prior to release of effluent in the Santa Cruz, thus levels of *E.* coli in the effluent did not change after the upgrades were complete. Levels of *E.* coli exceeded the standard most often during the rainy seasons.

High levels at all sites during the rainy season suggest that rain is washing fecal contamination into the river from multiple sources within the watershed. Research published in 2019 reported that microbial markers associated with humans and ruminants (sheep, goats, cattle, and deer) were the markers most frequently detected and were strongly correlated with flooding conditions.<sup>1</sup>

One source of *E. coli* contamination is the aging wastewater infrastructure along Nogales Wash. Several of the exceedances in Nogales Wash from 2017 were from samples taken during a sewage breach when untreated wastewater was flowing out of the International Outfall Interceptor and into Nogales Wash. Repairs began in 2022 and will be ongoing through 2024.

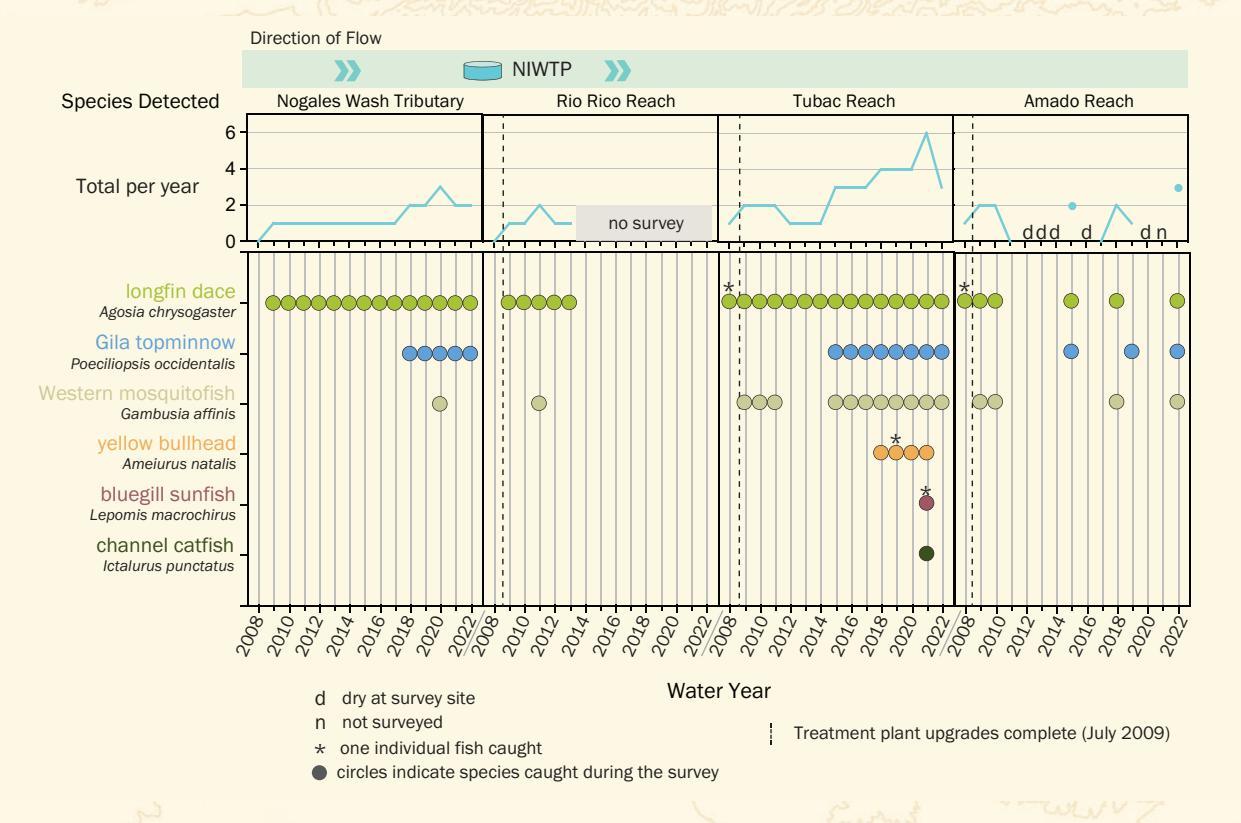
Annual fish surveys in the fall determine fish presence and species in Nogales Wash and at several locations downstream of the treatment plant. In 2008, only longfin dace were found, and in very low numbers (2 individual fish caught). After the treatment plant upgrade, the number of fish species increased to as many as 6 in 2021 (two native and four non-native). The endangered Gila topminnow returned to the river in 2015 and the relative ease of capturing them during surveys suggests they are thriving. In 2021, two new non-native species were identified in the Tubac reach: the channel catfish (*Ictalurus punctatus*) and bluegill sunfish (*Lepomis macrochirus*). In addition, a hybrid of the native Gila topminnow (*Poeciliopsis occidentalis*) and the non-native headwater livebearer (*Poeciliopsis monacha*) of Mexico was identified in 2022, although further research is needed to determine its potential impact on the endangered native. Surveys in 2022 found only longfin dace, Gila topminnow, and the everpresent non-native Western mosquitofish. Conditions in the Amado reach have been occasionally dry at the time of survey and thus may no longer represent perennial habitat.

Though not affected by the treatment plant upgrade, Nogales Wash has also seen an increase in fish species, most notably with the return of the Gila topminnow in 2018. The *Poeciliopsis occidentalis-monacha* hybrid has been found here too. Though not included in this summary, longfin dace were found in Nogales Wash in 2007. The reason why no fish were found in this area during the baseline year is unknown.

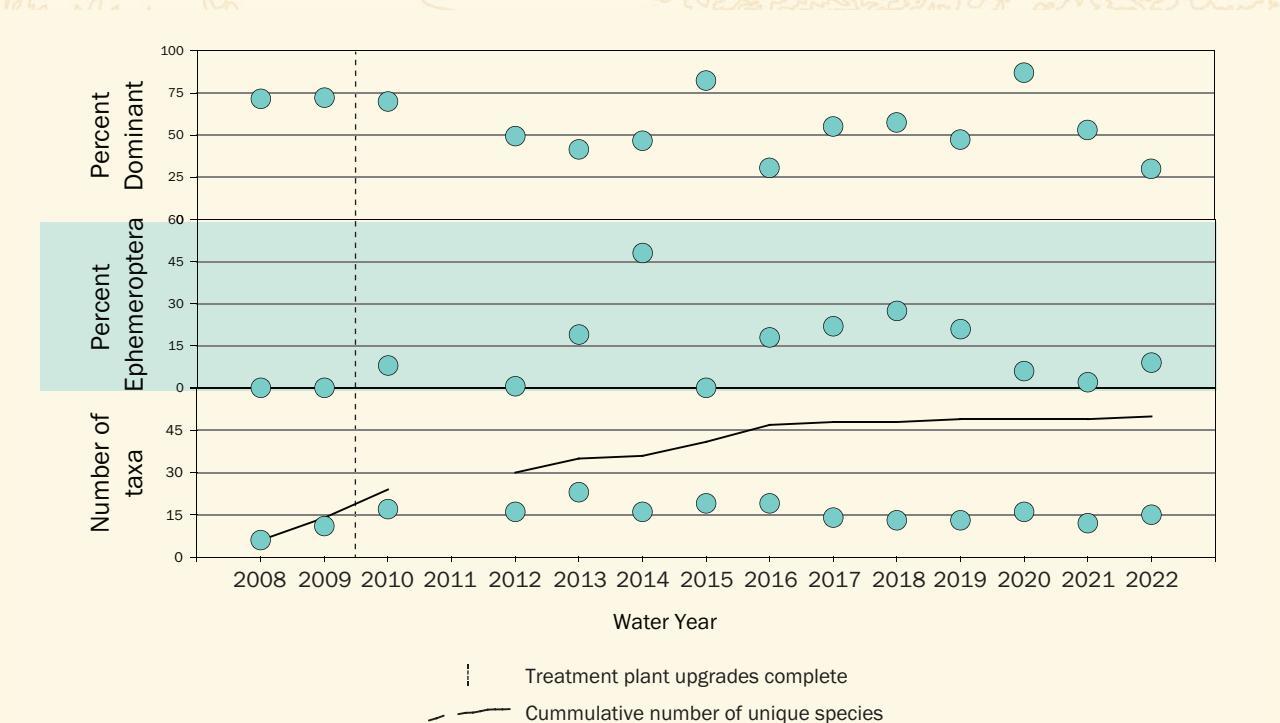
The percent of the community dominated by a single group has decreased, but still hovers around the 50% threshold. This suggests that the river may be under environmental stress. The percent of the aquatic community comprised of pollution-sensitive Ephemeroptera increased after the treatment plant upgrade, suggesting improvements in aquatic conditions, but dropped again in 2020 and have remained low since then. Furthermore, only 6 unique species were found in 2008. Since the upgrade, the number of unique species found increased to an annual average of 15 species. The cumulative number of unique species has also increased, reaching 49 by 2019. As only 2 new species have been found since 2016, the rate of increasing diversity may be slowing or reaching equilibrium.

Drier conditions and more variable flow in 2013 and 2014 may help explain some of the variability seen between 2013 and 2015. Further monitoring will be needed to determine if the aquatic invertebrate community will continue to improve.

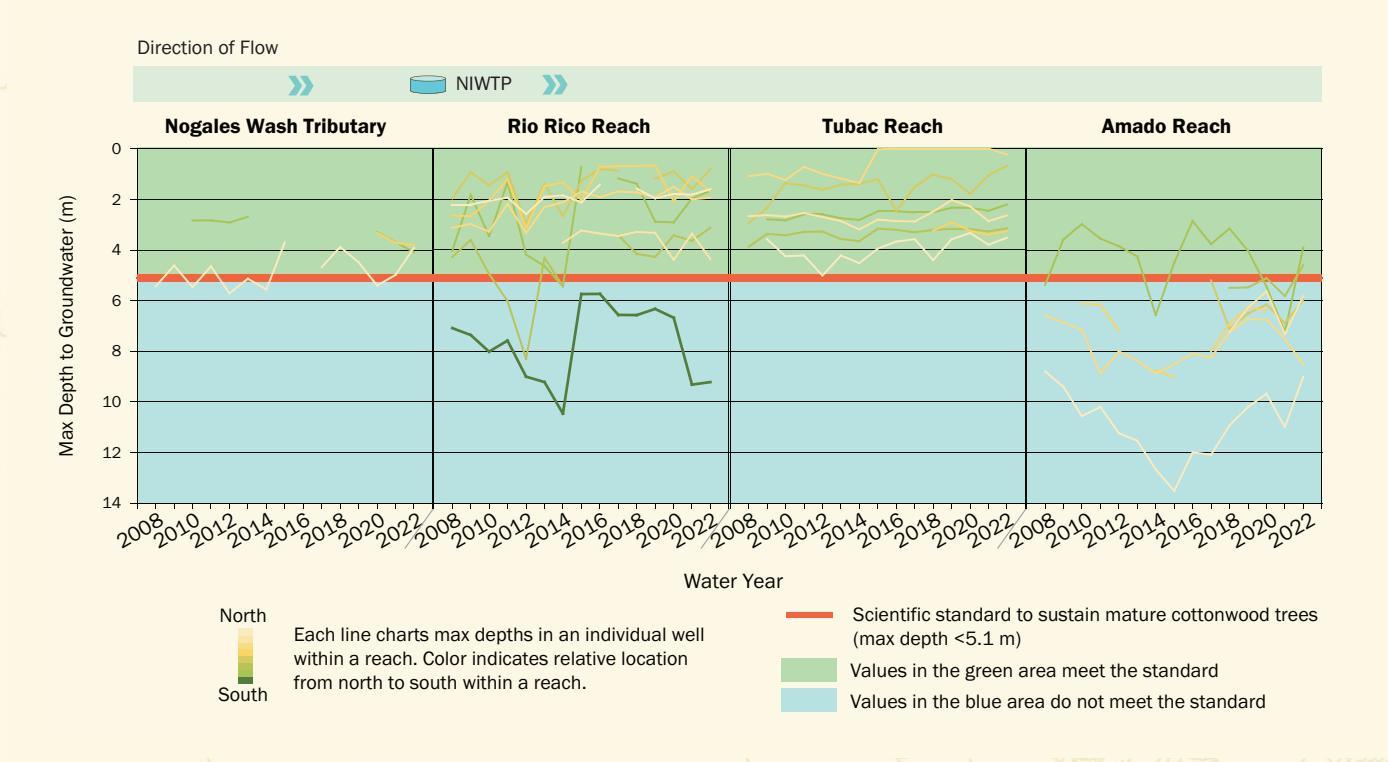
In Rio Rico, the wells with measurements below the standard are further south, near the beginning of the reach, representing wells closest to the release of effluent. In contrast, several wells in the Amado reach that were below the standard are located at the far northern end of the reach and represent wells that are furthest away from the release of effluent. The best conditions for supporting cottonwoods may be along the Tubac reach in between, where geologic and hydrologic conditions are optimal and the recharge of effluent is possibly highest.

Depths in Nogales Wash are a recent addition to this summary and tend to meet the standard. Farther north along the wash, depths increase toward the maximum depth that can still provide support for cottonwoods.

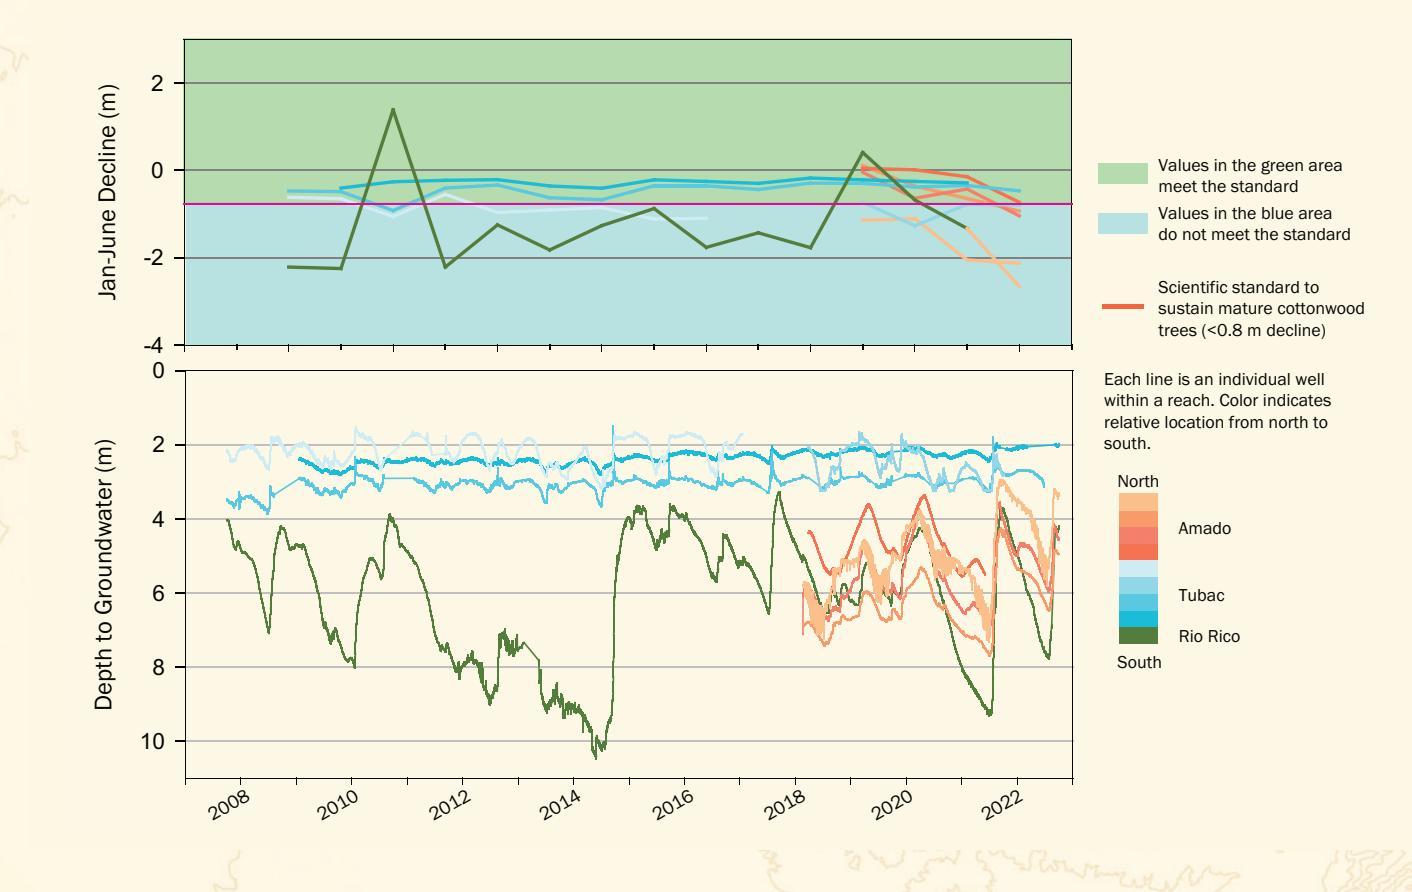
The number of wells with enough data to calculate the change in depth to groundwater from January to June varied over the years. Some wells with less frequent monitoring did not have enough data, or data were collected at the incorrect time to determine the decline. Wells with continuous monitoring are shown below. As with maximum depth to groundwater, variability in depth to groundwater in the Tubac reach appears low and the January to June standard was met at several well locations, providing good conditions for cottonwood trees. Groundwater variability was higher in the Rio Rico and Amado reaches, though data are limited.

Rio Rico had enough data only in one well, which is located at the southern end of the flowing reach, near the location where effluent is released from the treatment plant. Though the January to June standard was met a couple times, overall, the depths to groundwater appear to be deeper in this area.

Sonoran Institute launched a groundwater monitoring program in the Amado reach in 2018 that is providing additional data on groundwater levels in this reach. Wells closer to Tubac were more often meeting the standard than those at the northern end. This area may support cottonwoods but historically has been an area that transitions to the larger and deeper Tucson groundwater basin and tends to have fewer cottonwood and willow trees.

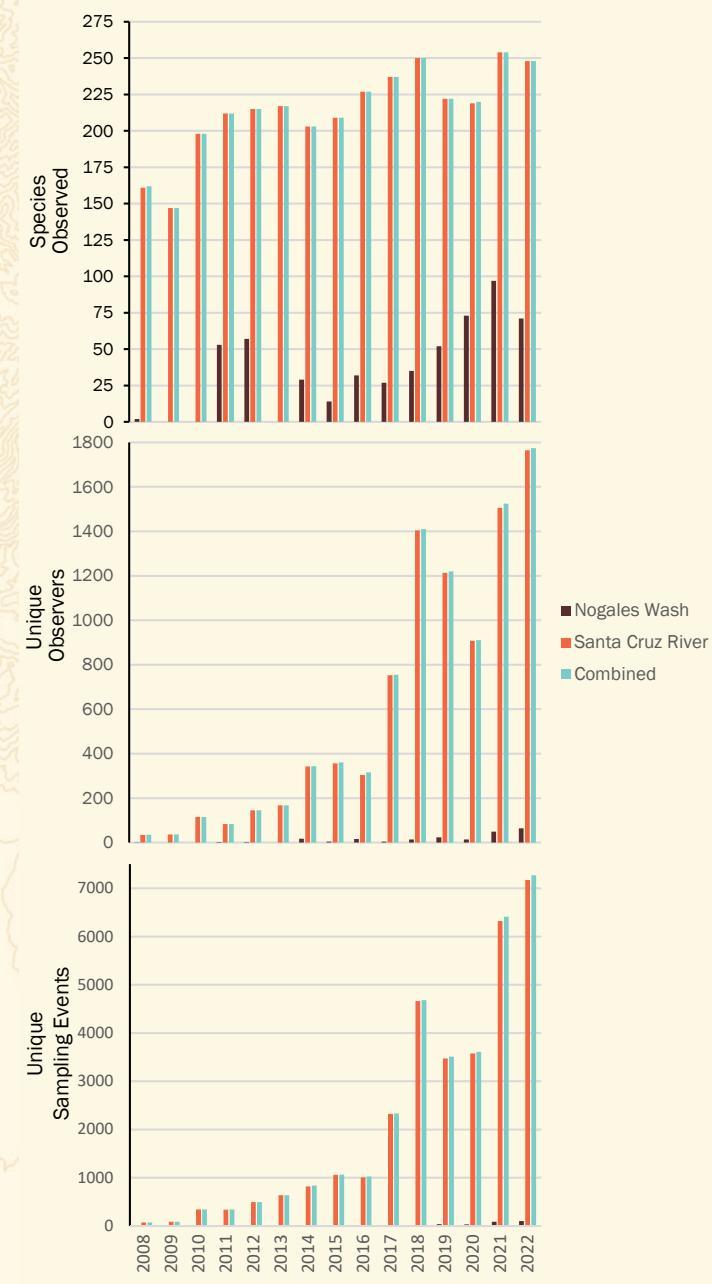
Numbers of observations submitted to eBird from along the Santa Cruz and Nogales Wash have been steadily climbing, with a noticeable increase starting in 2018 in both the number of observers and the number of observation events along the Santa Cruz. A similar jump in numbers along the Nogales Wash occurred in 2020. The highest number of species observed in one year across both areas was in 2021, when 254 total unique species were logged.
