a living river

CHARTING WETLAND CONDITIONS OF THE LOWER SANTA CRUZ RIVER 2014 Water Year

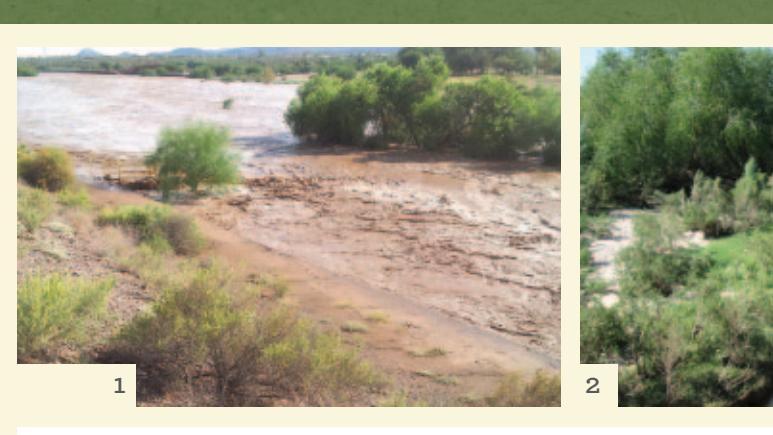
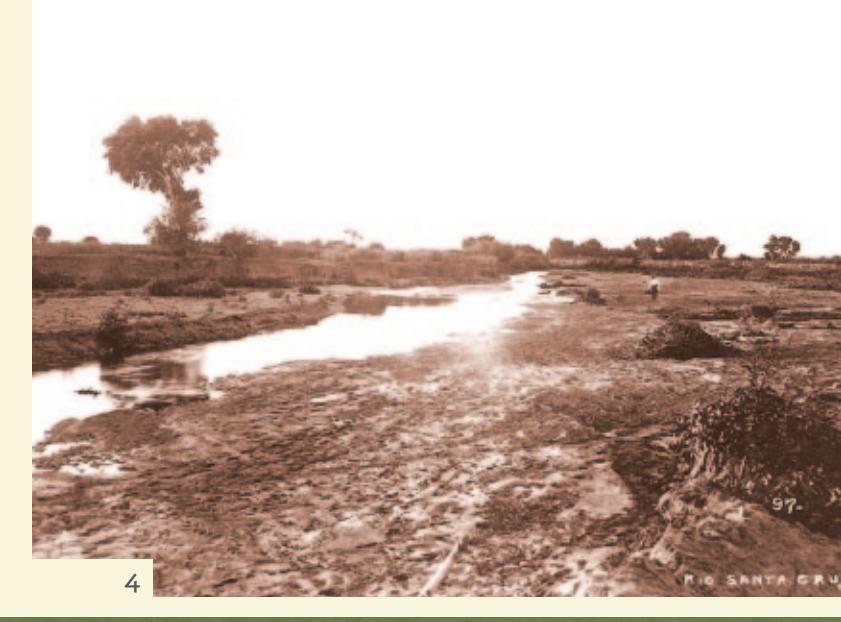
- 1. Looking southwest at floodwaters at the Agua Nueva outfall, September 2014
- 2. Flowing conditions near Sanders Road, October 2014
- 3. Dry conditions near Sanders Road, October 2014

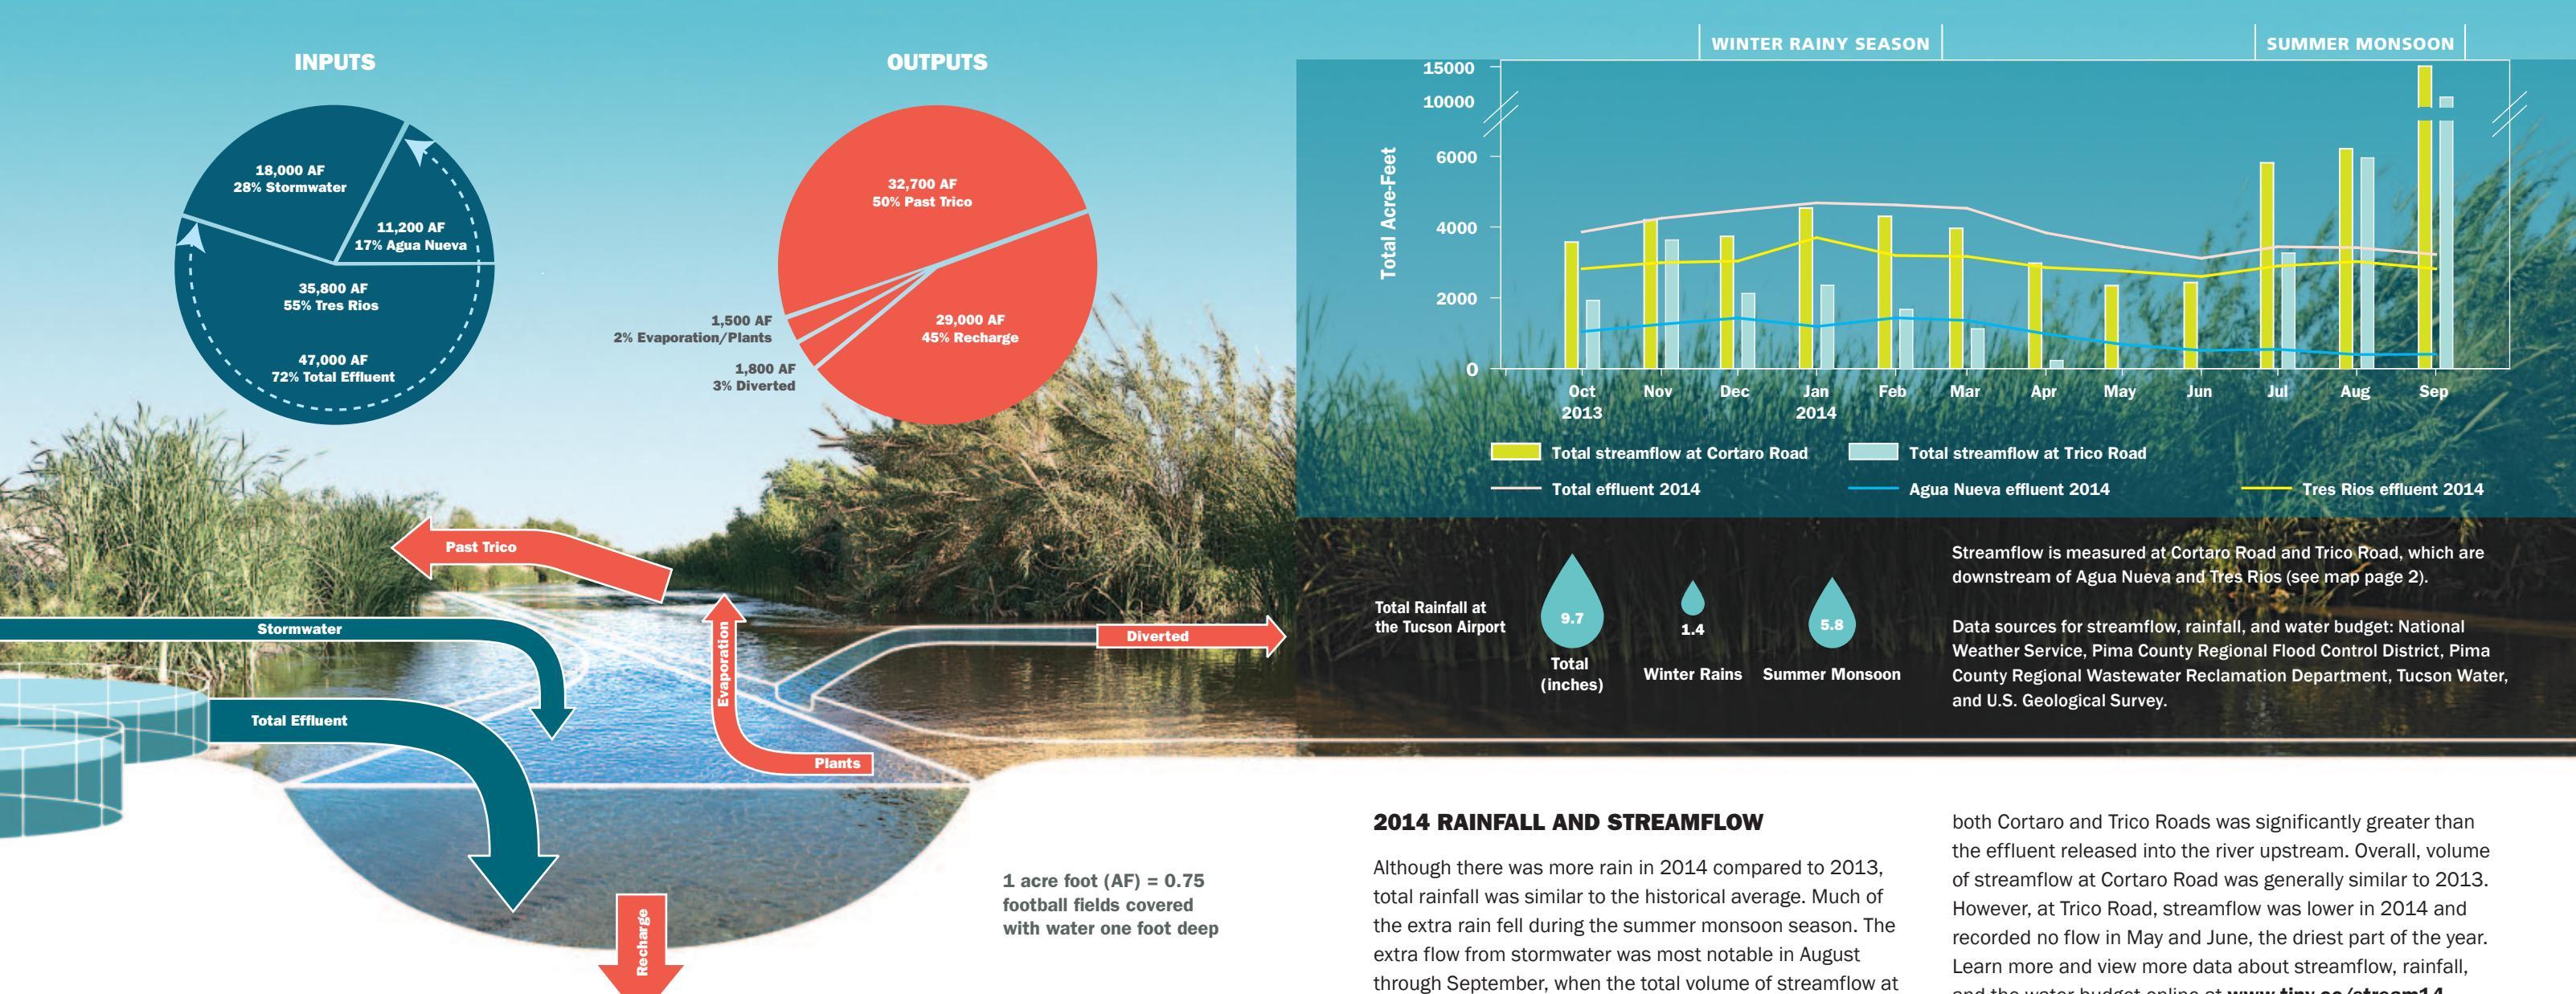
2014 WATER BUDGET

In comparison to 2013, total inputs were about 27% greater in 2014 from higher volumes of stormwater. In 2014 about 28% of the inputs came from stormwater, primarily from the summer monsoon season. In 2013, only 8% came from stormwater. Even with greater inputs, there was 12,000 AF more recharge in 2014 than in 2013, likely from increased infiltration rates in the riverbed after improved water quality

(see page 15). Although the total effluent released into the river remained similar to 2014, effluent releases from Agua Nueva have decreased, for two reasons. First, the facility upgrade resulted in some wastewater being redirected to Tres Rios and thus released further downstream. Second, more water was diverted to the reclaimed water system to irrigate Tucson's large turf areas. Compared to 2013, the volume of water diverted for irrigation increased by an average of 223 AF per month from March through September.

A water budget for the Lower Santa Cruz River estimates the water inputs and outputs. Inputs are effluent and stormwater, while outputs include water that does one of the following: flows past Trico Road (see map on page 2), evaporates or is used by wetland vegetation (a process called evapotranspiration), is diverted for agricultural use, or sinks into the riverbed to recharge local groundwater. Input and output volumes are totaled in acre-feet (AF), the number of acres that would be covered with water one foot deep.

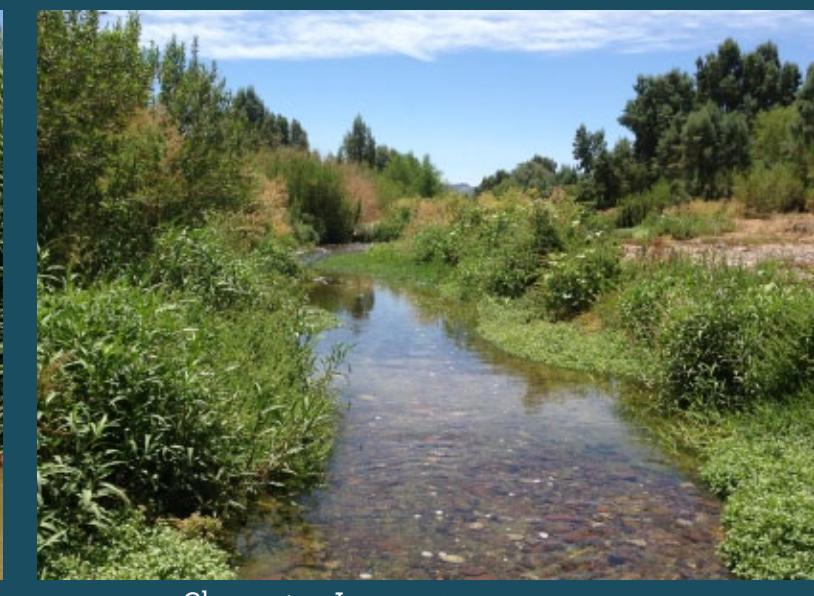
CATEGORY			2013 CONDITIONS	2014 CONDITIONS			
	FLOW Extent		Water was always flowing through all three reaches.	Flow extent decreased in both Three Rivers and Marana Flats (p. 12).			
	WATER Clarity	\bigcirc	High amount of particles moving through all three reaches during normal, non- flooding conditions. Materials in the water increased as the river flowed downstream.	Water clarity improved with reduced number of particles in the water column during normal, non-flooding conditions (p. 13).			
	WATER QUALITY		High levels of ammonia posed a health risk to aquatic life. Other measures met standards or provided a baseline for comparison in future assessments.	All water quality measures improved or remained similar to 2013. Most important were significant reductions in ammonia, improving conditions for aquatic wildlife (pp. 14–15).			
	AQUATIC WILDLIFE		No fish in Three Rivers, but Western Mosquitofish in Cortaro Narrows and Marana Flats. Aquatic invertebrate commu- nities in all three reaches suggest the river is impaired or under environmental stress.	Western Mosquitofish now found in all three reaches, but Three Rivers had less habitat with one site dry. Aquatic invertebrate communities showed some signs of improvement (pp. 16–17).	1. Cloudy water, May 2013

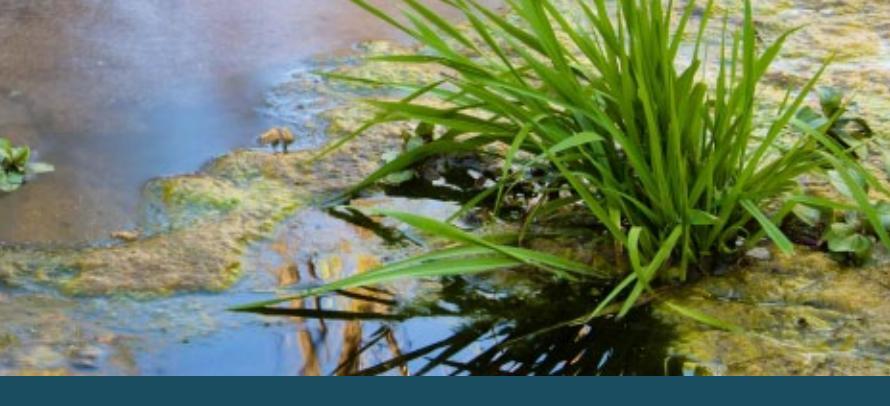
2. Clear water, June 2014
