# a living river

SANTA CRUZ RIVER 2025 DOWNTOWN TUCSON TO MARANA

## BUILDING RIVER COMMUNITY

SUPPLEMENTARY REPORT FOR 2013 TO 2024 WATER YEARS

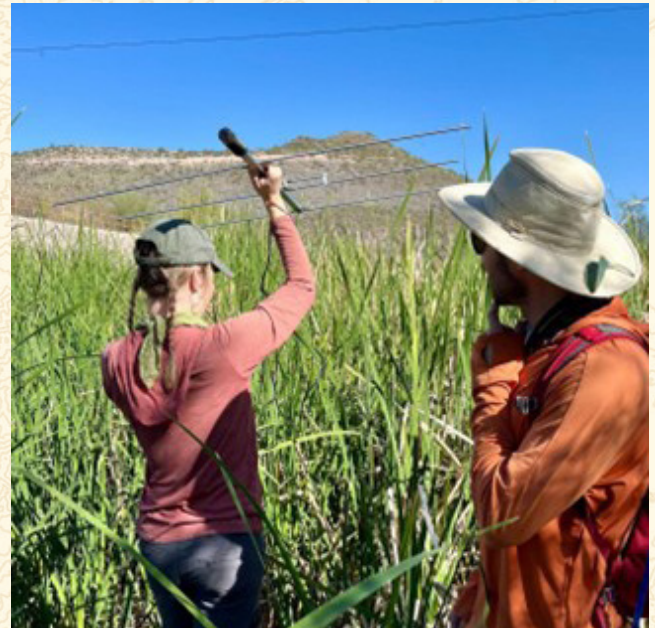
**Above left:** Map highlighting all the turtle trapping done in Fall 2024 (Sept & Oct) and where native and non-native turtles were found across all 60 trapping locations. Non-native turtles were far more abundant than native turtles; only two Sonoran Mud Turtles were found. **Above right:** Searching for translocated Sonoran mud turtles using a radio antenna receiver that 'listens' for the signal from the transmitter affixed to each turtle's shell.
